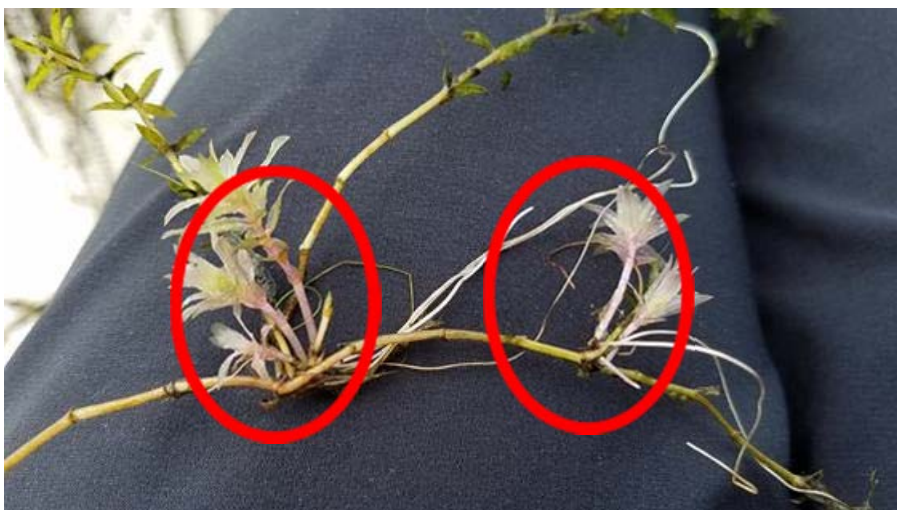
Photo: New growth tips highlighted.

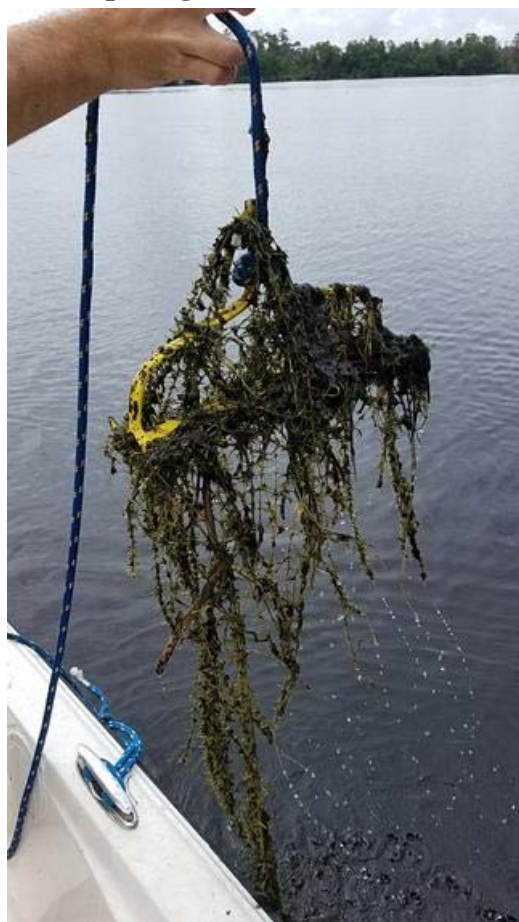
Photo: Hydrilla main stems decomposing.
