**Spring Lake (Lake Spring) MSBU  
Report for Fiscal Year (FY) 2011-2012 October 1, 2011 through September 30, 2012  
Lake Review Meeting Held July 11, 2012**

## **Spring Lake Inspections FY 2011-2012**

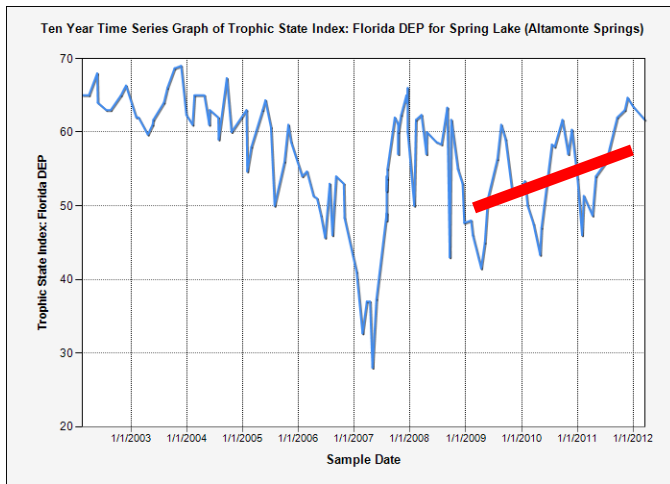
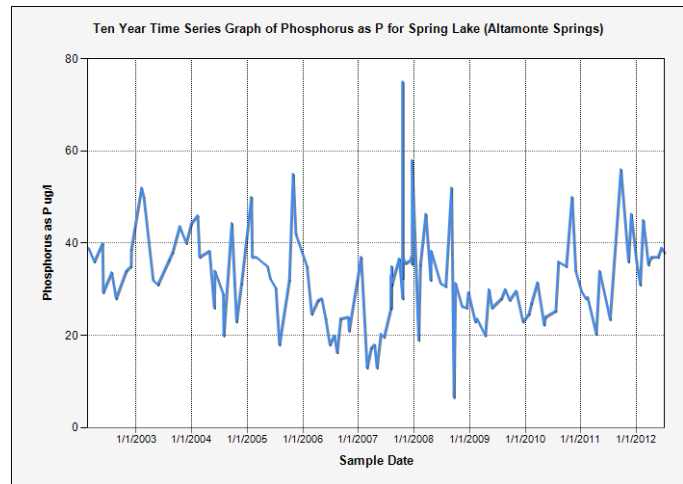
The two graphs below indicates nutrient levels (measured by TSI and/or Total Phosphorous [TP]) for your lake. A TSI score of 60 or above is considered an impaired (or polluted) lake. For Spring Lake, an increase in TSI and TP values has been recently documented. Continued reduction of TP sources (such as personal pollution inputs, run-off, landscaping practices, and shoreline erosion) can help reduce phosphorous in your lake that is abundantly available, potentially creating algae blooms, and negatively affecting TSI scores.

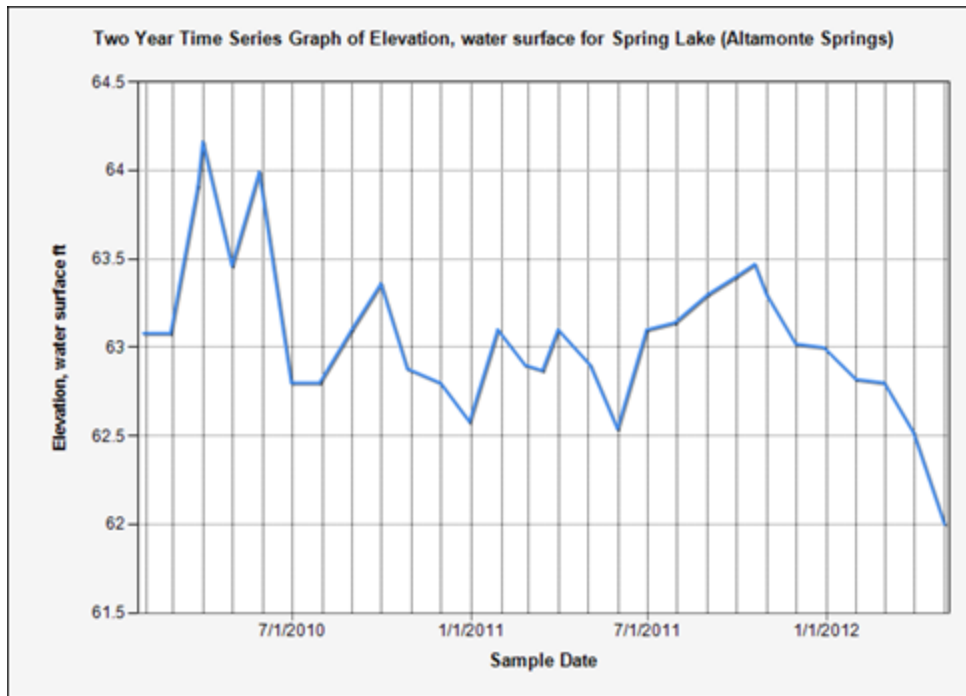
As experienced last year, as the water elevation within Spring Lake decreases, more eelgrass is exposed on the surface appearing as if the plant has expanded. Recent lake elevations indicate a 0.6 foot elevation change for your lake:

3/30	62.52 ft
4/30	62.00 ft
5/10	61.92 ft
