Greetings Howell Creek Residents!

On **December 18<sup>th</sup>, 2013**, Thomas Calhoun (Seminole County Lake Management Program) and Joey Cordell (Seminole County Watershed Management Intern) surveyed the aquatic plants in **Howell Creek and Lake Waumpi**.

On **February 10<sup>th</sup>, 2014**, Thomas Calhoun (Seminole County Lake Management Program) and Joey Cordell (Seminole County Watershed Management Intern) surveyed the aquatic plants in **Howell Creek and Lake Waumpi**.

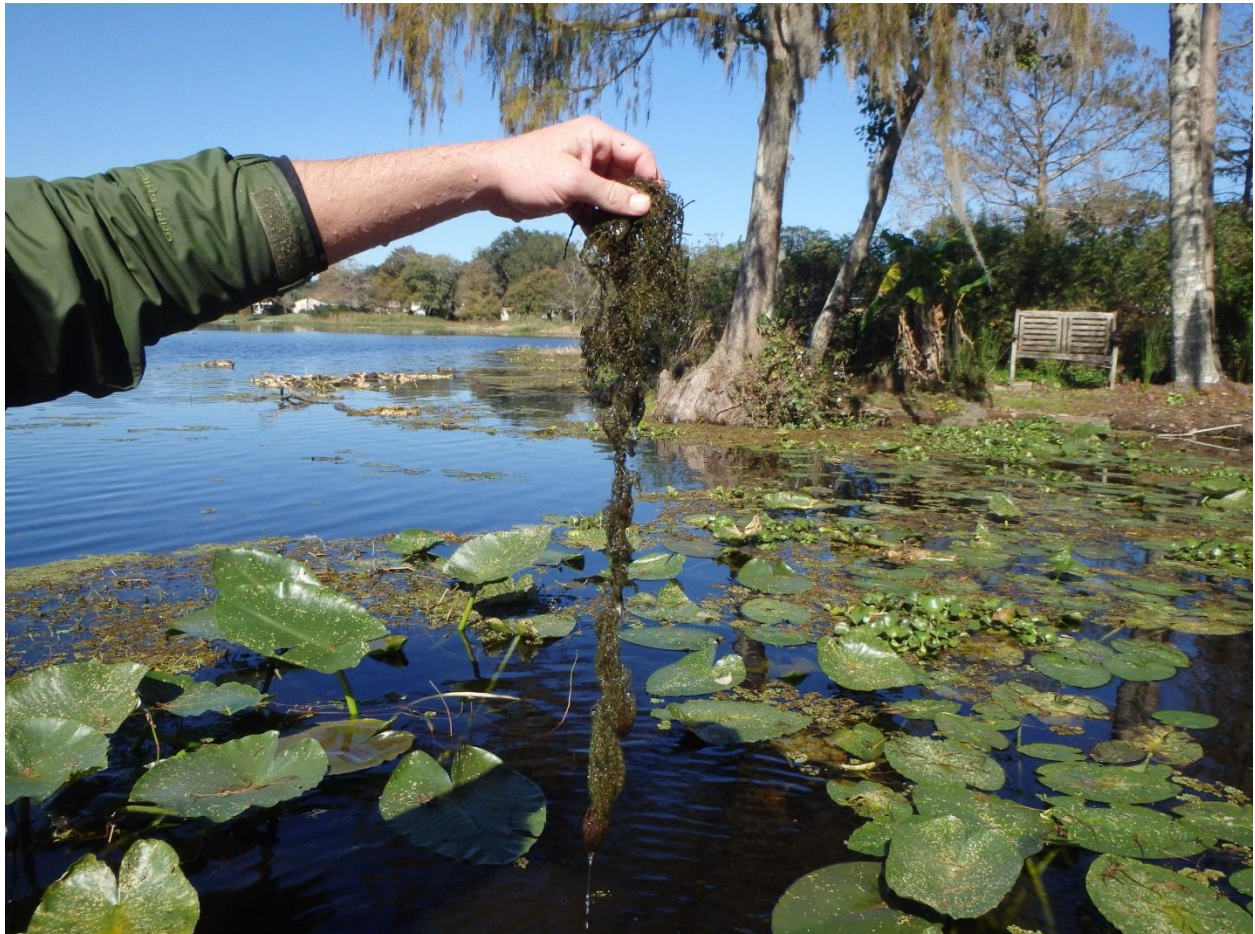
Five species of submersed aquatic vegetation (SAV) were found during the inspection. These SAV species included road grass, southern naiad, bladderwort, eelgrass, and hydrilla. The invasive species hydrilla was found in small springs only in a few regions of the creek. No treatment for hydrilla is needed at this time.

**Photo: Bladderwort.**

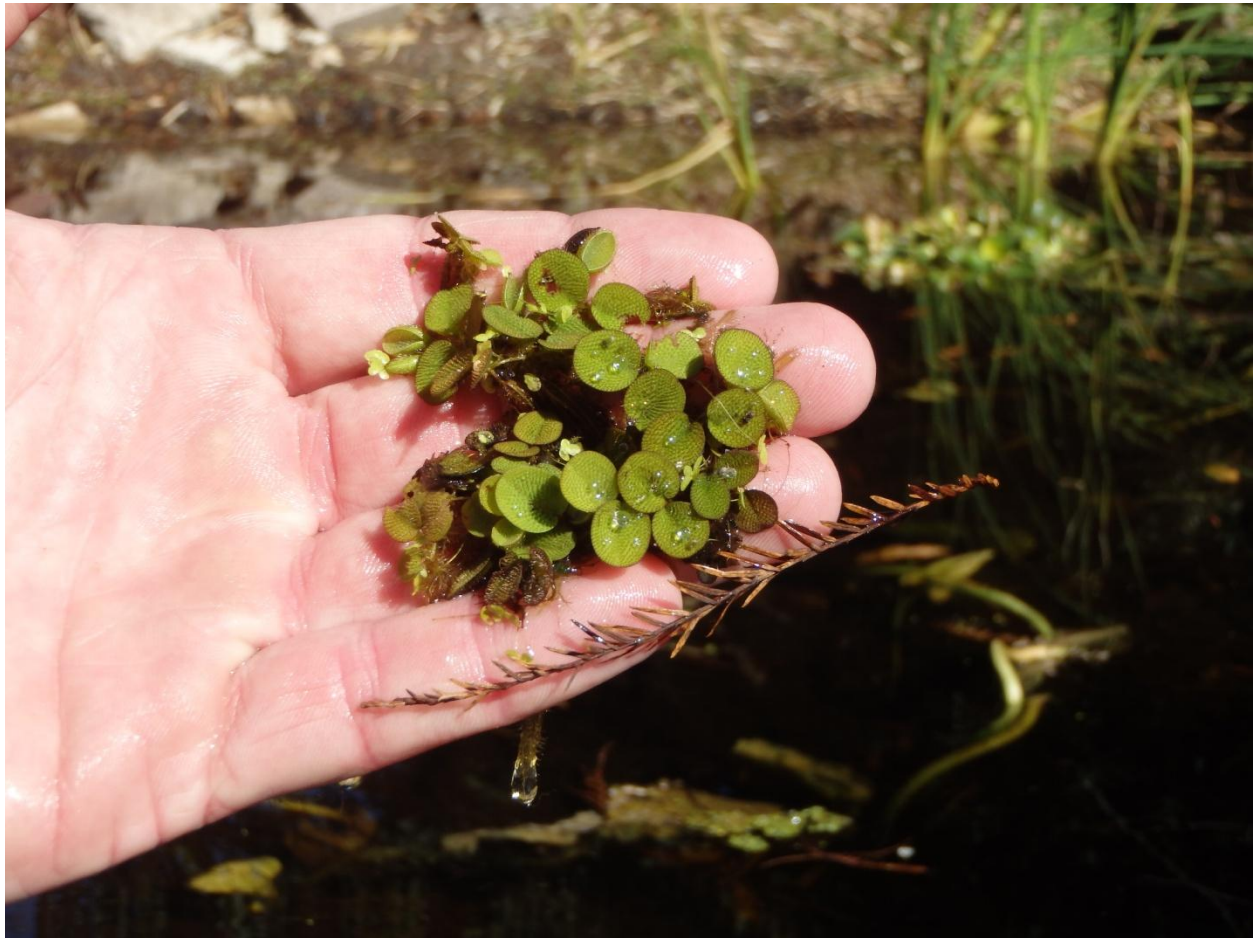
Invasive emergent vegetation found during the inspection included: alligator weed, elephant ear, and cattail. Water hyacinth, a floating invasive aquatic plant, has spread throughout the creek since the last inspection. There were several large mats of water hyacinth in the upstream portion of the creek and a few isolated water hyacinths downstream. Another floating invasive aquatic plant, salvinia, was seen in large quantities but has been impacted by the MSBU funded herbicide contractor.

**Photo: Salvinia.**

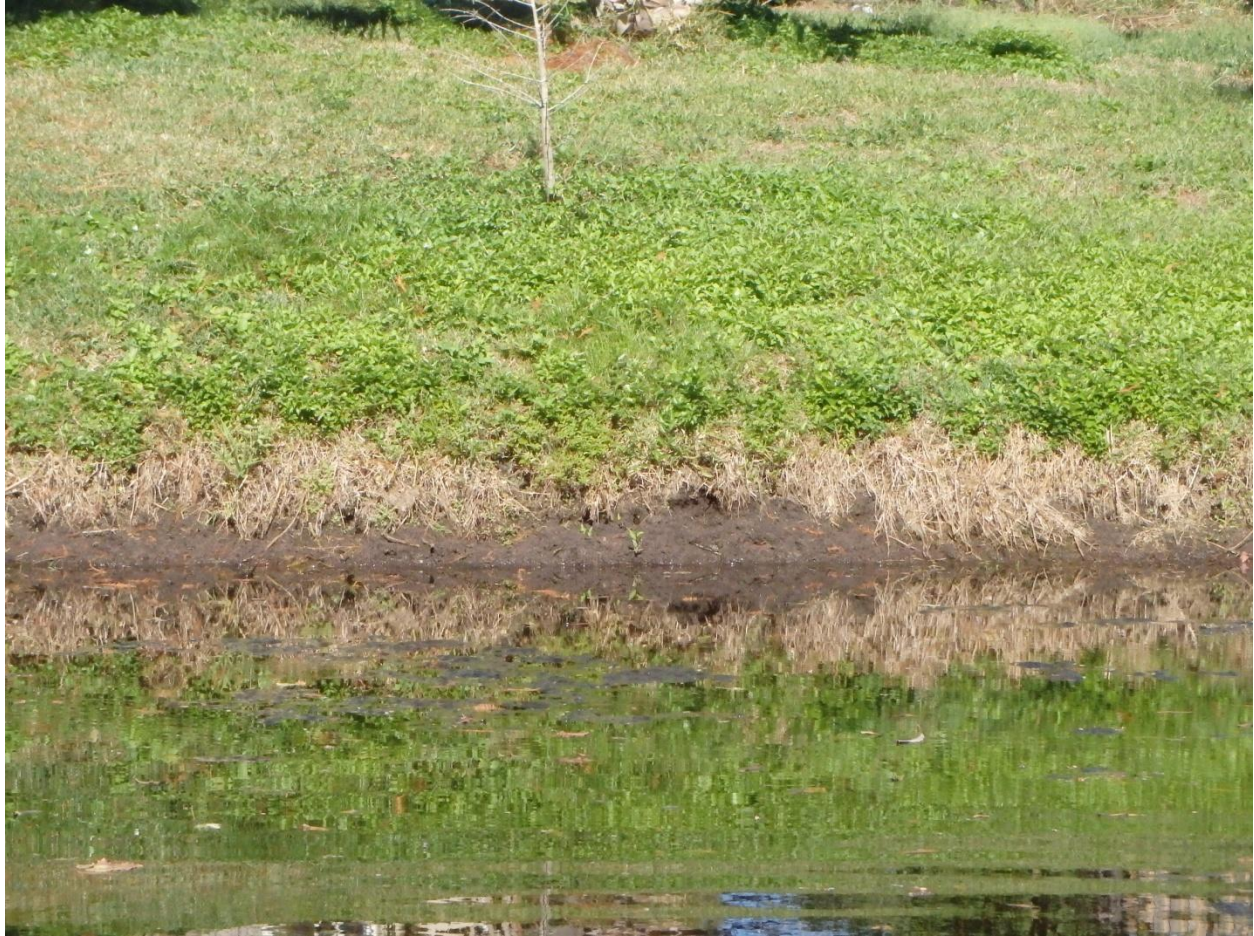
**Photo: Bare shoreline is susceptible to erosion.**

Now that the torpedo grass has been reduced, some of the shorelines along the north bank of the creek are bare and showing signs of erosion. It is recommended that native shoreline vegetation be planted to help reduce erosion, stabilize the shoreline, and prevent the return of torpedo grass. Recommended native species include, but are not limited to: pickerelweed (scientific name: *Pontederia cordata*), duck potato (*Sagittaria lancifolia*), golden canna (*Canna flacida*), fire flag (*Thalia geniculata*), and cord grass (*Spartina bakeri*). Native vegetation found during the inspection included yellow cow lily, pickerelweed, soft rush, and pennywort.

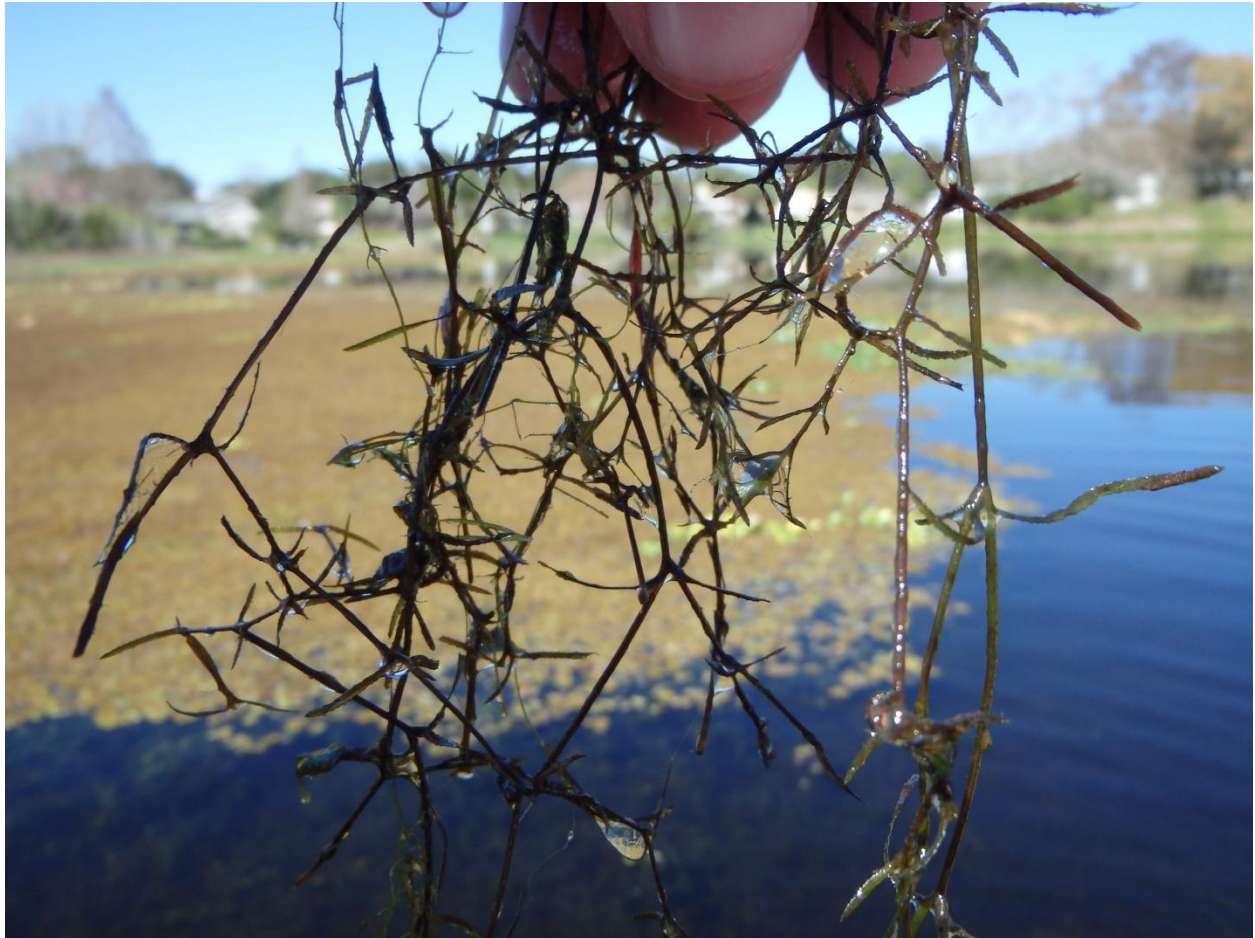
Five species of submersed aquatic vegetation (SAV) were found during the inspection. These SAV species included road grass, bladderwort, eelgrass, southern naiad and coontail. The invasive species hydrilla was not found during this inspection

**Photo: Southern naiad.**

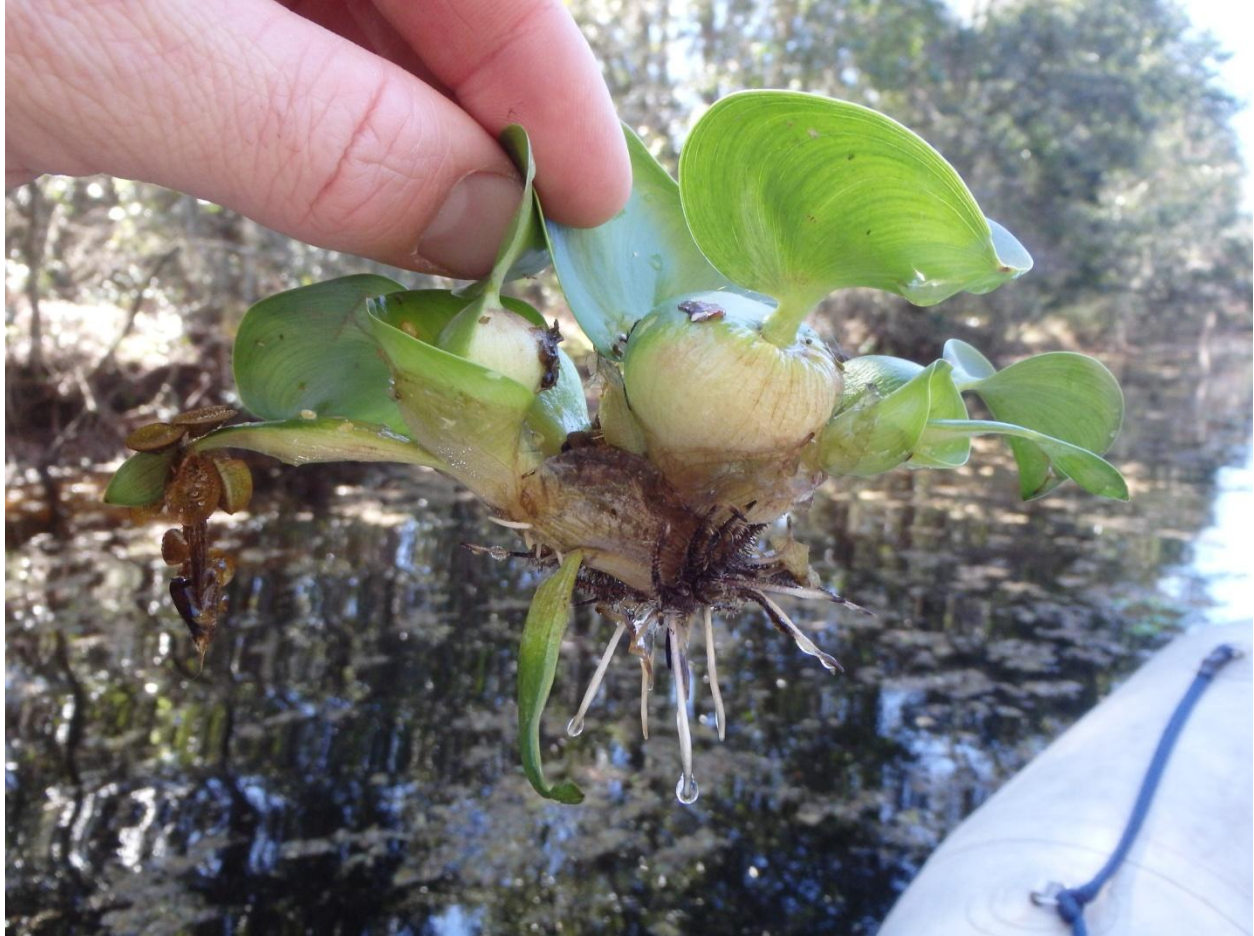
Invasive emergent vegetation found during the inspection included: alligator weed, elephant ear, and cattail. Water hyacinth was found throughout the creek. Salvinia is washing in from Lake Waumpi due to the recent rainfall. This is causing large pockets of salvinia to occur especially around the weir.

**Photo: Water hyacinth.**

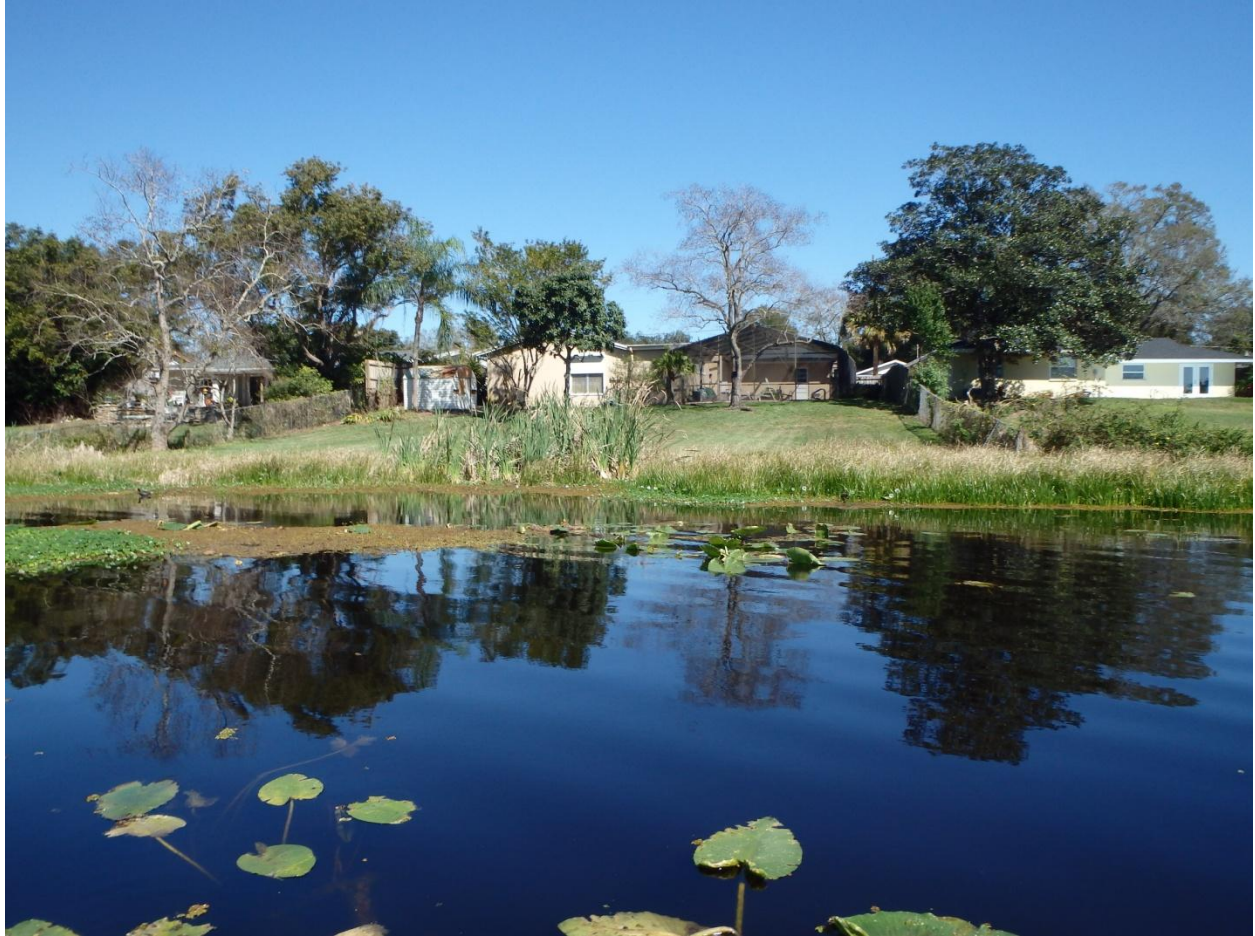
Lake Waumpi was also surveyed during this inspection. There were significantly less lily pads on Waumpi than in the previous inspection. Coontail and hydrilla were the only SAV found in the lake. Most of Lake Waumpi's shoreline was dominated by invasive species including: burhead sedge, primrose willow, Carolina willow, cattails, alligator weed, and salvinia. Some floating mats extending from the shoreline show signs of herbicide treatment. Salvinia was found in large quantities around Lake Waumpi's shoreline

**Photo: Burhead sedge and cattails on Lake Waumpi's shoreline.**

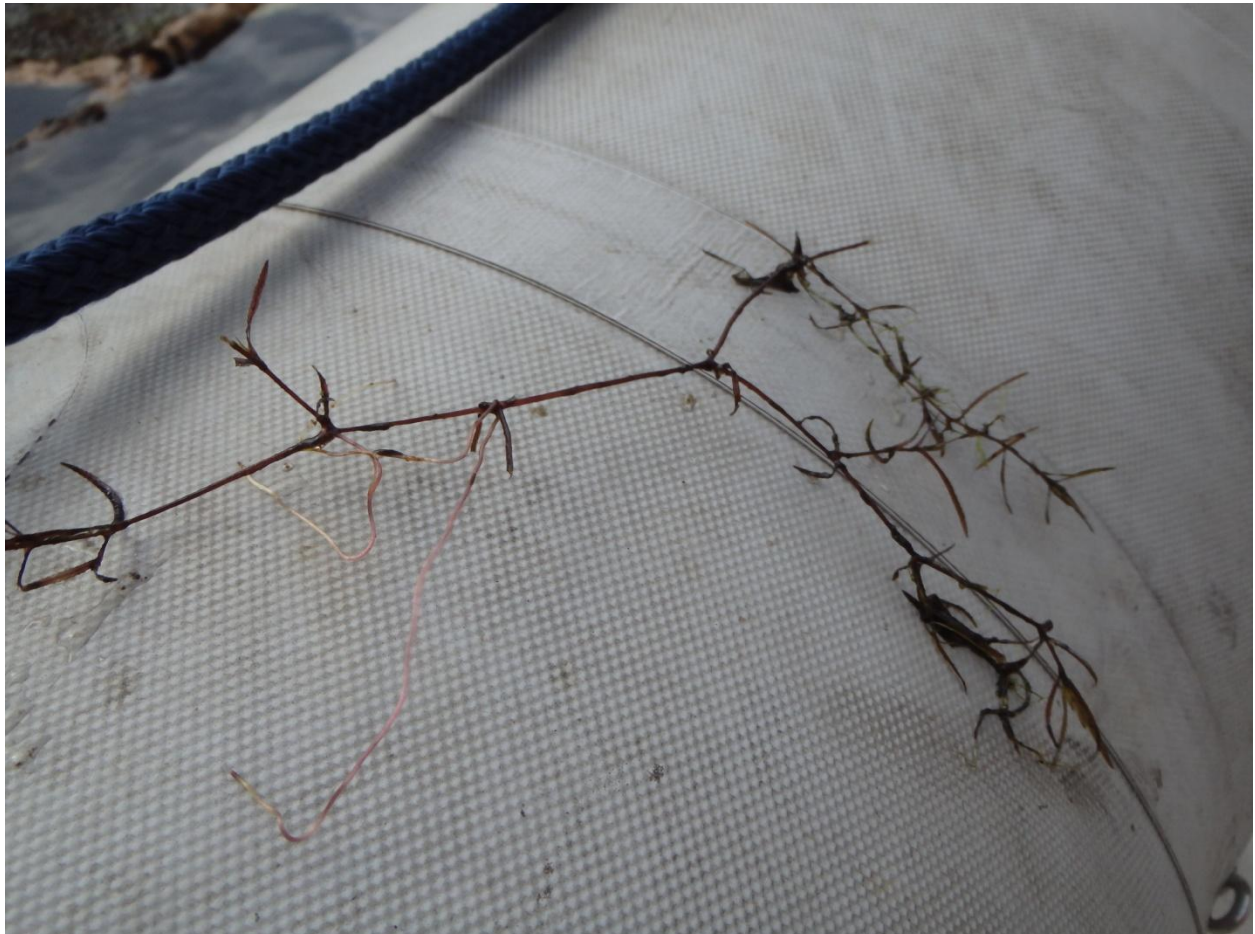
Four species of submersed aquatic vegetation (SAV) were observed during the inspection. These SAV species included road grass, southern naiad, coontail, and eelgrass. Hydrilla was not observed during this inspection. This was a reduction in hydrilla from the previous inspection in which only a few sprigs were found.

**Photo: Southern naiad found in creek.**

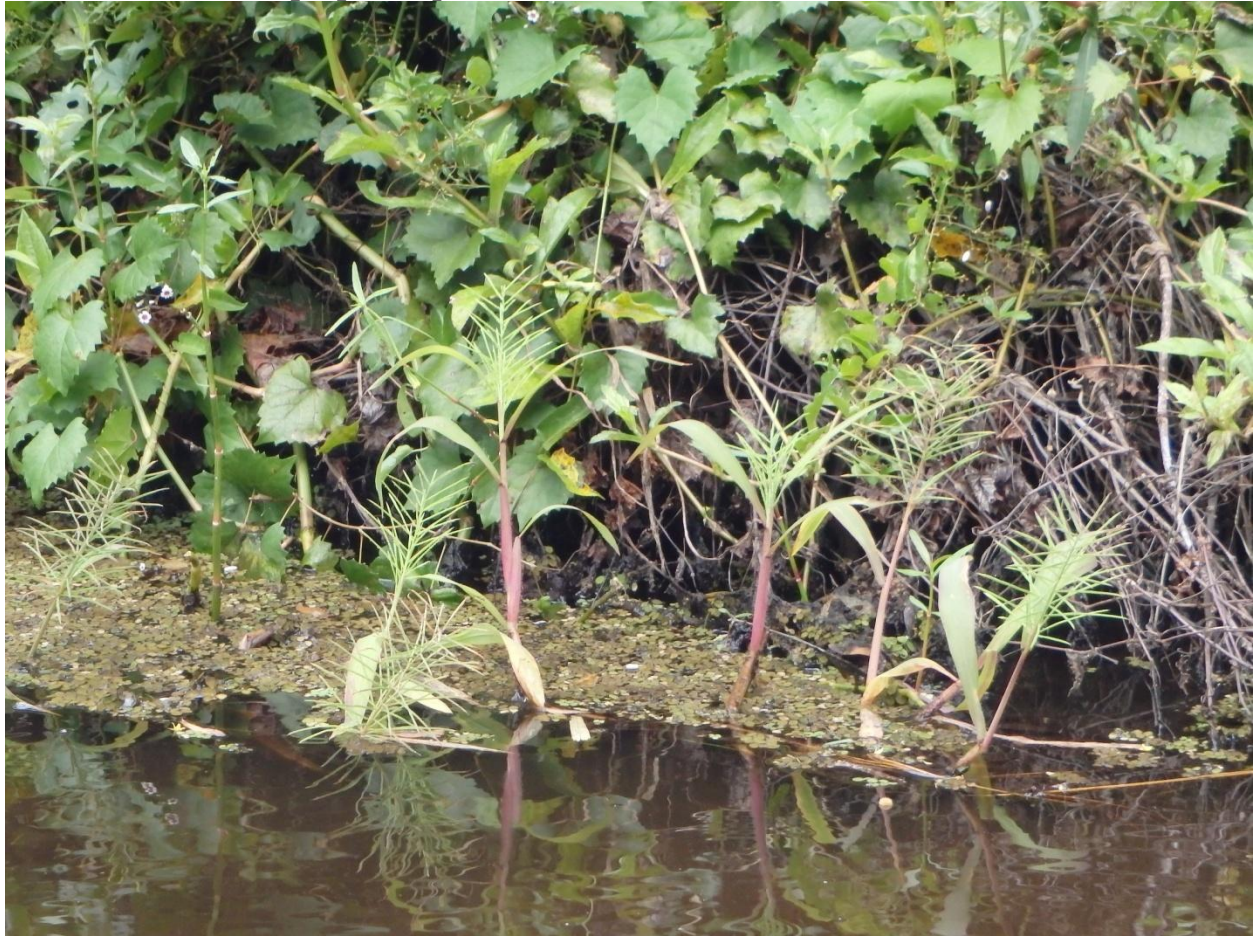
Native vegetation found during the inspection included: yellow cow lily, pennywort, and water paspalum. Some shorelines along the north bank of the creek had visible erosion issues. It is recommended that native shoreline vegetation be planted to help reduce erosion and stabilize this shoreline. Recommended native species include, but are not limited to: pickerelweed (scientific name: *Pontederia cordata*), duck potato (*Sagittaria lancifolia*), golden canna (*Canna flacida*), fire flag (*Thalia geniculata*), and cord grass (*Spartina bakeri*).

**Photo: Native water paspalum plant found in Howell Creek.**

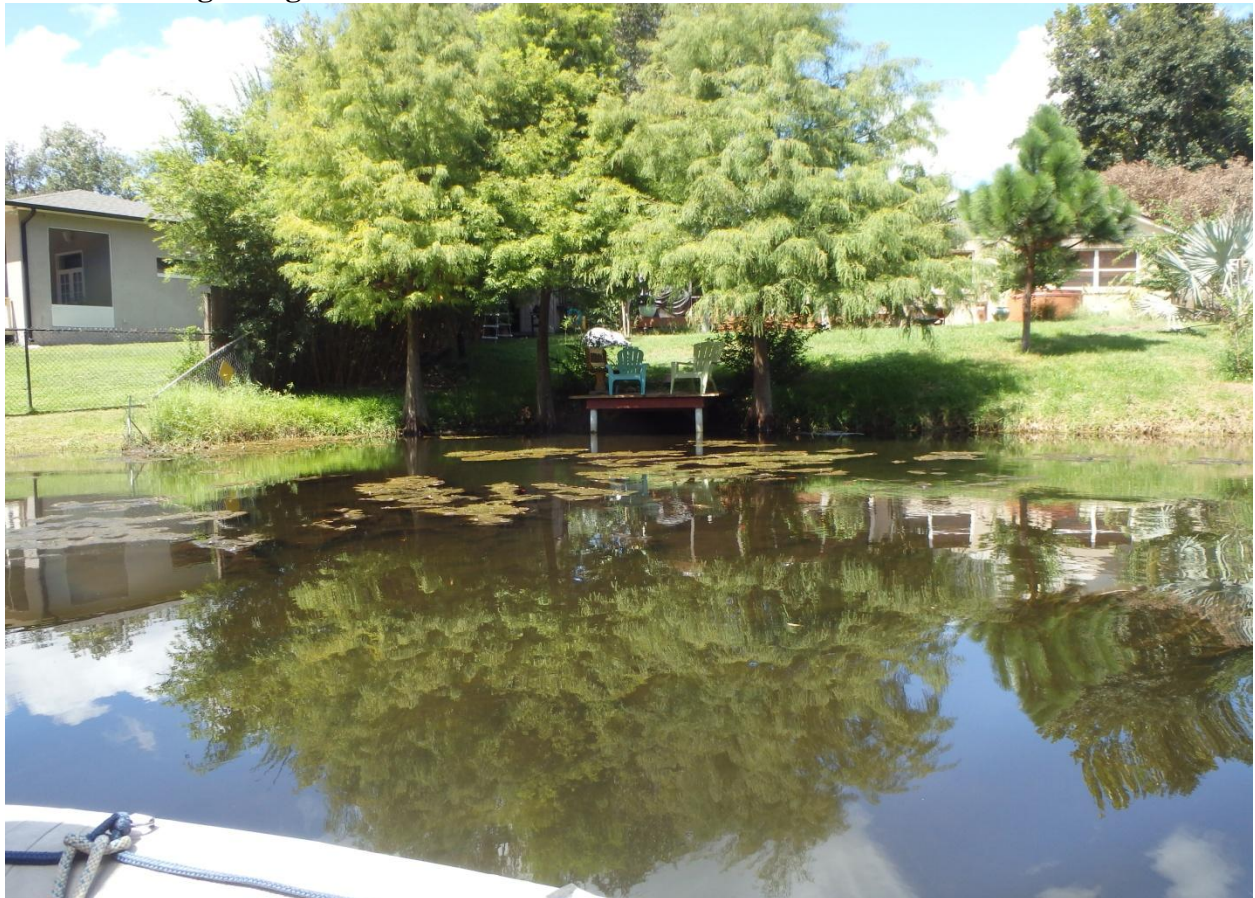
Five species of native submerged aquatic vegetation (SAV) were observed during the inspection. These SAV species included: coontail, roadgrass, southern naiad, bladderwort, and eelgrass. The eelgrass had grown enough to top out (reach the surface) in 2 feet of water close to Lake Waumpi. Several floating mats of roadgrass had formed just downstream from the canopied bend of Howell Creek. The carp had continued to eat the hydrilla and only one sprig was found in the creek.

**Photo: Floating roadgrass mats.**

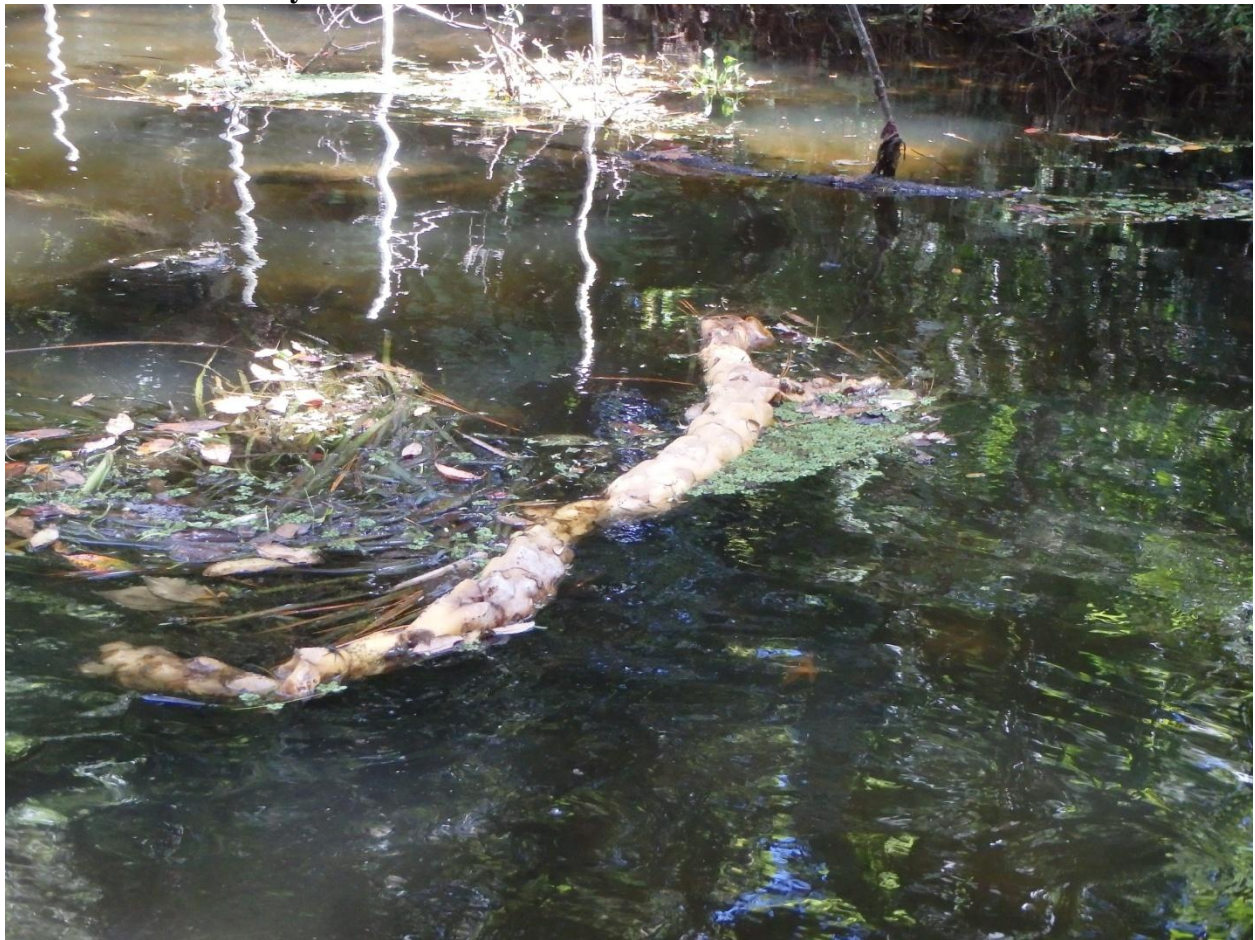
The inspection resulted in the identification of four invasive emergent vegetation species in Howell Creek: alligator weed, elephant ear, torpedo grass, and cattail. The alligator weed expanded since the previous inspection. Invasive species observed in the creek also included two floating species: water hyacinth and salvinia. A few large clusters of water hyacinth had formed along the shoreline of the creek near the lake. After last month's herbicide treatment of lilies, the plants' large rhizomes had floated to the surface.

**Photo: Yellow cow lily rhizome.**

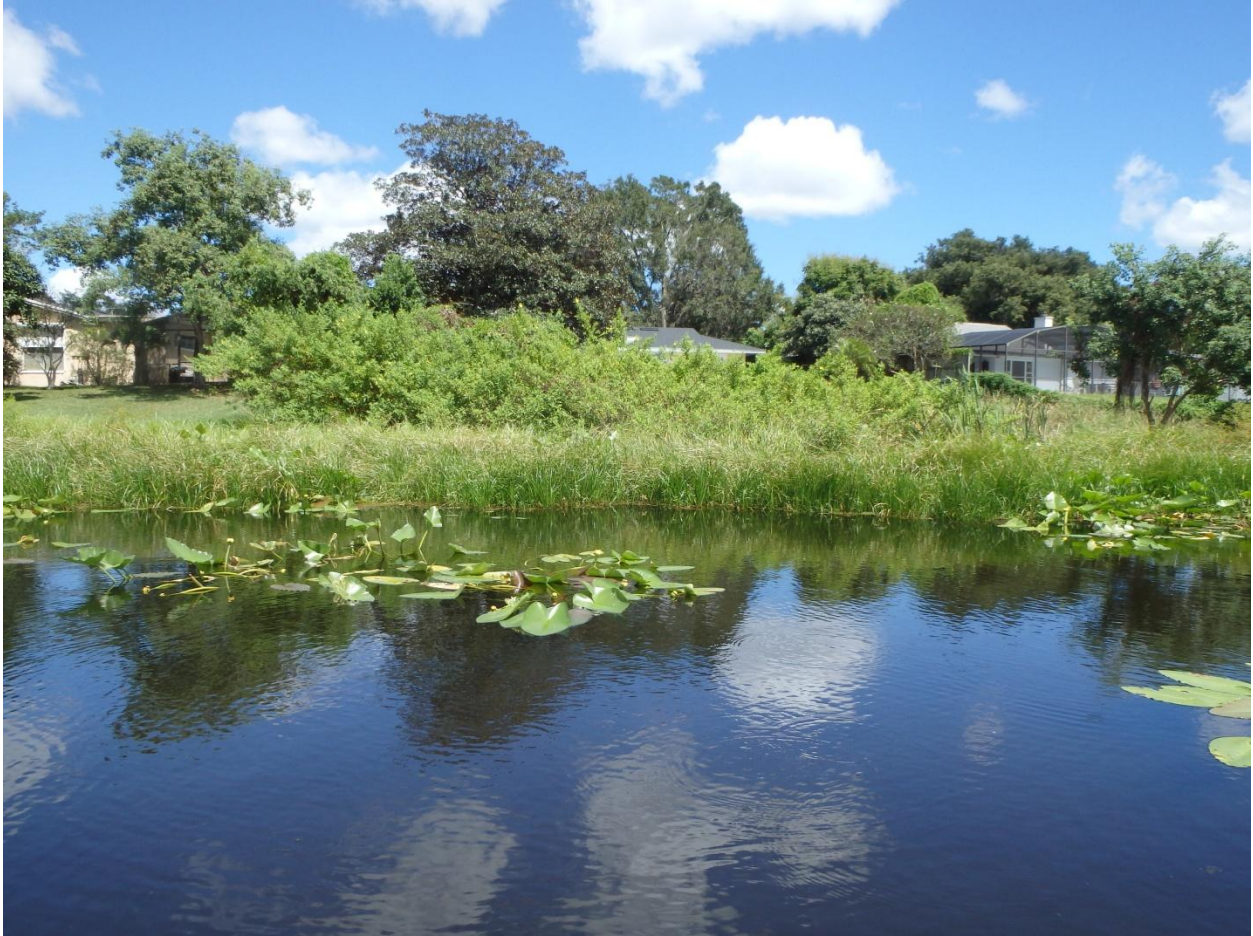
Lake Waumpi had many invasive species around its perimeter. These species included: Carolina willow, Mexican primrose, burhead sedge, cattail, alligator weed, and salvinia. Large floating mats along the shoreline were reducing the area of the lake. No submerged vegetation was found in Lake Waumpi.

**Photo: Floating mat on Lake Waumpi**

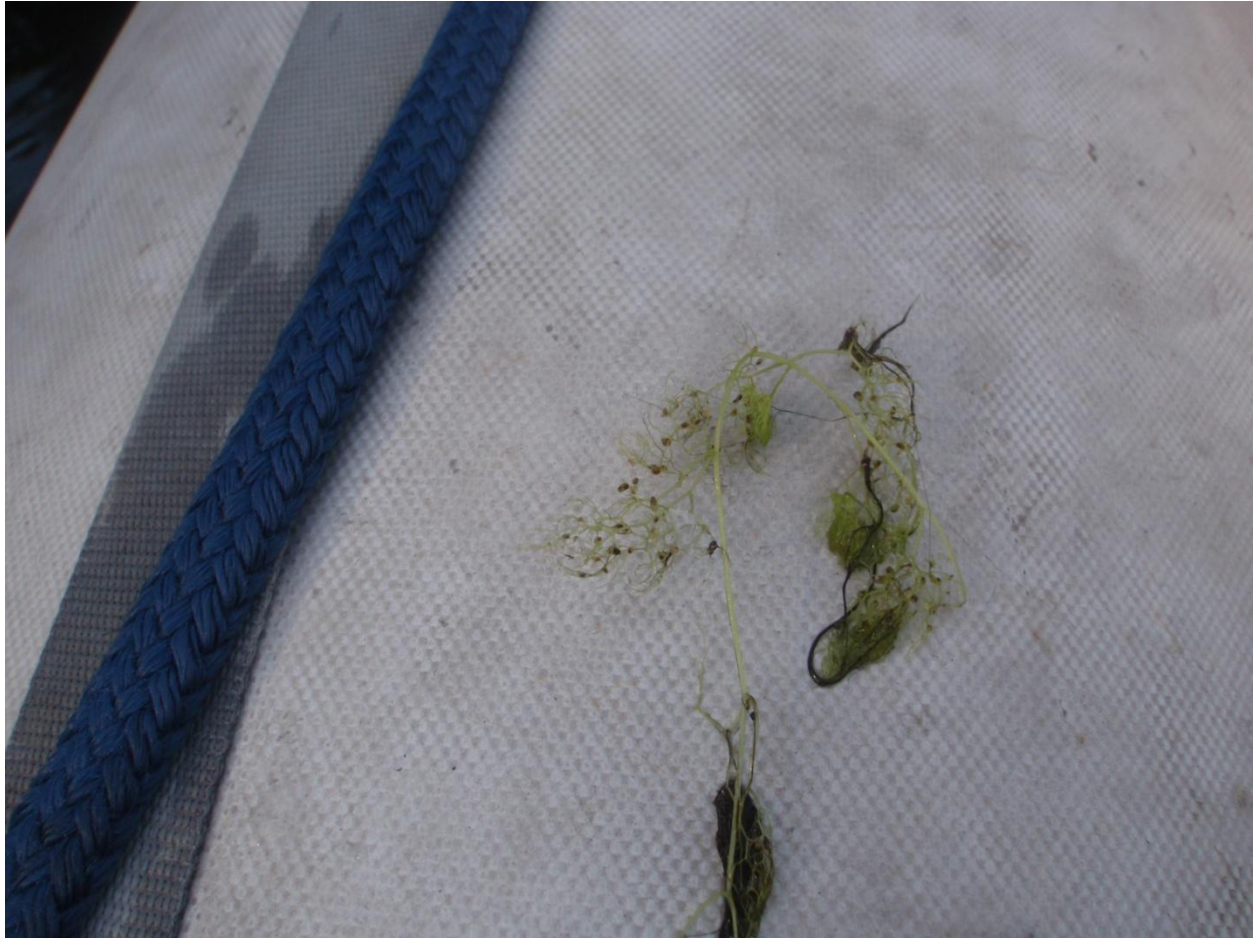
Four species of native submerged aquatic vegetation (SAV) were observed during this inspection. These species included: coontail, bladderwort, eelgrass, and roadgrass, each to a depth of 2 feet. One patch of hydrilla was found, but it was evident that grass carp had been eating it.

**Photo: Bladderwort.**

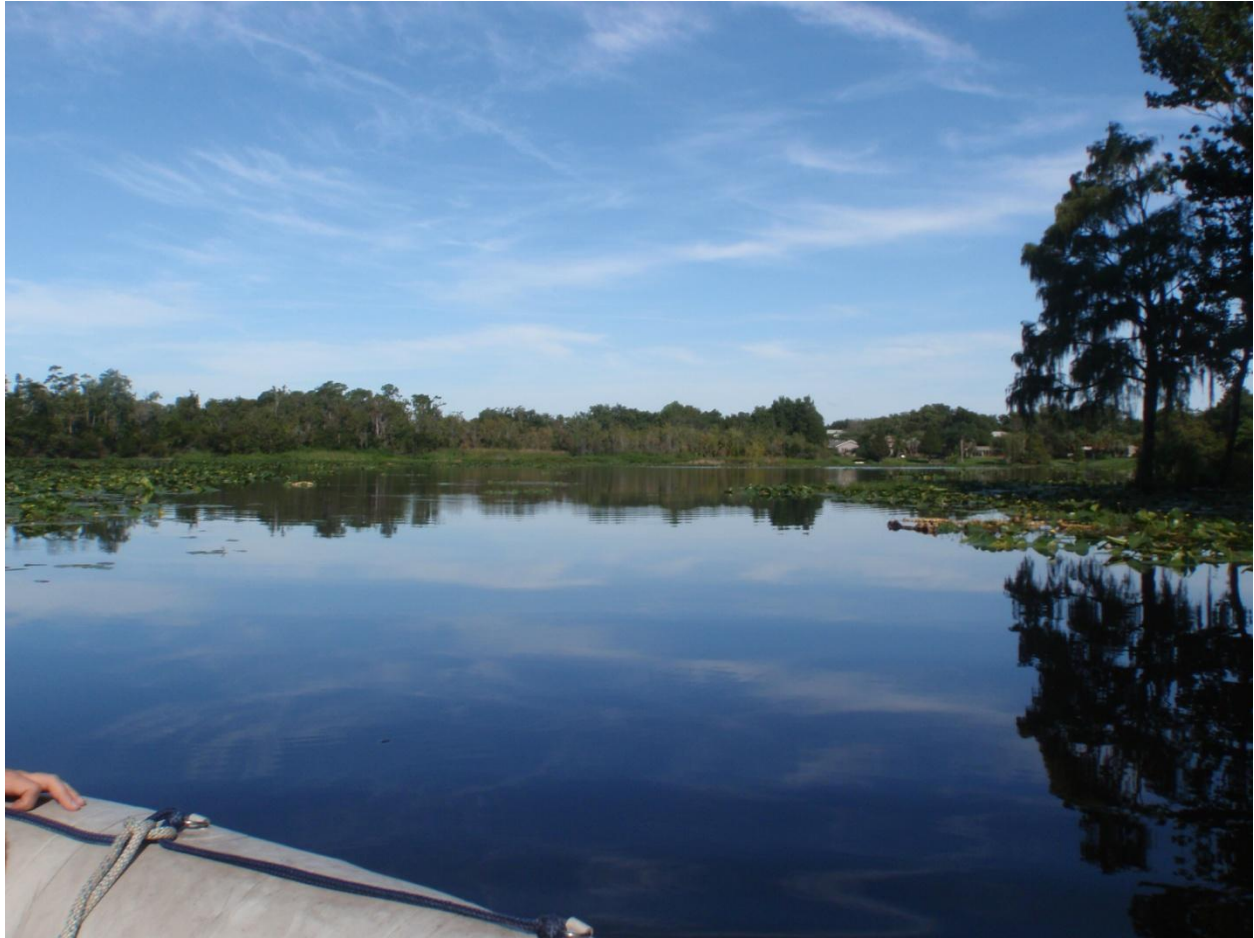
**Photo: View of Lake Waumpi from Howell Creek.**

Entry into Lake Waumpi from Howell Creek was easier during the last inspection because of a reduction in yellow cow lilies. Vegetation in the middle of the lake had been reduced, but the invasive plants on the shoreline were still prominent. The most prominent species were: burhead sedge, primrose willow, Carolina willow, cattails, alligator weed, and salvinia. These invasive species reduce the size of the lake as they grow out away from the shoreline as floating mats. No submerged vegetation was found in Lake Waumpi.
