Greetings Spring Lake!

On **July 2nd, 2013**, Seminole County Lake Management Program (SCLMP) staff, Thomas Calhoun and Gloria Eby, surveyed the aquatic plants in **Spring Lake**.

Spring Lake Study

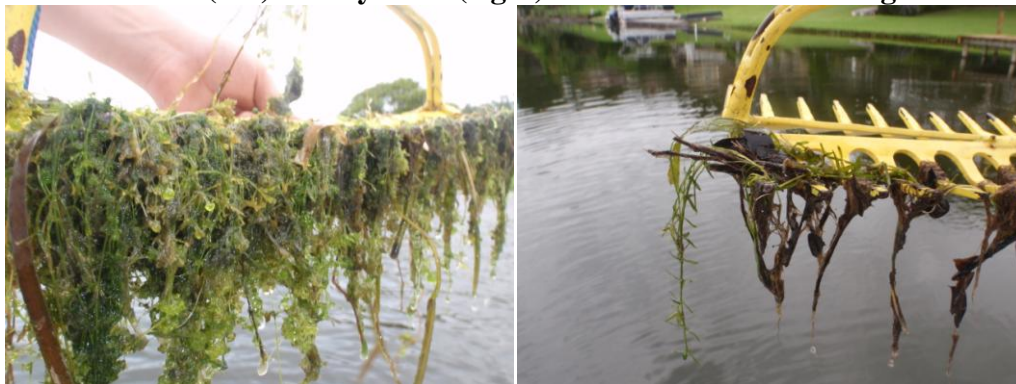
Only 2 plants of rooted hydrilla were found during inspection at a depth of 6 feet. Native submersed aquatic plants observed during the inspection included; eelgrass to a depth of 6 feet, pondweed to 6 feet, water hyssop to 2 feet, and nitella to 2.5 feet. Nitella was observed to be expanding in biomass from prior survey (May 2013). Eelgrass continues to be the dominant SAV with blades reaching the surface from a depth of 6 feet. The eelgrass corridors were found in good condition especially with elevated lake levels. With the rise in water elevation, eelgrass corridor maintenance treatments will be on hold as access is currently not impeded. Additionally, the cost and successes of treatments are a large factor to consider when much of the plant is located in deeper water.

Photo: Nitella (left) and hydrilla (right) shown mixed in with eelgrass.

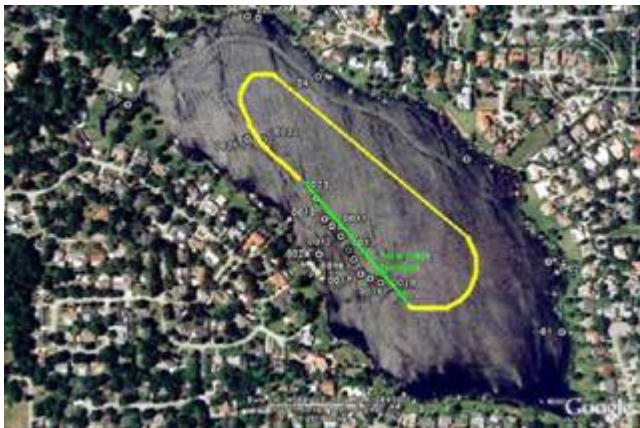
The navigational corridor is currently open and navigable. This corridor (as indicated on map below in green) was previously marked with buoys connecting the two deeper lobes of Spring Lake. This would be the third occurrence in which the buoys were removed from the lake. *Please continue to navigate in the shallow areas with caution especially with current low water conditions.*

Map: Eelgrass access corridor (in green) and illustrated navigable loop (in yellow).

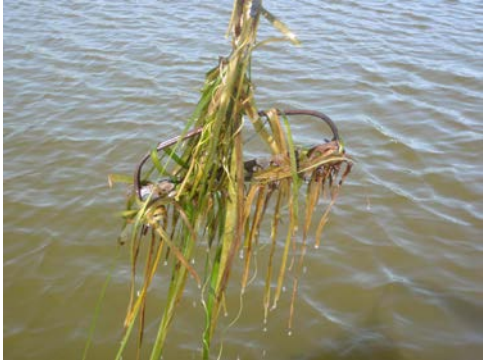
Only plant fragments of hydrilla were found floating during inspection. Lake samples taken did not find any rooted/established hydrilla at this time. Native submersed aquatic plants observed during the inspection included eelgrass to a depth of 8 feet and nitella to 3 feet. Eelgrass continues to be the dominant SAV with blades reaching the surface from a depth of 6 feet. The eelgrass corridors were found in good condition with some locations requiring maintenance/treatment. This maintenance treatment took place the week of April 22nd and a retreatment is currently being coordinated.

Photo: Eelgrass with coiled flower stalk.

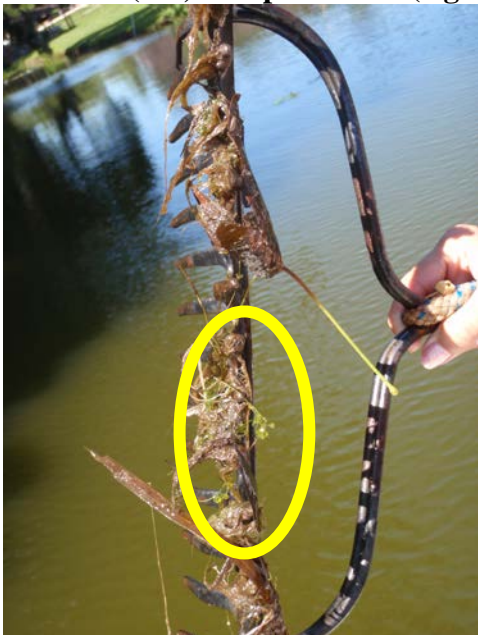
Photo: Nitella (left) and pondweed (right) shown mixed in with eelgrass.

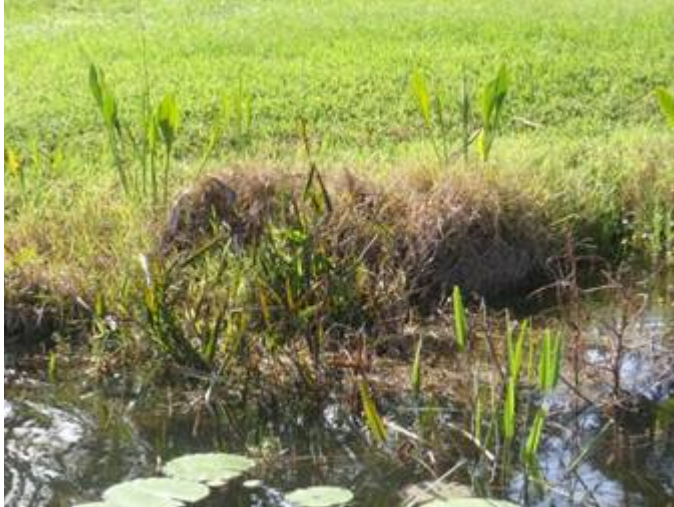
The MSBU funded herbicide applicator continues to treat the torpedo grass around the lake as well as cattails, pennywort, and primrose willow. It is encouraged to remove the torpedo grass once the contractor has treated it, allowing for natives to expand.

Photo: Example of treated torpedo grass around duck potato.

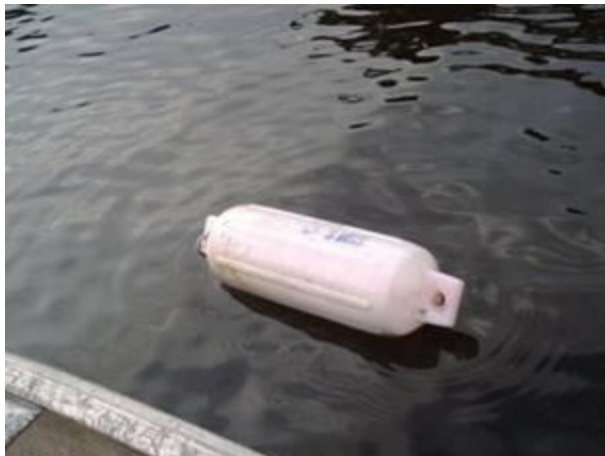
Schematic and photo example of seepage meter:

A total of 15 seepage meters are currently installed in Spring Lake by ERD. These meters will remain in the lake for the 12 month field monitoring period. ERD personnel will collect samples from the meters on a monthly basis. The locations of the seepage meters are indicated by orange or white floats connected to the meter by a steel cable.

Please do not disturb this equipment. Valuable data for the lake will be lost in the event of vandalism. If you notice a meter which has been damaged, please call ERD at **407-855-9465**.

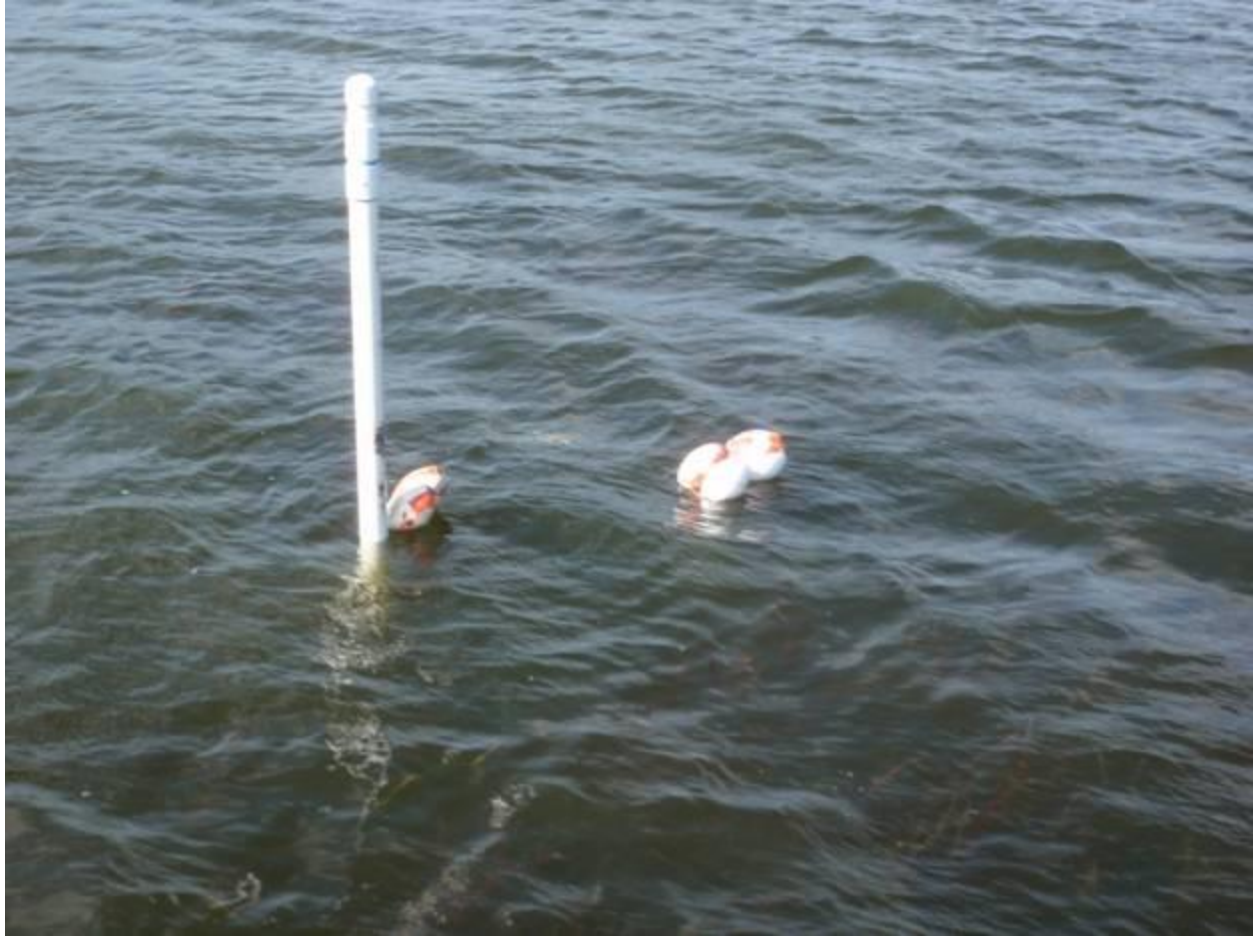
Photo: Buoy indicating seepage meter in center of lake.

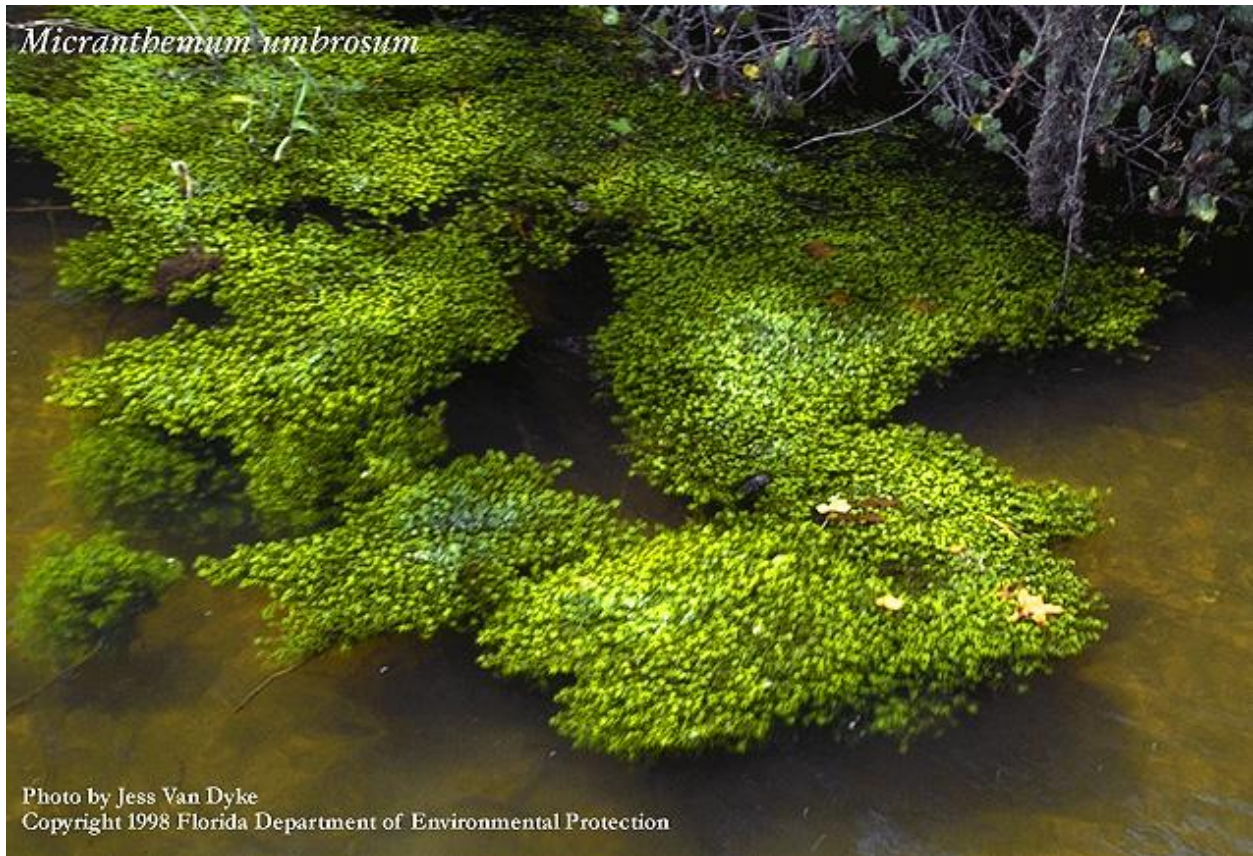
No hydrilla was found during this inspection. This is the ninth month in a row that the plant was not observed. Four native submersed aquatic plants were found during the inspection which included eelgrass to a depth of 6 feet, southern naiad to a depth of 3 feet, stonewort to a depth of 3 feet and baby's tears to a depth of 3 feet. Eelgrass continues to be the dominant SAV with blades reaching the surface from a depth of 5 feet. The eelgrass corridors were found open during this inspection. The corridors will continue to be monitored to see if treatment will be needed.

Photo: Baby's tears.

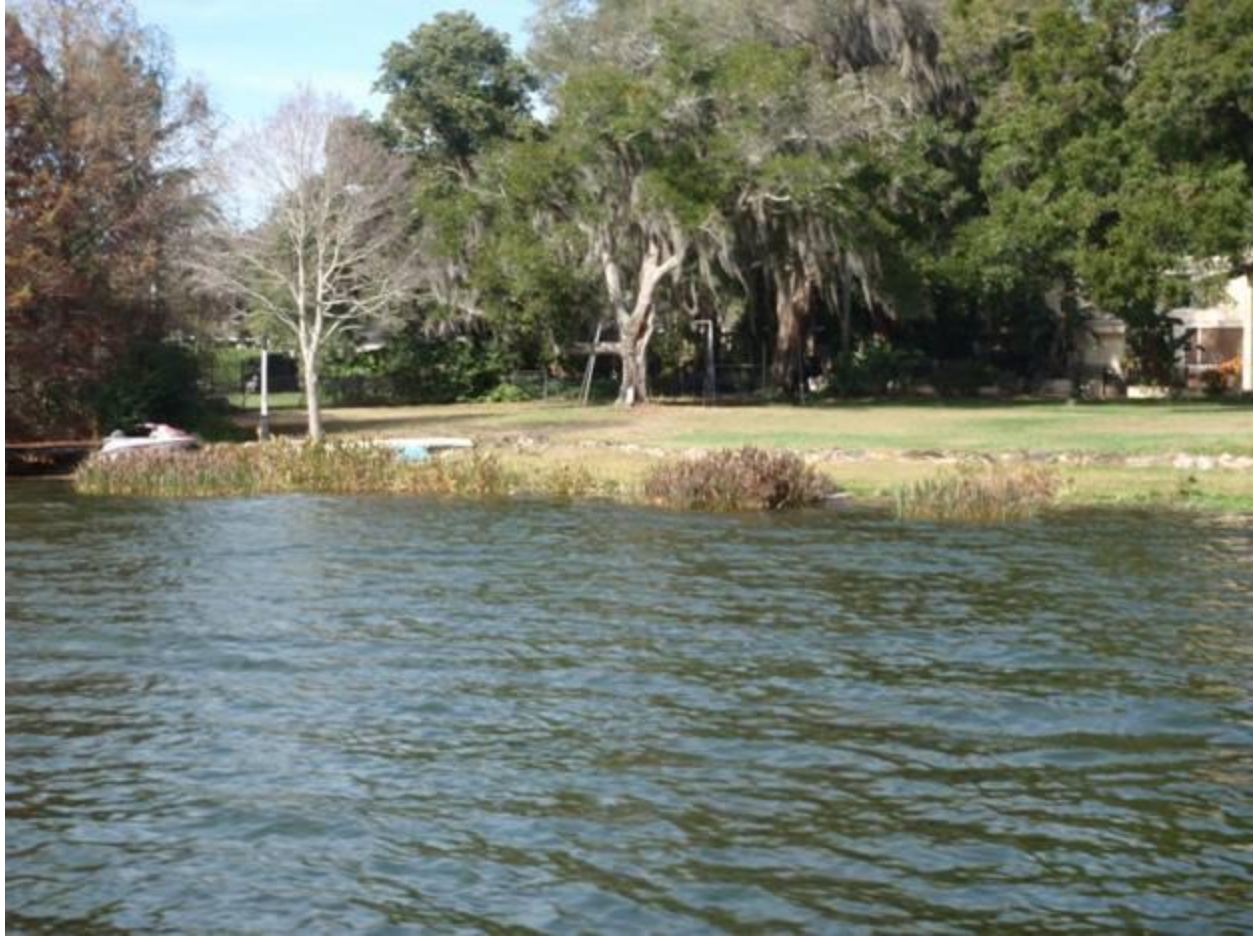
In many areas pickerelweed, duck potato, fire flag and canna are continuing to expand to the point that native species are the dominant vegetation. After torpedo grass has been treated and has died back, it is a great time to pull the dead grass to allow for natives to expand.

Photo: Pickerelweed expanding along shoreline.

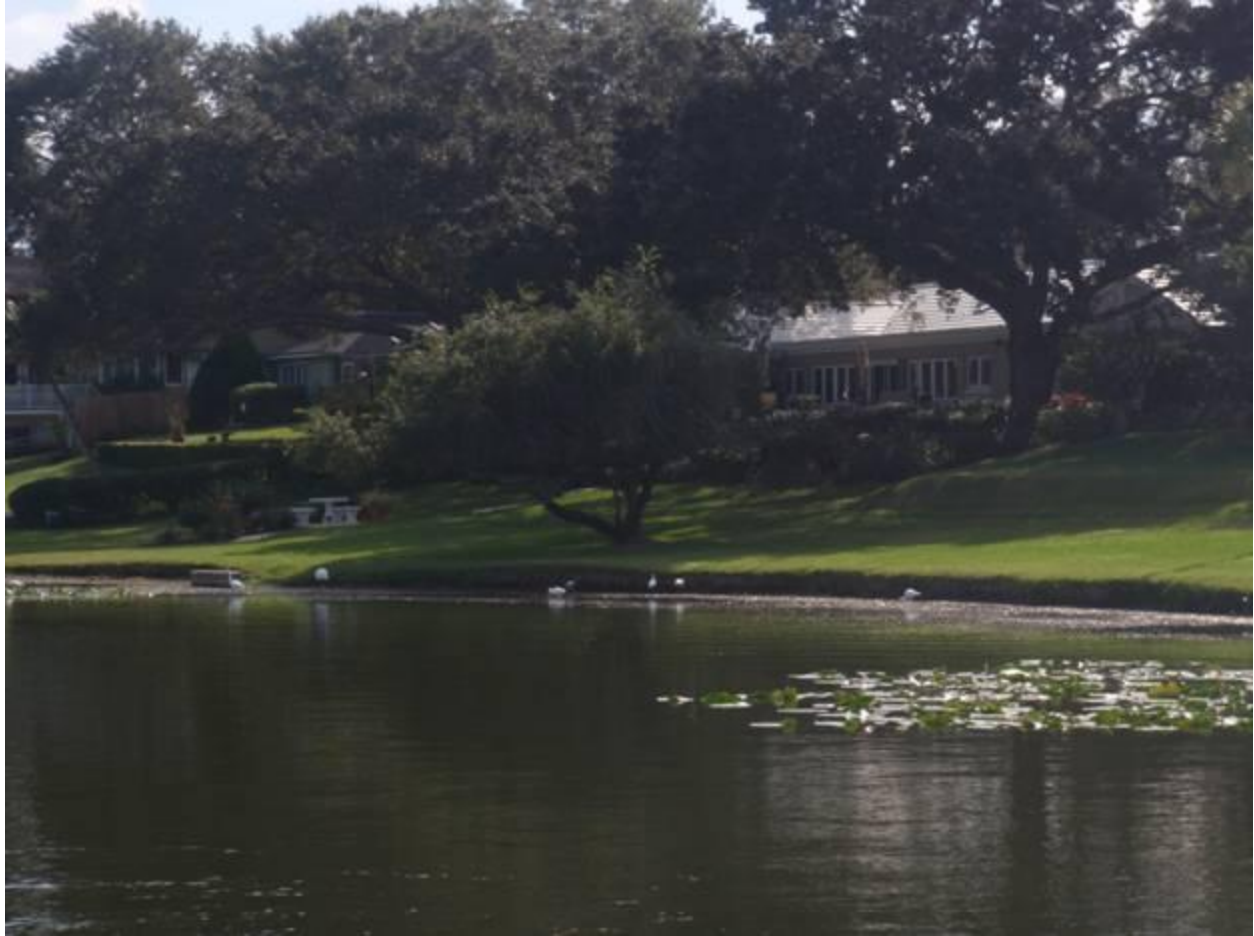
No hydrilla was found during this inspection. This is the eighth month in a row that the plant was not observed. Also again four native submersed aquatic plants were found during the inspection which included eelgrass to a depth of 6 feet, southern naiad to a depth of 3 feet, stonewort to a depth of 3 feet and baby's tears to a depth of 3 feet. Eelgrass continues to be the dominant SAV with blades reaching the surface from a depth of 5 feet. These native SAV species are playing an important role in competing for space with hydrilla. The eelgrass corridors were found open during this inspection.

Photo: Birds feeding in eelgrass along the shoreline.

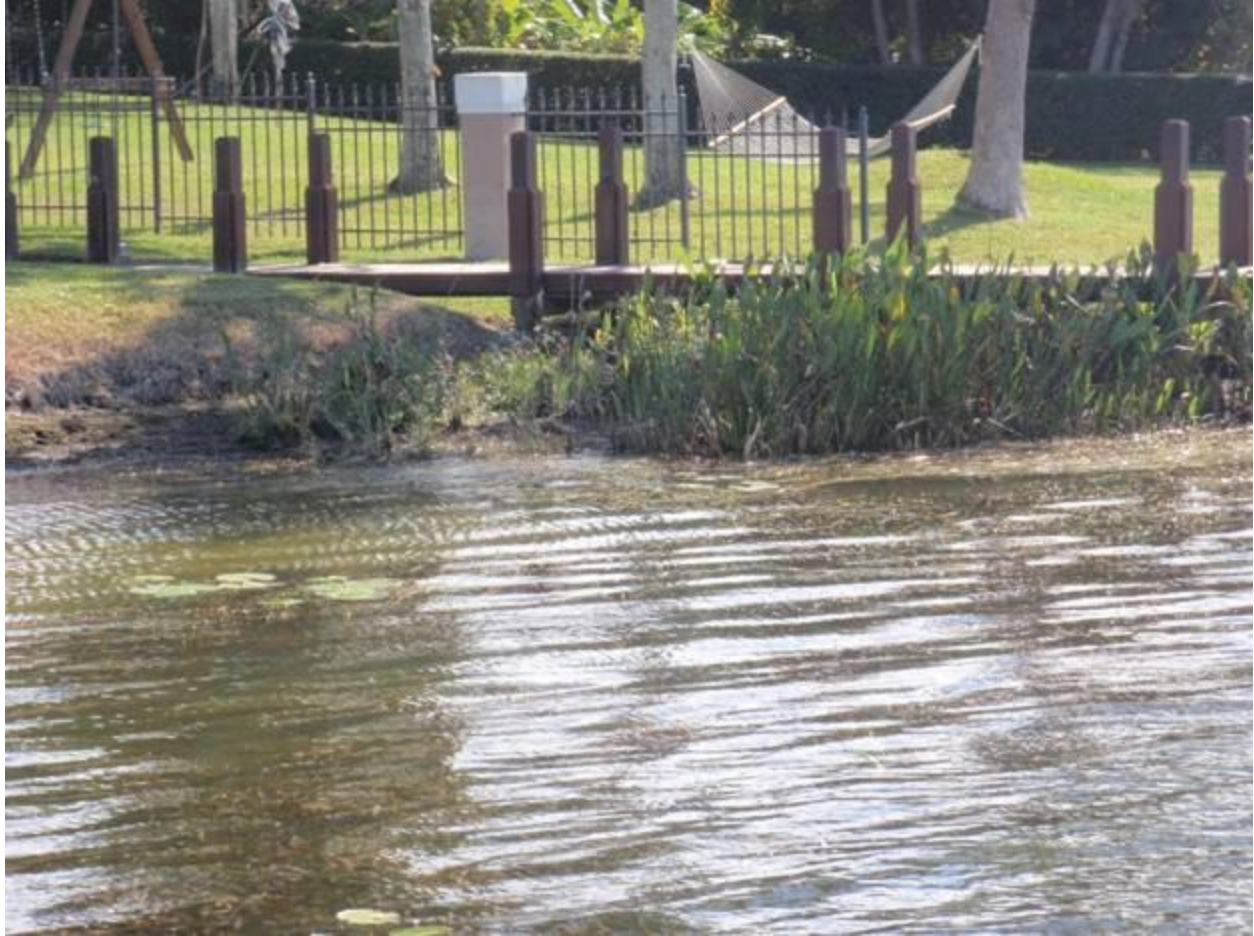
Invasive shoreline plants found during the inspection included; torpedo grass, cattail, alligator weed, umbrella flat sedge and elephant ear. However, in many areas pickerelweed, duck potato, fire flag and canna has expanded to the point that native species are the dominant vegetation.

Photo: Duck potato expanding along shoreline.

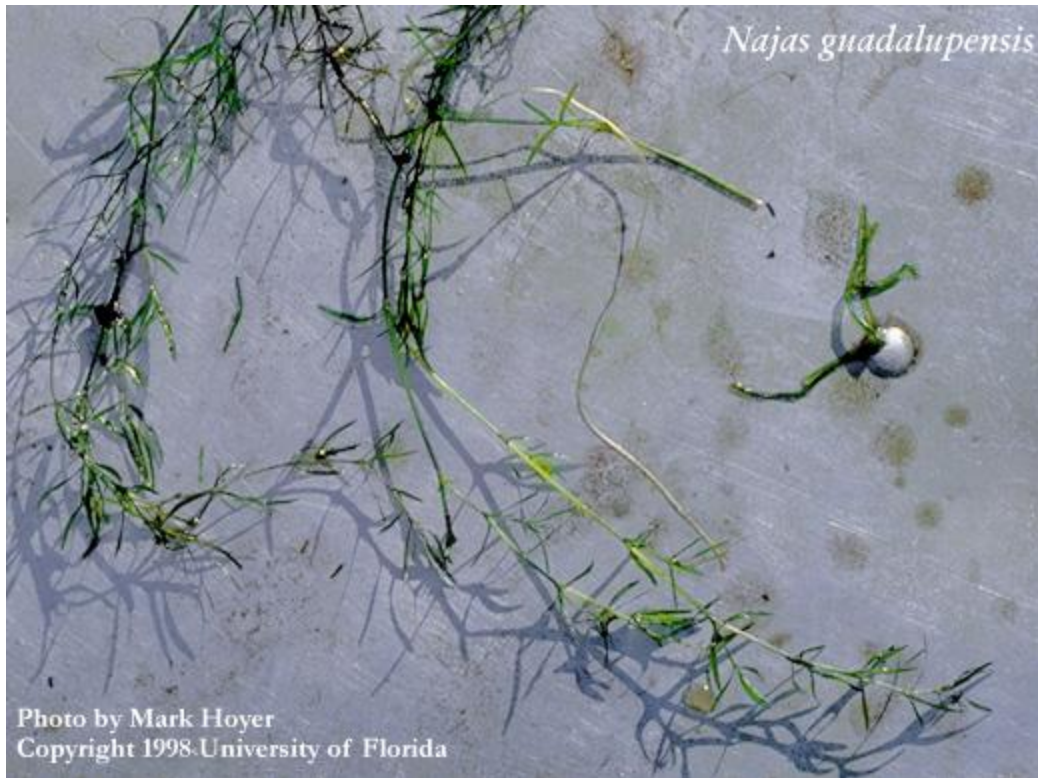
No hydrilla was found during this inspection. This is the seventh month in a row that the plant was not observed. Four native submersed aquatic plants were found during the inspection which included eelgrass to a depth of 7 feet, southern naiad to a depth of 3 feet, stonewort to a depth of 3 feet and baby's tears to a depth of 3 feet. Eelgrass continues to be the dominant SAV with blades reaching the surface from a depth of 5 feet. The eelgrass corridors were found open during this inspection.

Photo: Native SAV southern naiad.

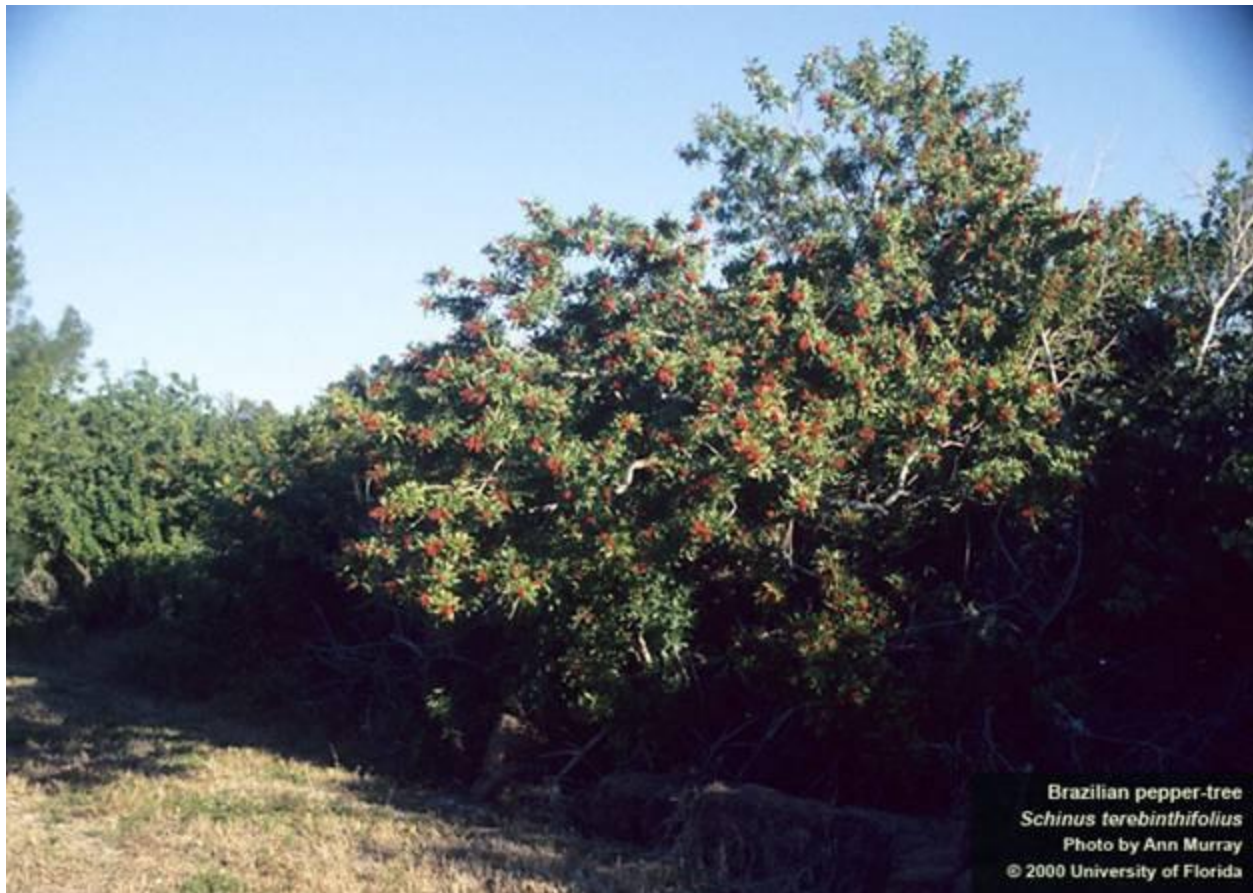
Invasive shoreline plants found during the inspection included; torpedo grass, cattail and elephant ear. These invasives will continue to be targeted by the Seminole County herbicide contractor. Also found during the inspection were the invasive Brazilian pepper tree and camphor tree.

Photo: Brazilian pepper tree.
