On 14 October 2010, Seminole County Lake Management Program staff Gloria Eby (SC Senior Environmental Scientist), Thomas Calhoun (SC Assistant Scientist) and Dean Barber (SC Consultant) surveyed the aquatic plants in Spring Lake. Submersed aquatic vegetation (SAV) found in Spring Lake include; eelgrass (*Vallisneria americana*), coontail (*Ceratophyllum demersum*), stonewort (*Nitella* spp) and hydrilla (*Hydrilla verticillata*). Eelgrass continues to be the dominant aquatic plant from shallow water to a depth of 8 feet. Some of the access corridors needs to be retreated for eelgrass. Hydrilla was found during the inspection mixed in with the eelgrass (image #72) to a depth of 9ft as well as along the outfall canal shoreline (photo#35) but was found to be reduced from previous inspection.

On **September 16th, 2011**, Seminole County Lake Management Program (SCLMP) staff Gloria Eby and Thomas Calhoun surveyed the aquatic plants of **Spring Lake**.

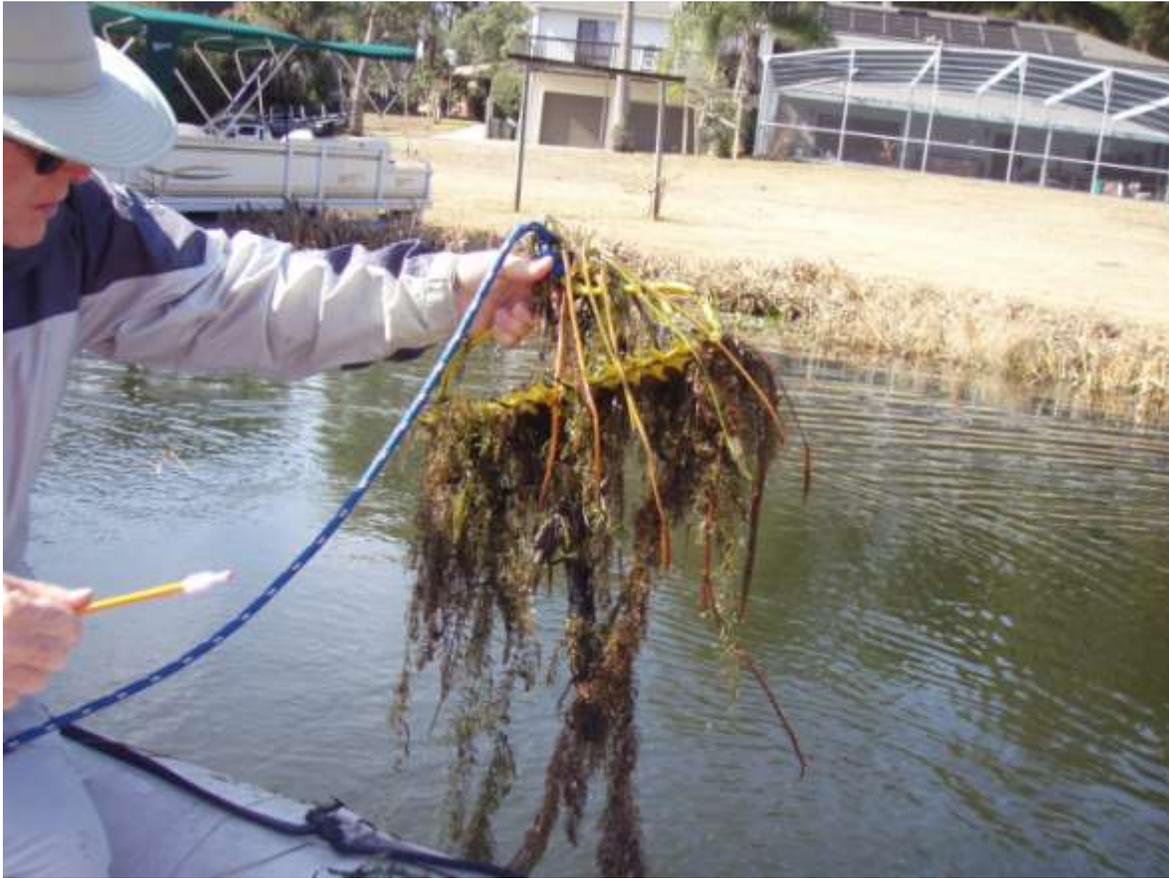
Example of Coontail found in Spring Valley Cove

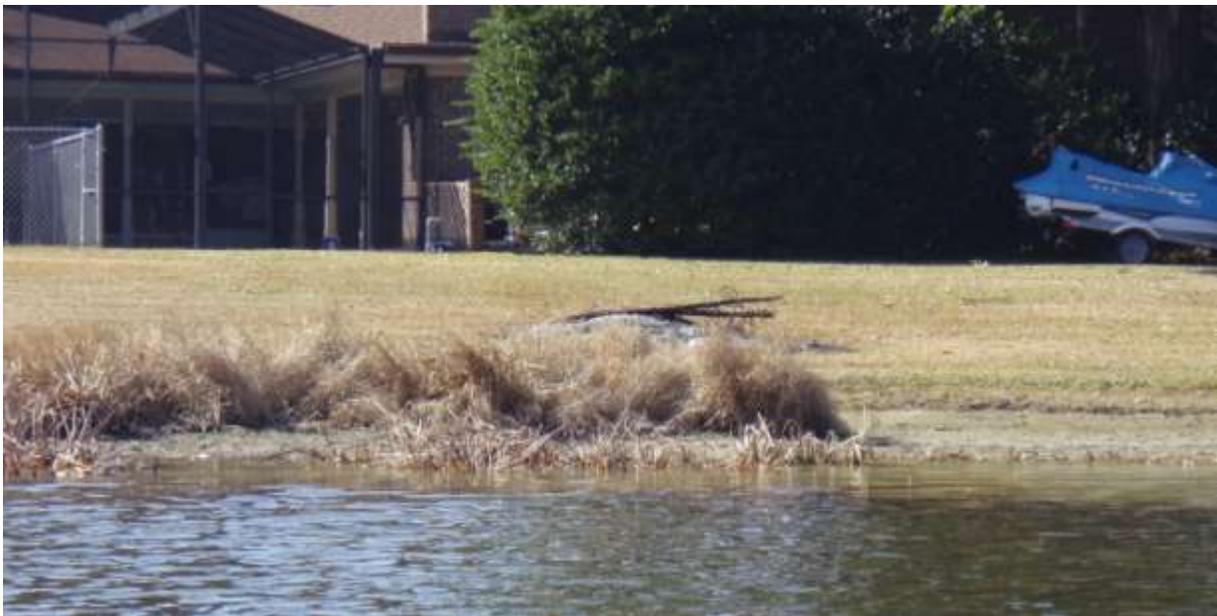
Example of treated Torpedo grass and cold impacted Duck Potato:

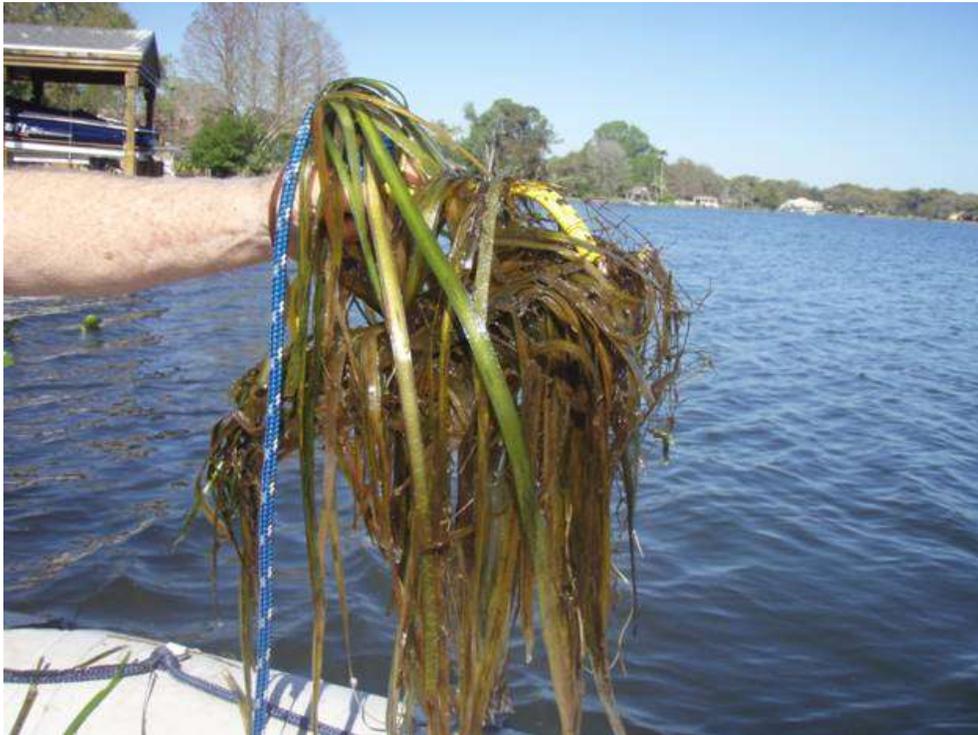
Photo: Eelgrass and southern naiad found during inspection.

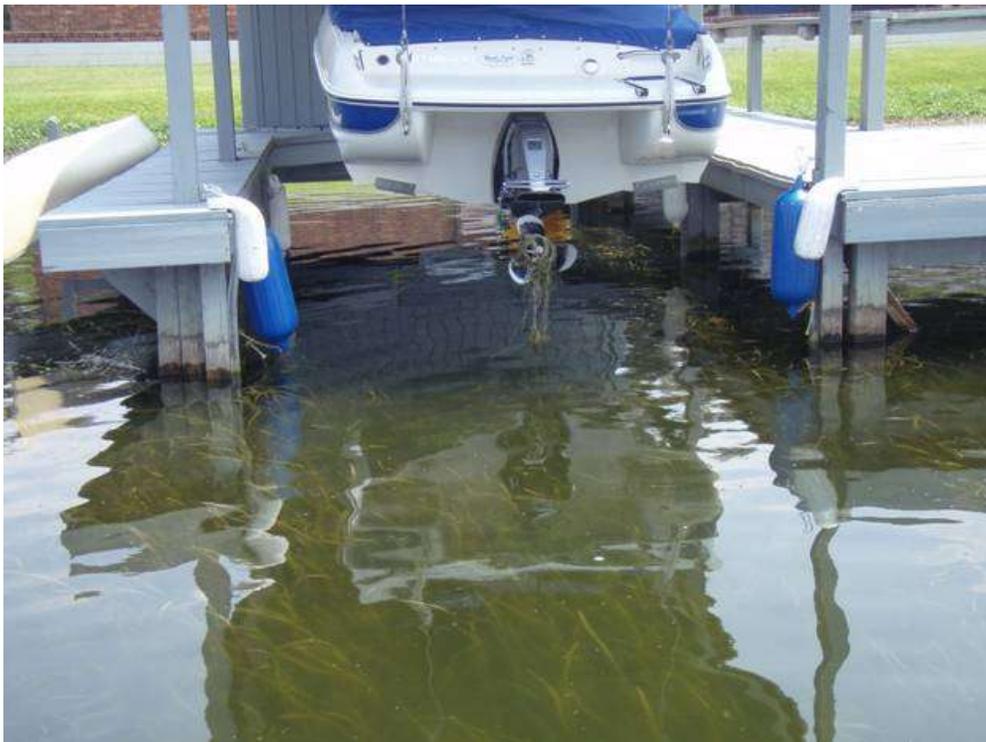
Photo: Eelgrass blocking access.

Upon inspection of the treated eelgrass boat access corridors, most were open with 3 needing re-treatment. There were new access corridors observed of which will be added for treatment; this does include an area in the cove to allow boat passage to the main lake. The county contractor is scheduled to treat eelgrass in the designated access corridors upon next service date.

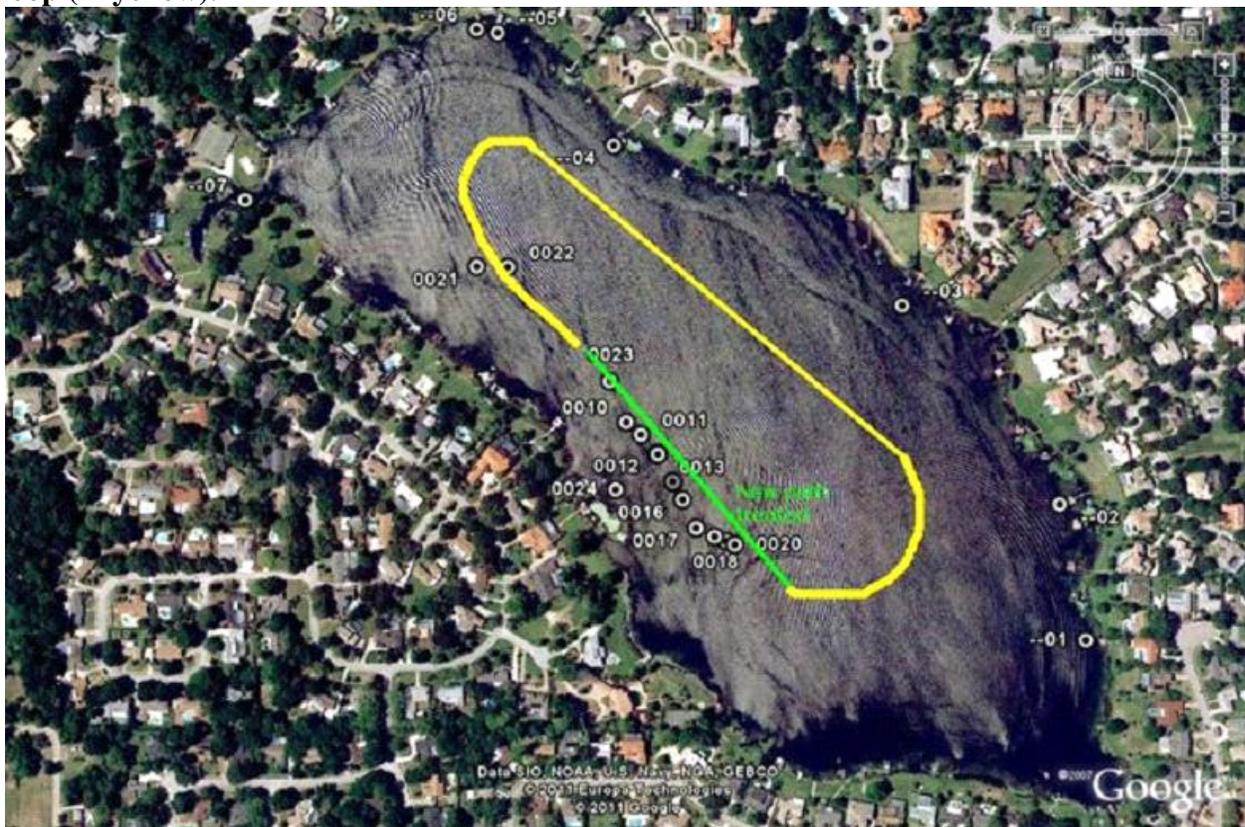
The navigational corridor is currently open and navigable. This corridor (as indicated on map below in green and marked with buoys in lake) has been created connecting the two deeper lobes of Spring Lake. This access corridor is currently being treated for eelgrass and is located in the shallow area along the south side of the lake. In conjunction with the slalom course to the north, this should provide a navigable loop for traversing around the lake. *Please continue to use corridor and proceed in the shallow areas with caution.*

Map: New eelgrass access corridor under management (in green) and illustrated navigable loop (in yellow).

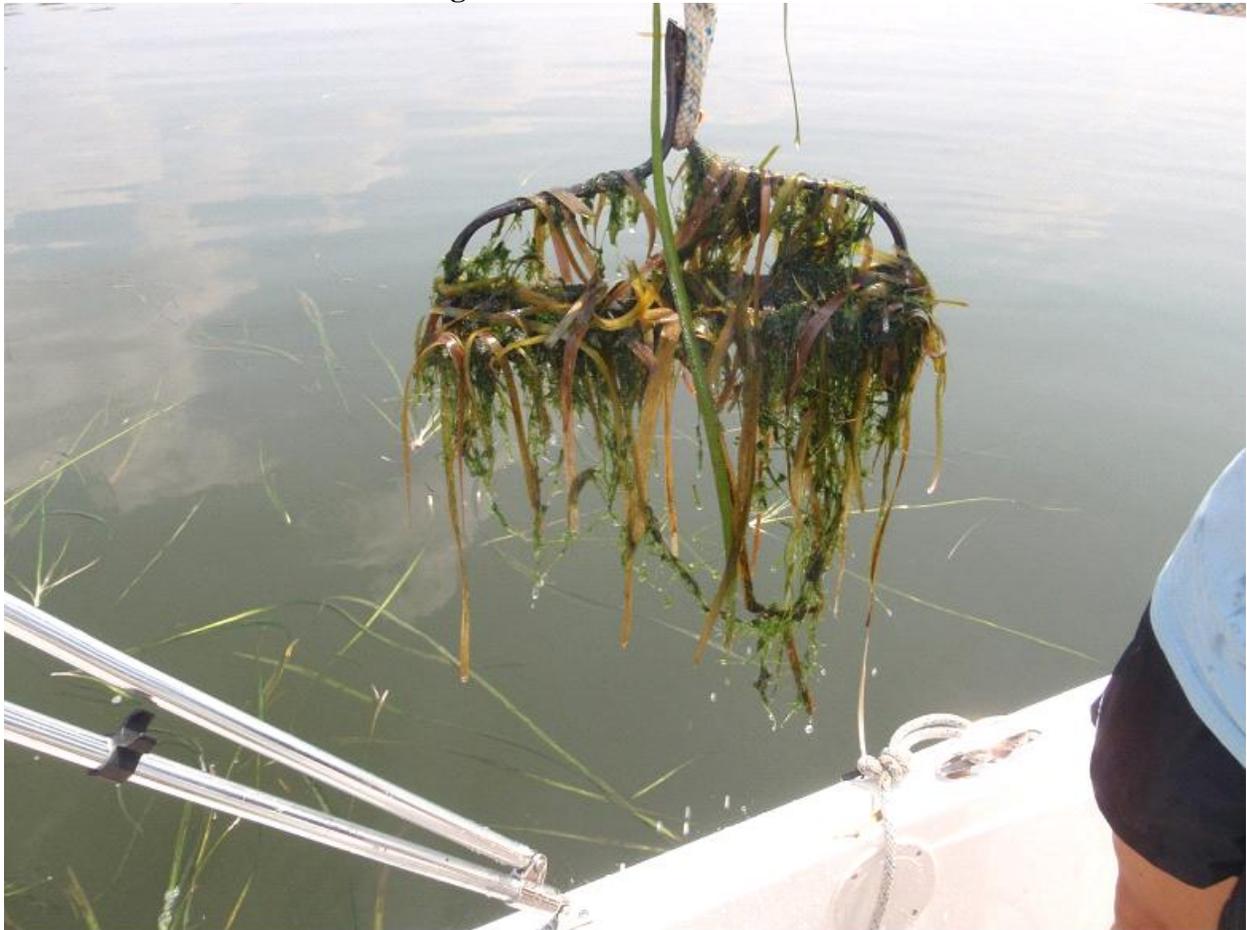
Other than the recreational impedances of eelgrass, Spring Lake has a good diversity of SAV. Submersed species found during inspection includes: hydrilla to 3 ft, stonewort to 5 ft, musk grass to 5 ft, eelgrass to 8 ft and filamentous algae. Along some shorelines in the lake, stonewort is beginning to mix in and compete for space with the eelgrass. Hydrilla was not found in the outfall canal on the NW side of the lake. In order to impact hydrilla growth in the deeper portions of the lake 50 triploid grass carp (sterile) were stocked on August 26th.

Photo: Stonewort mixed with eelgrass.

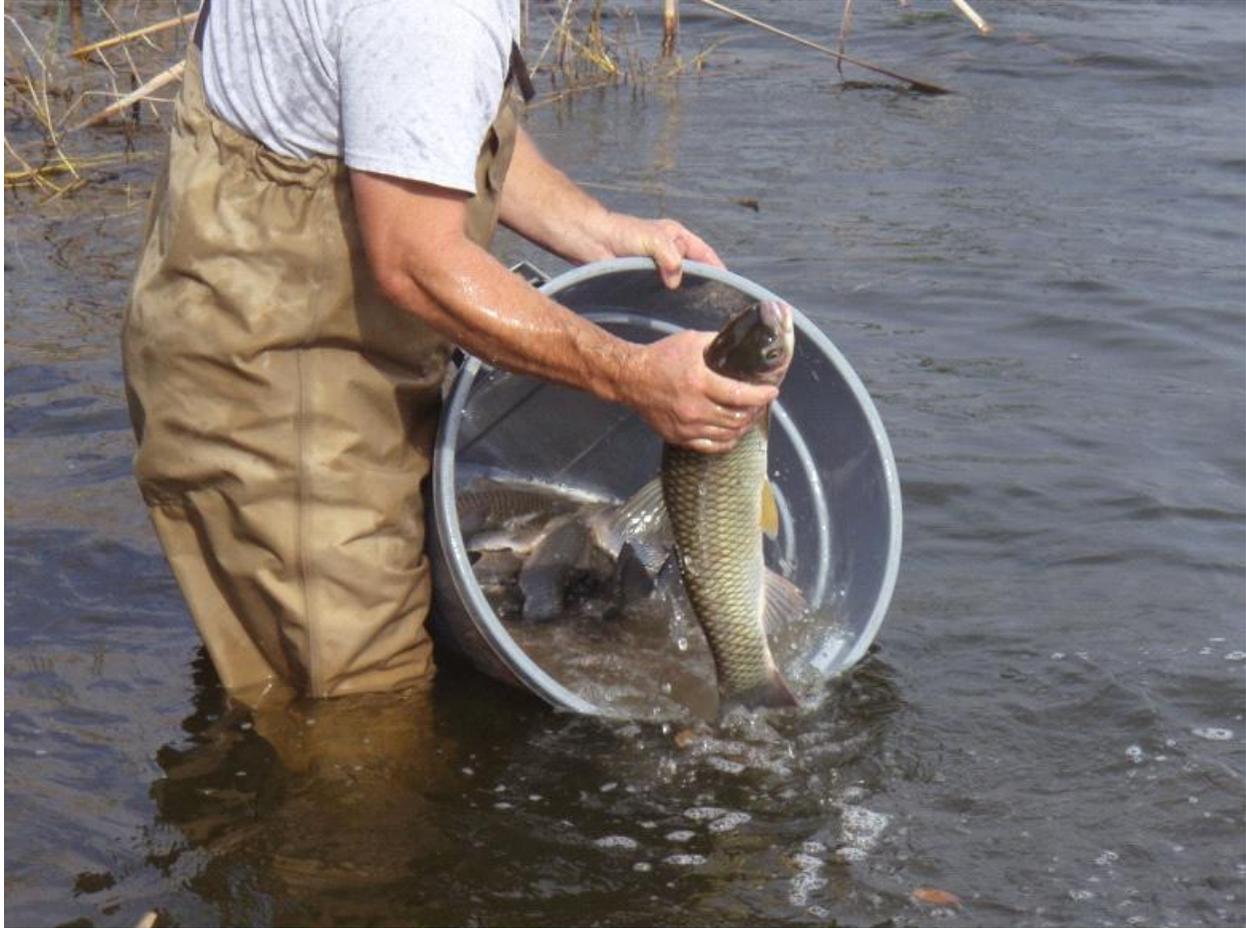
Photo: Grass carp stocking.

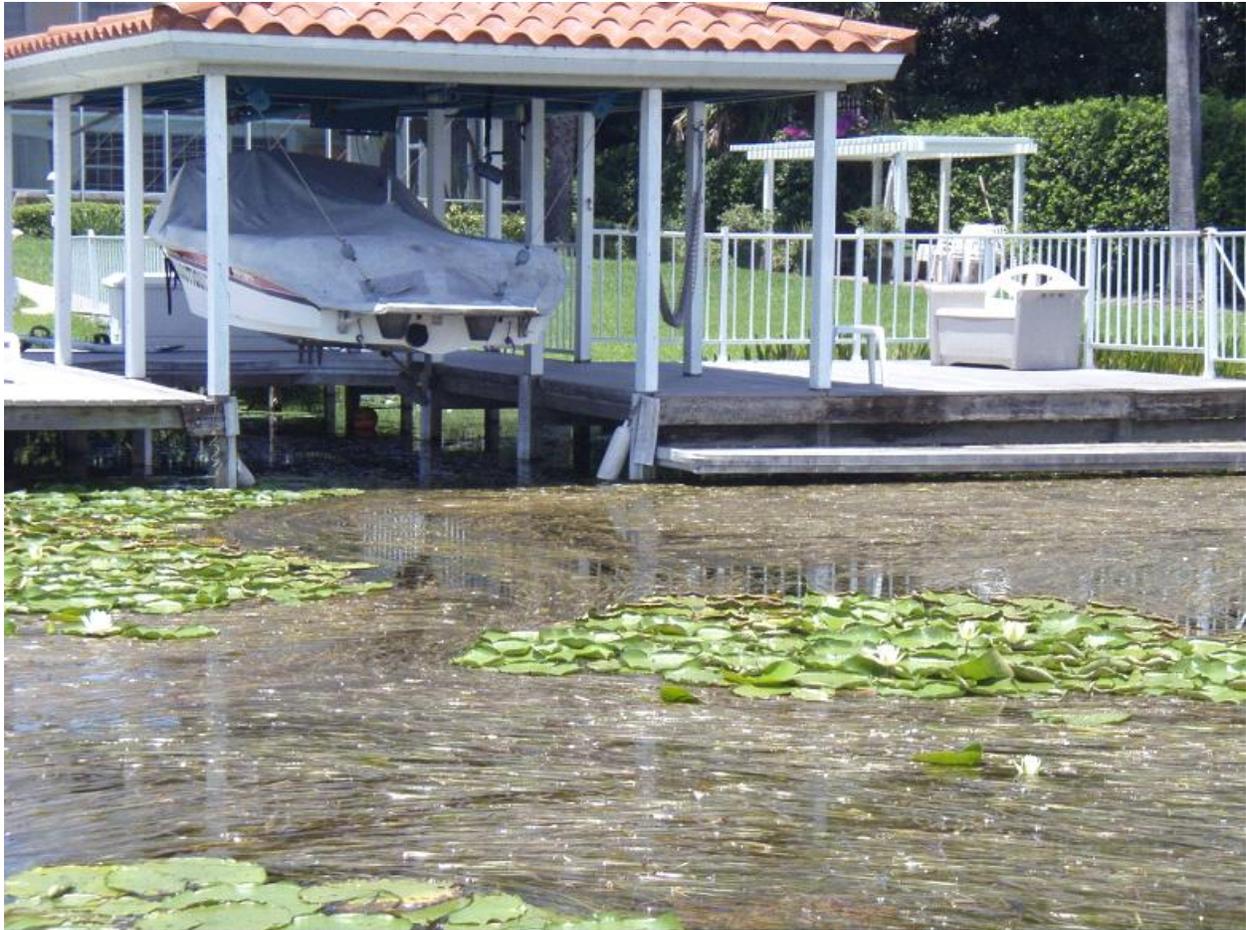
Eelgrass is still the major concern for the lake- blocking access in some areas. In efforts to address navigational concerns, SCLMP in conjunction with the liaisons of Spring Lake, have set forth creating a new access corridor via the MSBU/County herbicide contractor. This corridor (as indicated on map below in green only) has been created connecting the two deeper lobes of Spring Lake. This access corridor is currently treated and is located in the shallow area along the south side of the lake. In conjunction with the slalom course to the north, this should provide a navigable loop for traversing around the lake.

Photo: Example of access blocked by eelgrass.
