Greetings Spring Wood Lake and Spring Wood Waterway!

Spring Wood Lake

Springwood Waterway

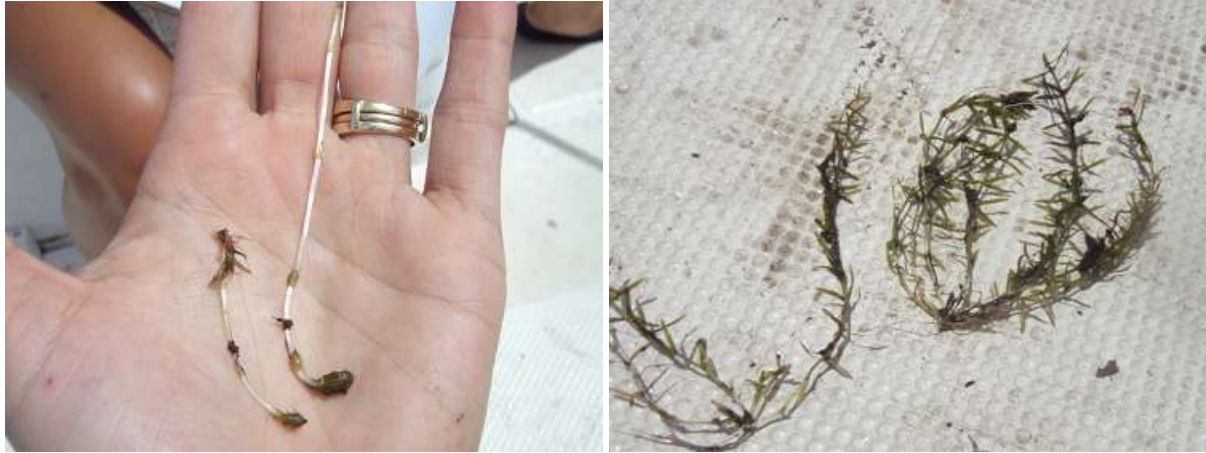
Submersed aquatic vegetation (SAV) found during inspection included: hydrilla to a depth of 8 feet, stonewort to 8 feet, roadgrass to 8 feet and lemon bacopa found to 3feet. Hydrilla was observed with new growth intermixed within other SAV. Additionally observed was the potato- like tubers generating new hydrilla plant. Hydrilla tubers can remain viable in lake sediments for up to 4 years.

Photo: Hydrilla tubers (potato-like bulbs) with new plant growth found during inspection.

Stonewort continues to be the dominant aquatic plant, blanketing the bottom of the lake to depths of 8 feet. With this dominance, stonewort assists in hindering hydrilla from establishing due to competition for space. We will closely monitor the hydrilla growth to determine if more grass carp fish will be needed to control hydrilla within the deep waters of Spring Wood Lake.

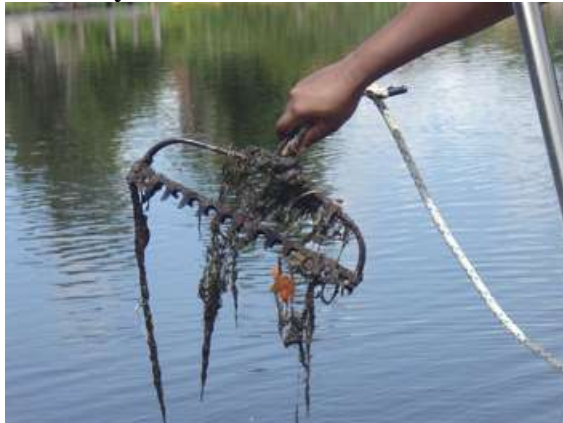
Photo: Hydrilla intermixed with stonewort.

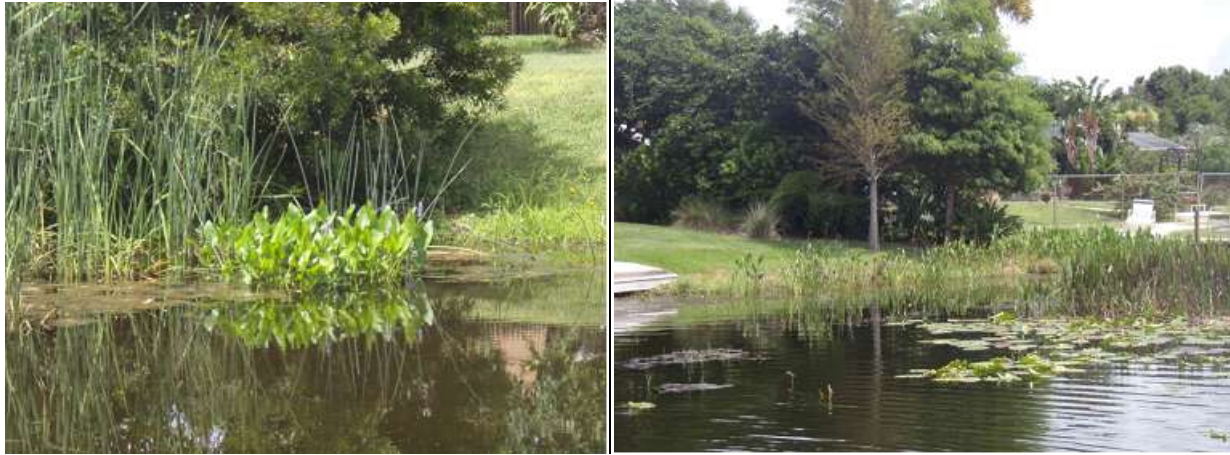
Torpedo grass continues to be treated by the Seminole County contractor via the MSBU. This, coupled with the shoreline restoration events, has resulted in torpedo grass no longer being the dominant shoreline plant in many parcels. A GREAT achievement! Plants from the April restoration event continue to do well and show signs of expansion. To encourage the expansion of the planted native vegetation, it is suggested that torpedo grass be removed from around the new plants where the monthly herbicide treatments may not impact due to affecting the new native plants.

Photo: Duck potato and pickerel weed from restoration event.

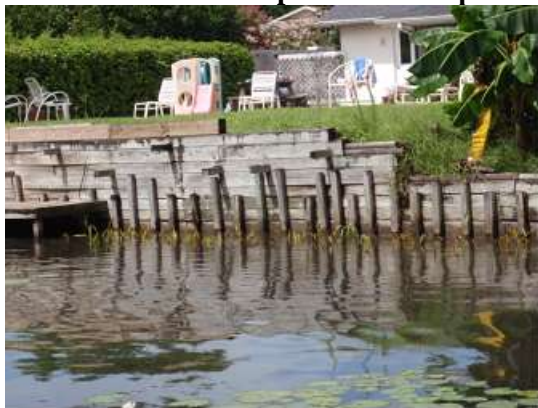
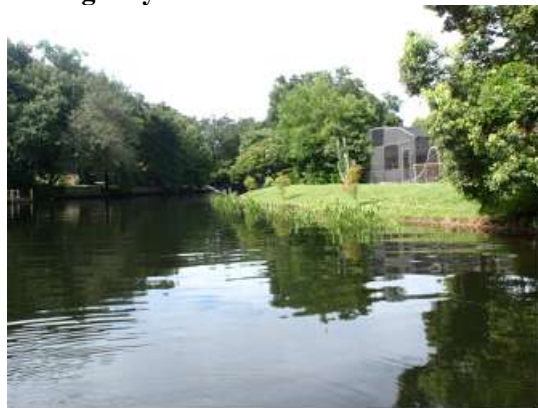
The July 16th restoration event on Springwood Waterway was a great success. We had ~80 volunteers that planted more than 2,500 plants at various locations within the waterway. These plants included pickerelweed, duck potato, canna and fire flag (Thalia).

Photo: Location examples that were planted during July's event.

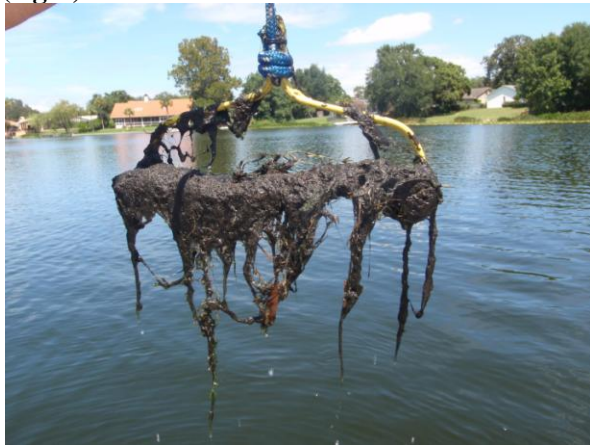
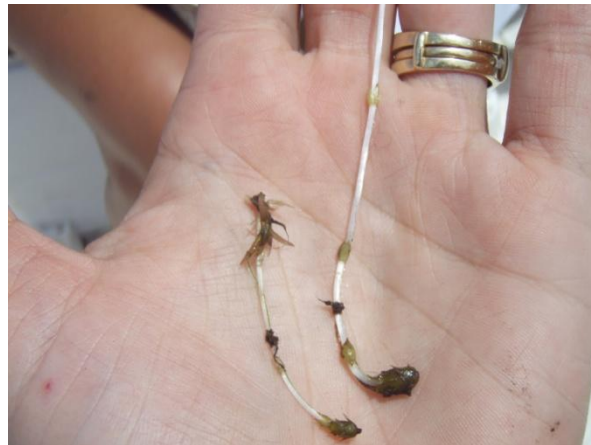
Submersed aquatic vegetation (SAV) found during inspection included one exotic and three natives: exotic hydrilla to a depth of 8 feet (same depth as previous inspection), stonewort to 10 feet, roadgrass to 8 feet, and lemon bacopa to 3 feet. Hydrilla was observed with new growth intermixed within the other native SAV and filamentous algae along the bottom. Additionally observed was the potato- like tubers generating new hydrilla plant. Hydrilla tubers can remain viable in lake sediments for over 4 years.

Photo: Hydrilla intermixed with filamentous algae (left) and tuber generating new hydrilla plant (right).

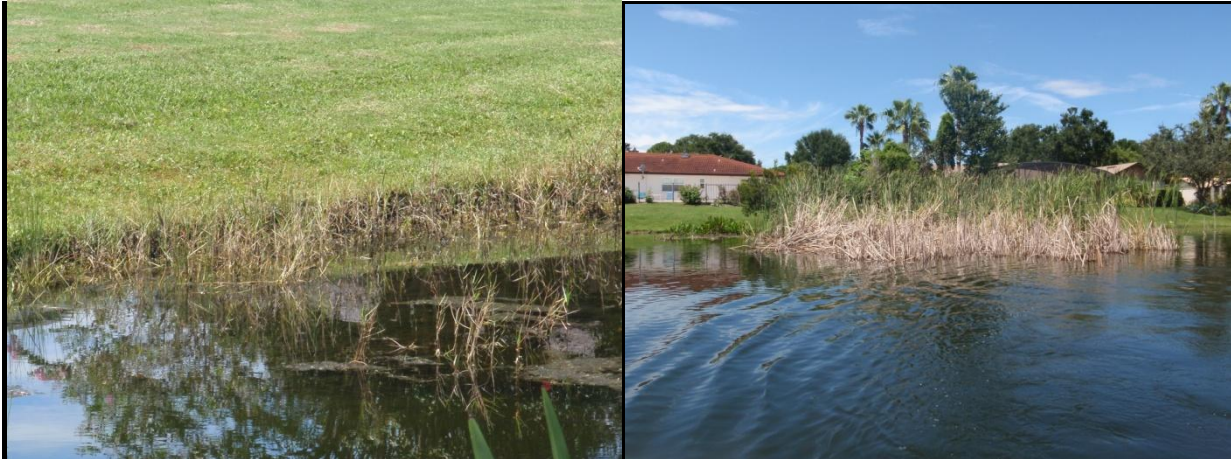
Plants from the April Restoration Event continue to do well and show signs of expansion. To encourage continued expansion of the planted native vegetation, it is suggested that torpedo grass be hand removed from around the new plants where the monthly herbicide treatments may not be able to treat due to impacting the new native plants. Torpedo grass and cattails continue to be treated by the Seminole County contractor via the MSBU. This, coupled with the shoreline restoration events, has resulted in torpedo grass no longer being the dominant shoreline plant in many parcels.

Photo: Treated torpedo grass and cattails.

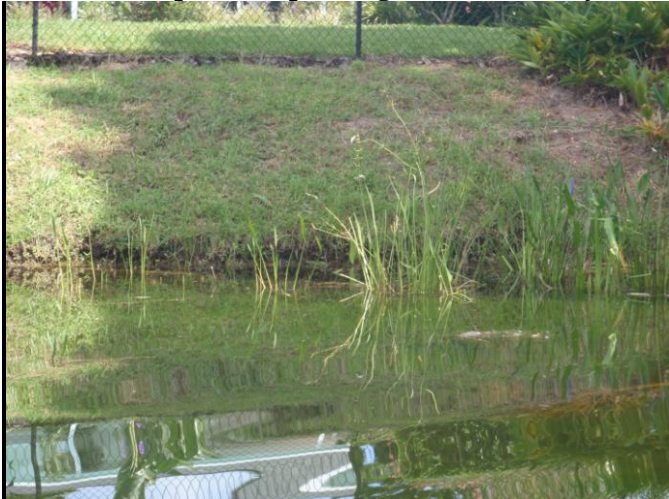
Many sites that were planted during the July 9th restoration event are doing great and plants are expanding however some sites have lost plants. We suspect that the plants are either “popping up” or have been mowed. Please take extra care when doing lawn maintenance in these areas. If you have a lawn maintenance contractor, please flag the vegetation or tell your contractor to proceed with caution in these areas.

Photo: Duck potato expanding in the waterway.

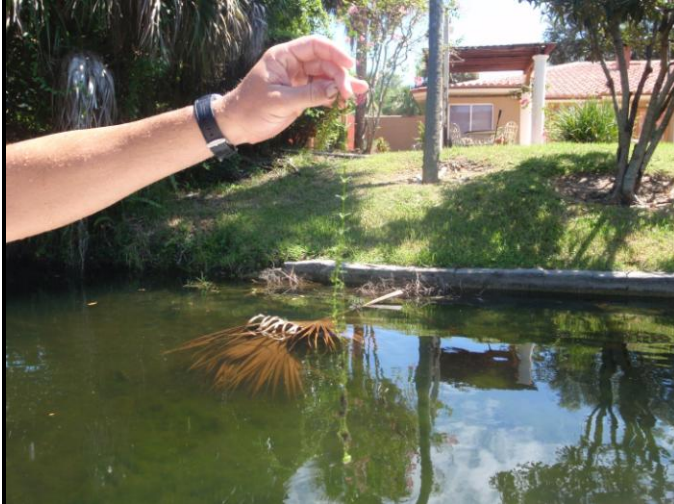
The invasive exotic hydrilla was observed during this inspection for the first time in several months where a few springs were found near the bend. In addition, the boat ramp for Lake Destiny, at the end of Lake Destiny Trail, contains hydrilla that encompasses the entire dock area that will be scheduled for treatment next month.

Photo: Hydrilla found in waterway.

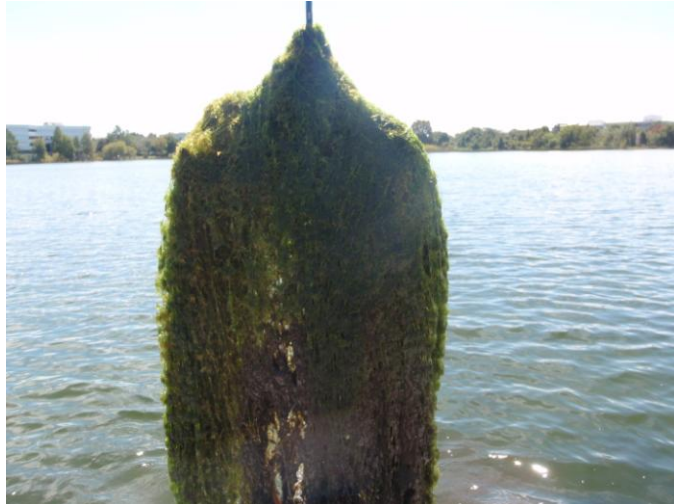
Native submersed aquatic vegetation (SAV) observed included: lemon bacopa to a depth of 2 feet, stonewort (*Nitella*) to 5 feet, purple bladderwort to 5 feet, and eelgrass in shallow water. Stonewort and bladderwort are found in 2 to 3 feet mats along the bottom and at the entrance of the waterway.

Photo: Stonewort (*Nitella*) mat found at the entrance of the waterway.
