# LAKE ASSESSMENT REPORT

## BOAT LAKE

6 /18/2002

# Boat Lake

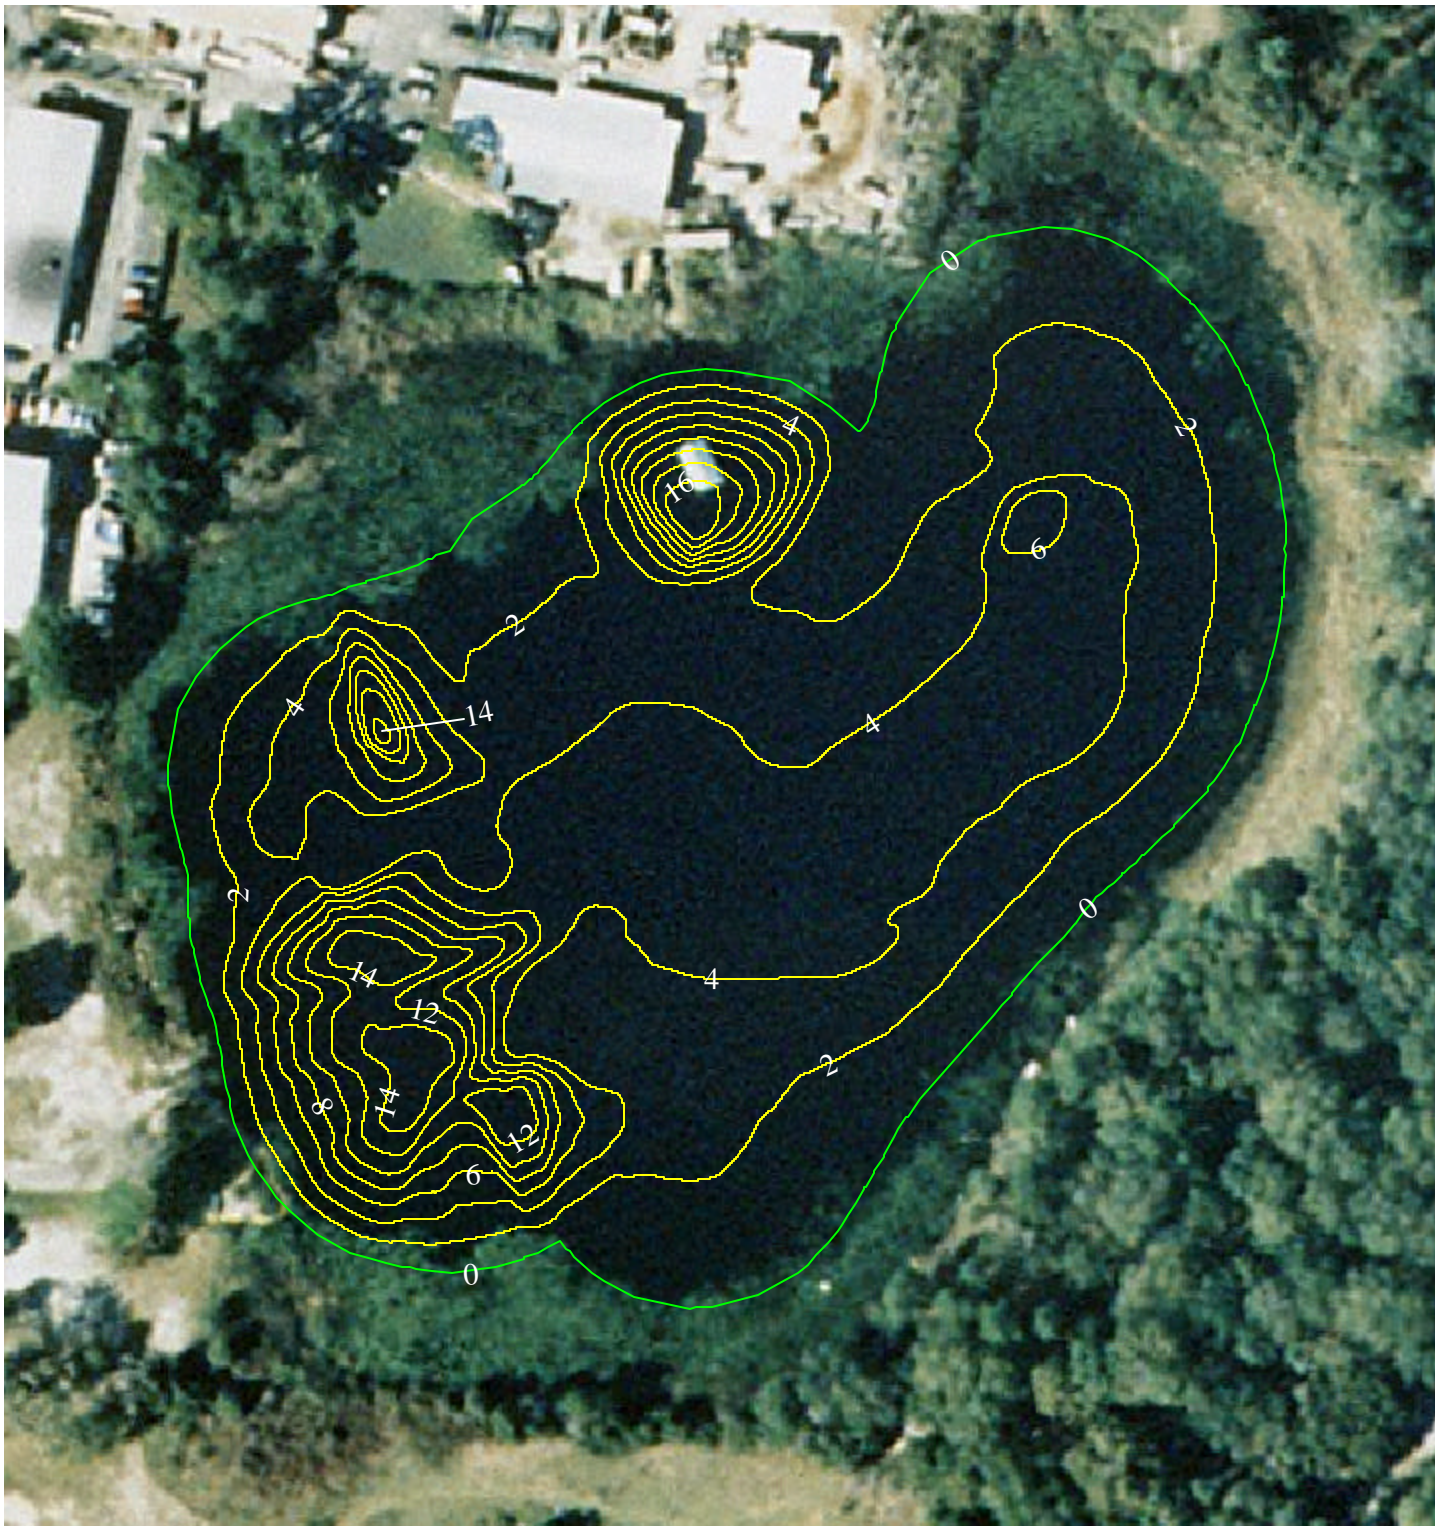
Contour Lines  
Expressed in  
2-Foot Intervals

Assessment Date: June 19, 2002.

Lake water level was 45.3 feet above sea level when the lake was assessed. Contours are expressed in absolute depth below this level and may not exclude the presence of submerged aquatic vegetation.

Seminole County 1999 color aerials provided by Seminole County Public Works. All contours generated by Florida Center for Community Design and Research based on GPS/Sonar data provided by the Seminole County Stormwater Division.
