LAKE ASSESSMENT REPORT

CATHERINE LAKE

7 /28/2000

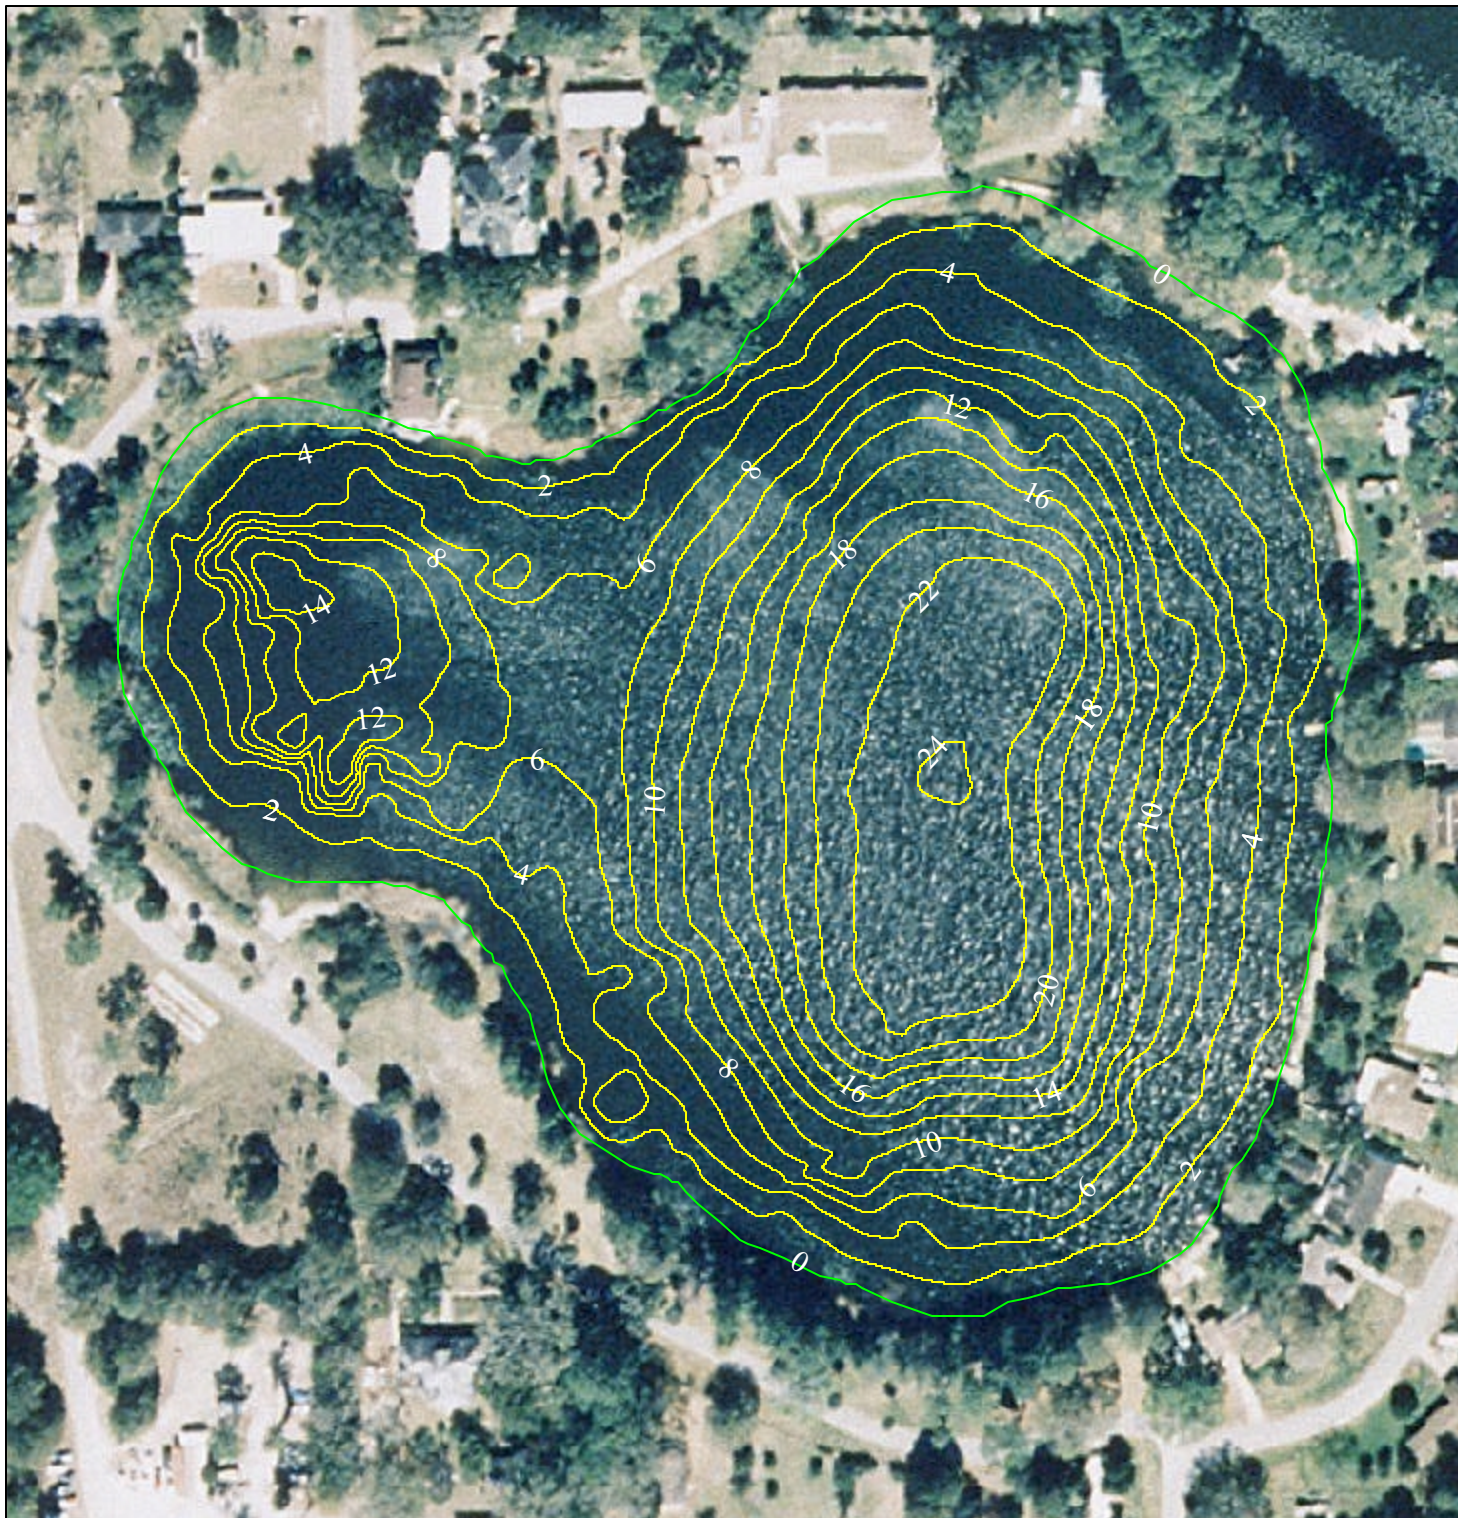
Lake Catherine

Lake water level was 52.6 ft.
above sea level when the lake was
assessed. Contours are expressed in
absolute depth below this level.

Seminole County 1999 color aerials
provided by Seminole County Public
Works. All contours generated by
Florida Center for Community Design
and Research based on GPS/Sonar
data provided by the Seminole County
Stormwater Division.

The bottom of the lake was mapped using a Global Positioning System (GPS) to determine the boat's position, and a depth-finder to provide depth associated with that measured position. The result is an estimate of the lake's area, mean and maximum depths, and volume (Table 1) and the creation of a bottom contour map. *NOTE: This map is for recreational purposes only.*
