LAKE ASSESSMENT REPORT

KATHRYN, LAKE

7 /11/2001

Lake Kathryn

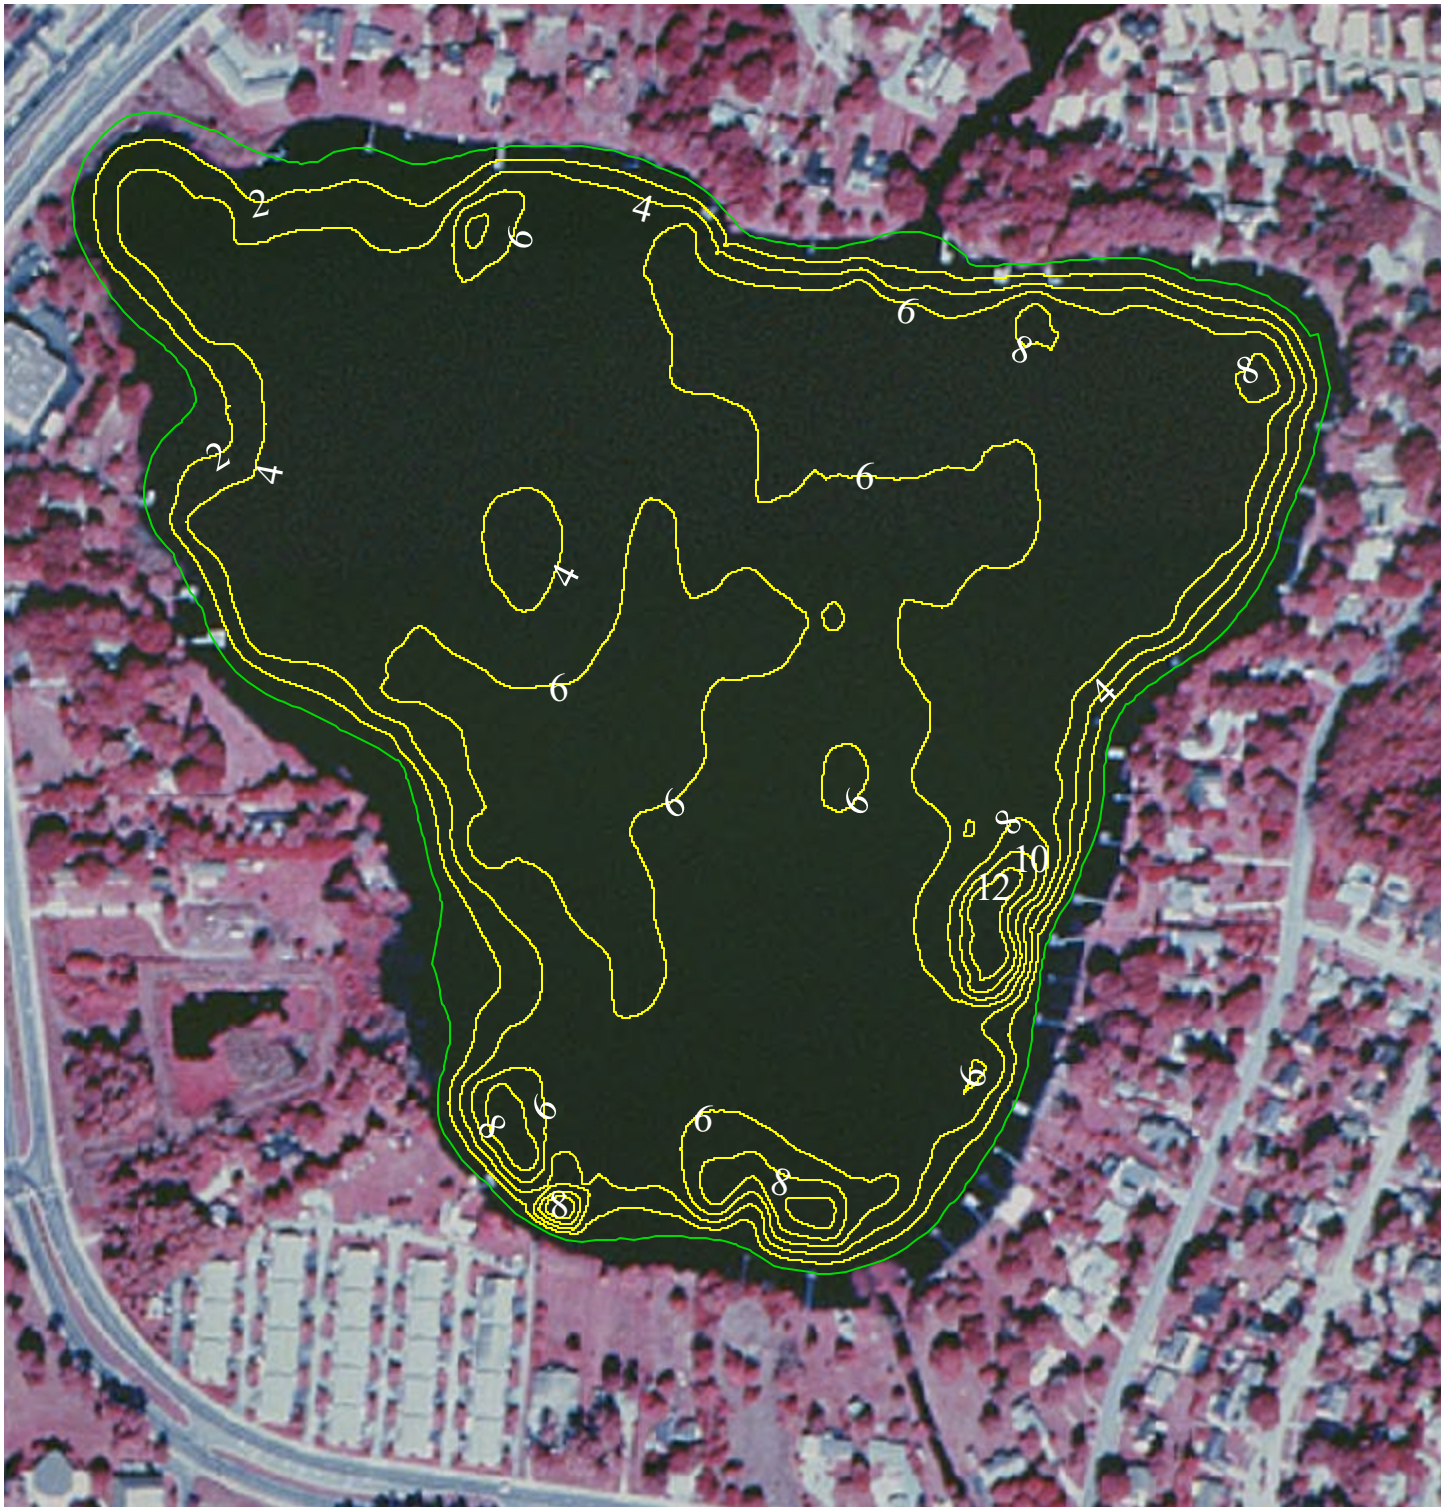
Assessment Date: July 11, 2001.

Lake water level was 47 ft.
above sea level when the lake was
assessed. Contours are expressed in
absolute depth below this level.

Seminole County 1999 color aerials
provided by Seminole County Public
Works. All contours generated by
Florida Center for Community Design
and Research based on GPS/Sonar
data provided by the Seminole County
Stormwater Division.
