# LAKE ASSESSMENT REPORT

## MARIETTA NORTH, LAKE

8 /1 /2002

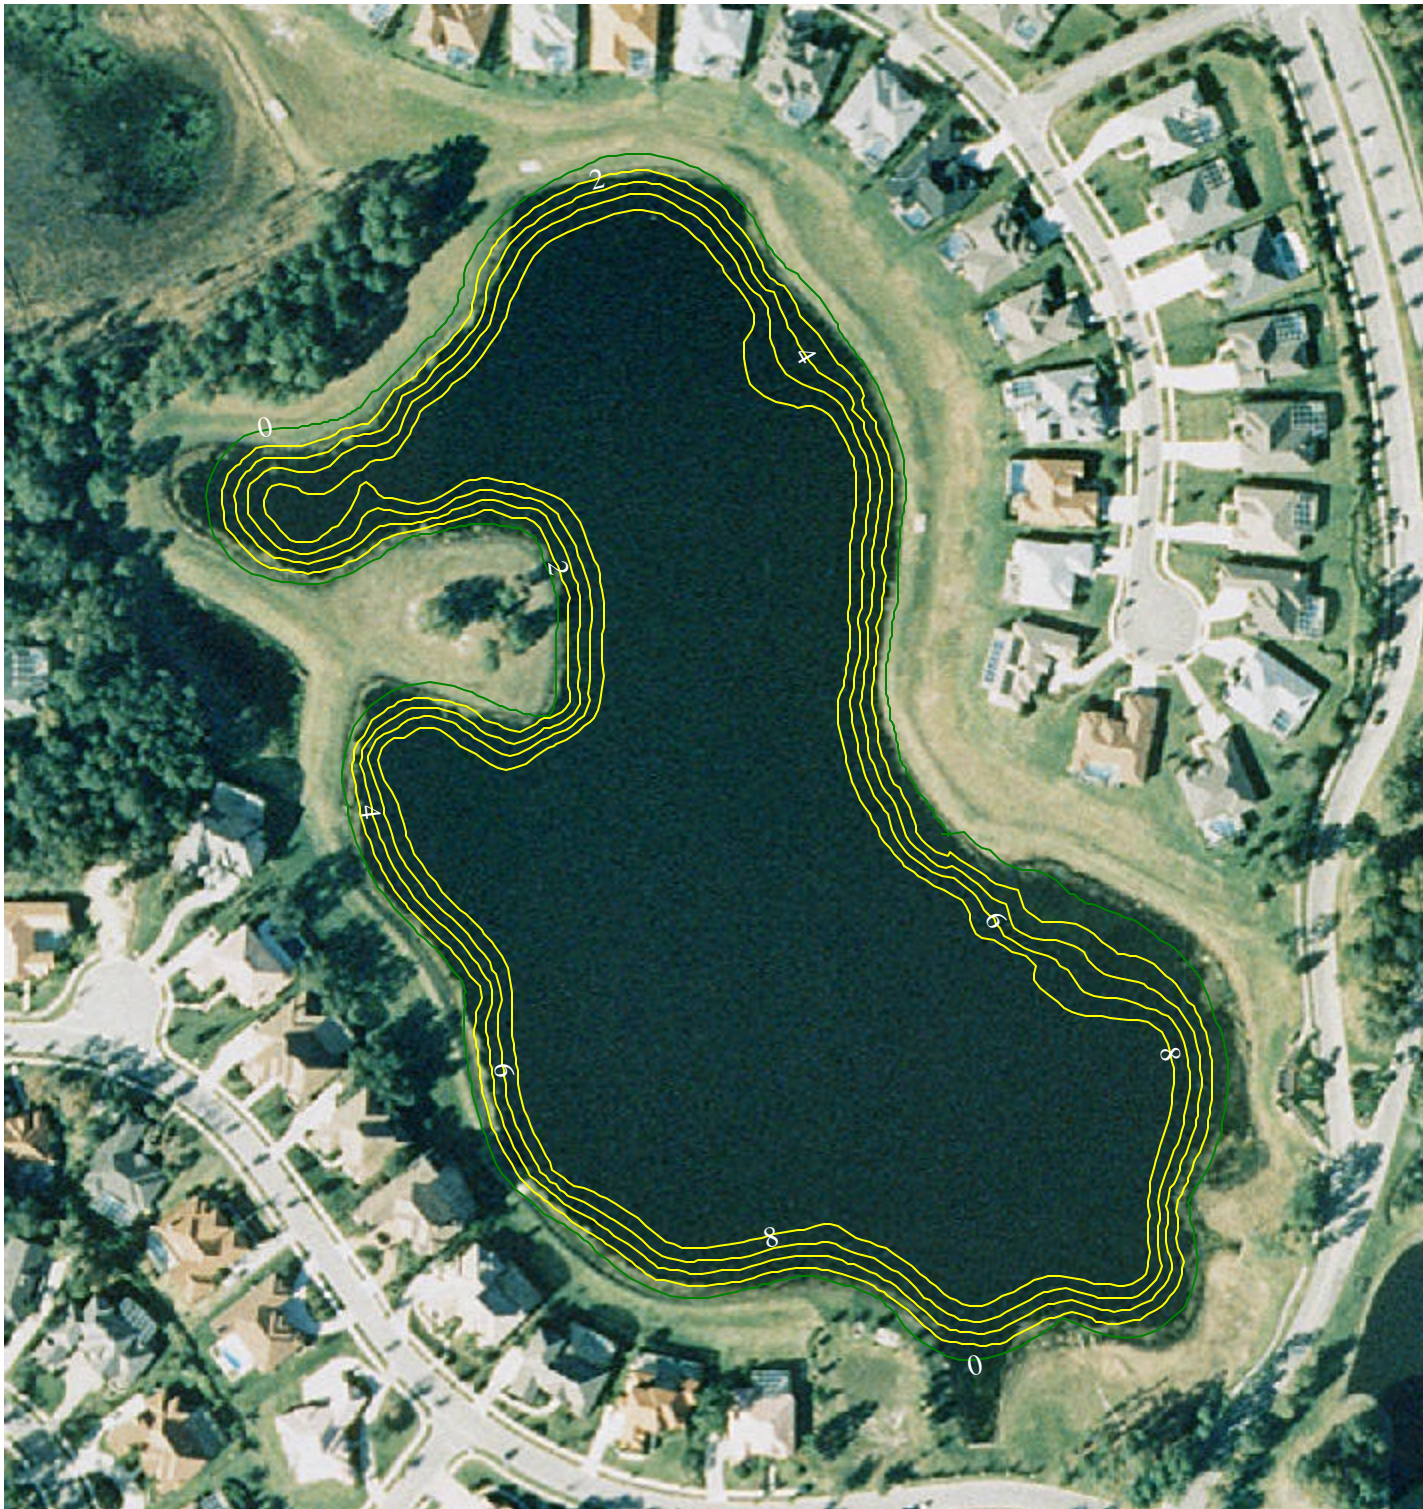
# Lake Marietta North

Contour Lines  
Expressed in  
2-Foot Intervals

Assessment Date: August 1, 2002.  
Lake water level was 39.18 feet above sea level when the lake was assessed. Contours are expressed in absolute depth below this level and may not exclude the presence of submersed aquatic vegetation.

Seminole County 1999 color aerials provided by Seminole County Public Works. All contours generated by Florida Center for Community Design and Research based on GPS/Sonar data provided by the Seminole County Stormwater Division.
