# LAKE ASSESSMENT REPORT

## QUEENS MIRROR LAKE

8 /6 /2001

# Queens Mirror Lake

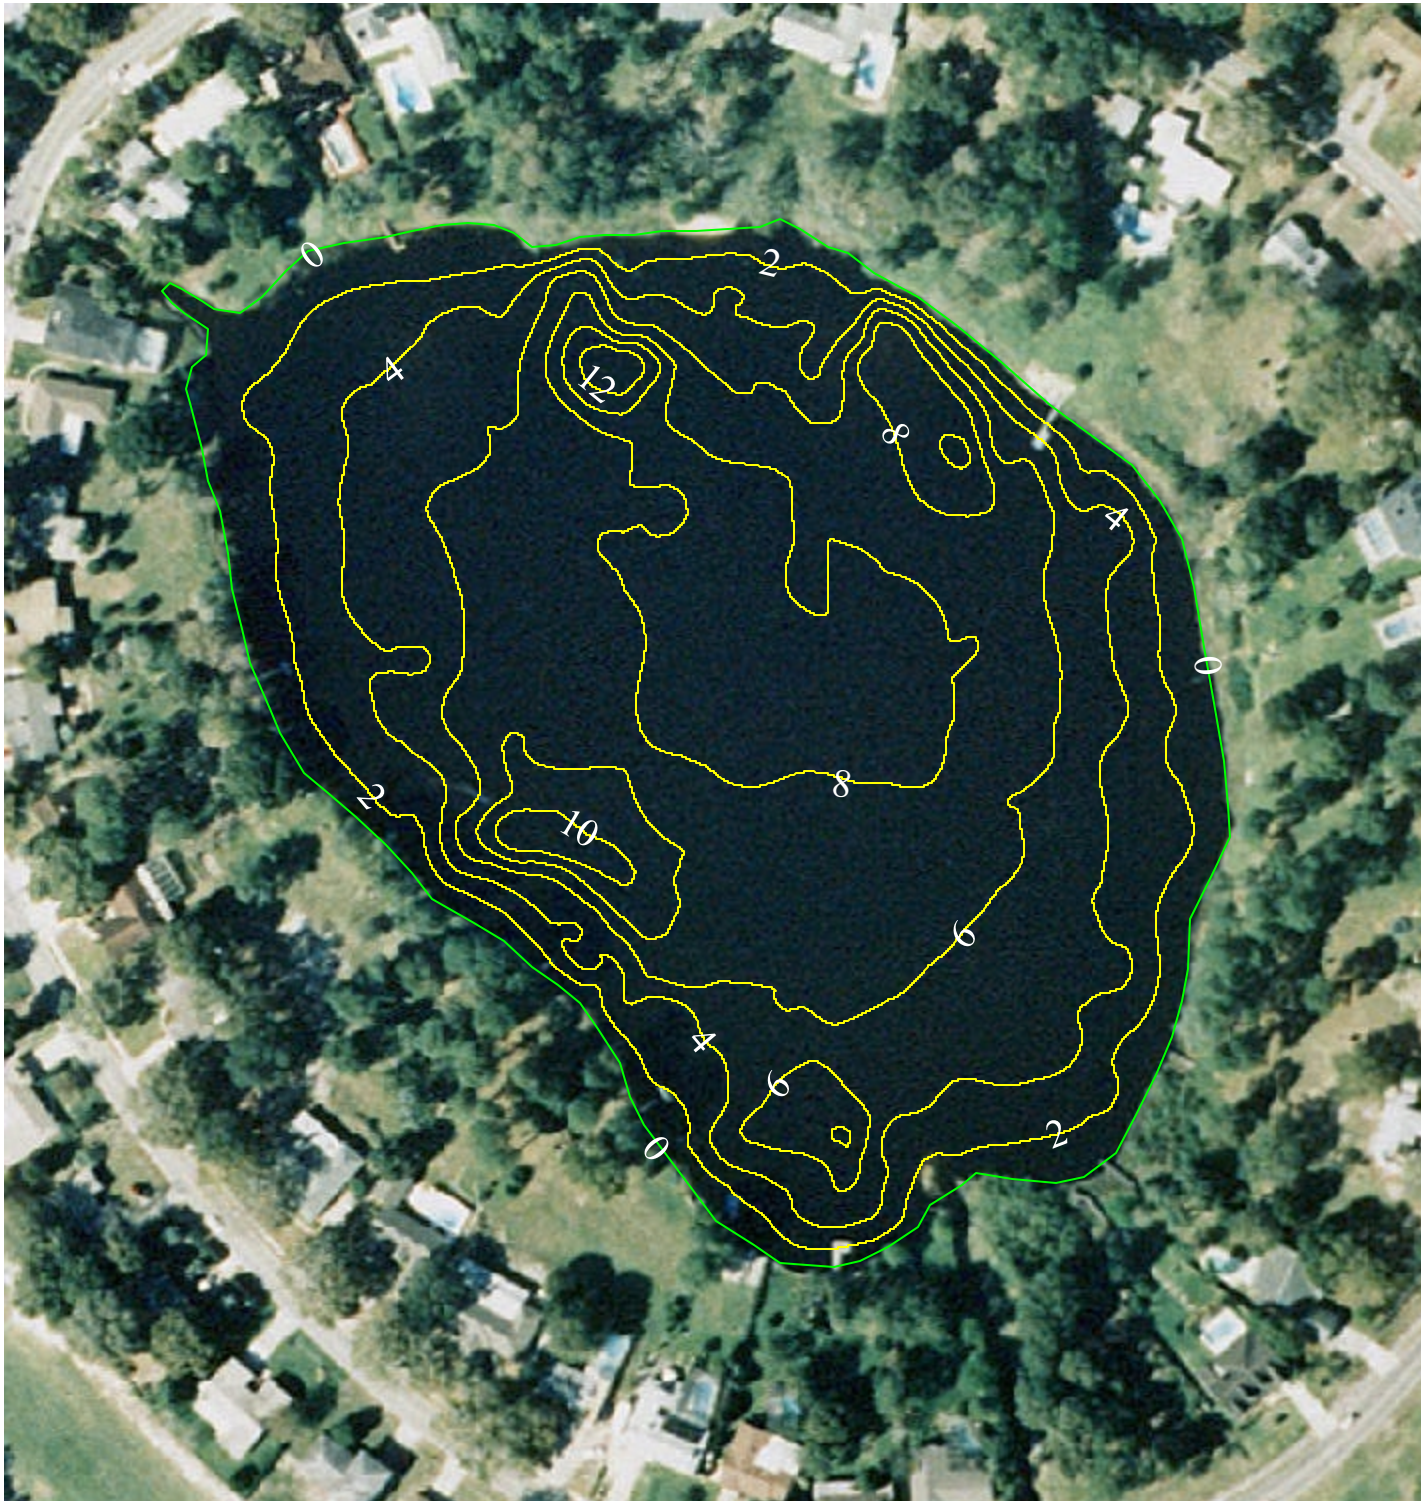
Assessment Date: August 6, 2001.

Lake water level was 50.7 ft.  
above sea level when the lake was  
assessed. Contours are expressed in  
absolute depth below this level.

Seminole County 1999 color aerials  
provided by Seminole County Public  
Works. All contours generated by  
Florida Center for Community Design  
and Research based on GPS/Sonar  
data provided by the Seminole County  
Stormwater Division.
