# LAKE ASSESSMENT REPORT

## ROUND LAKE

7 /3 /2002

# Round Lake

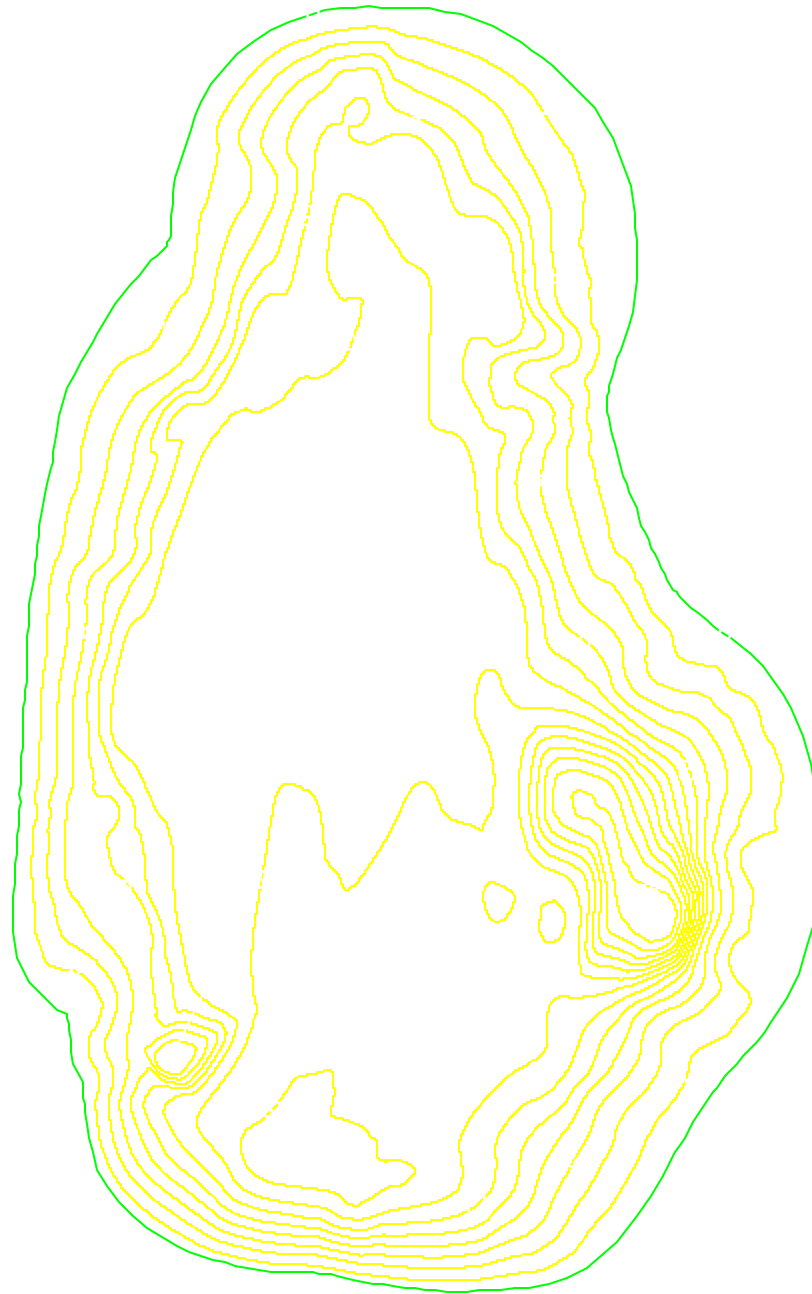
Section - Township - Range  
11-21-31

Assessment Date: July 3, 2002.

Lake water level was 45.68 feet above sea level when the lake was assessed. Contours are expressed in absolute depth below this level and may not exclude the presence of submersed aquatic vegetation.

Seminole County 1999 color aerials provided by Seminole County Public Works. All contours generated by Florida Center for Community Design and Research based on GPS/ Sonar data provided by the Seminole County Stormwater Division.
