Greetings Lakes Martha and Burkett Residents!

Please find the latest bioassessment of your lake below. Our next survey is scheduled for **March 2016**. Key highlights of this update include:

Bioassessments:

On **August 27th, 2014**, Seminole County Lake Management Program (SCLMP) staff Thomas Calhoun, Gloria Eby, and Marianne Pluchino surveyed the aquatic plants in **Lakes Martha and Burkett**.

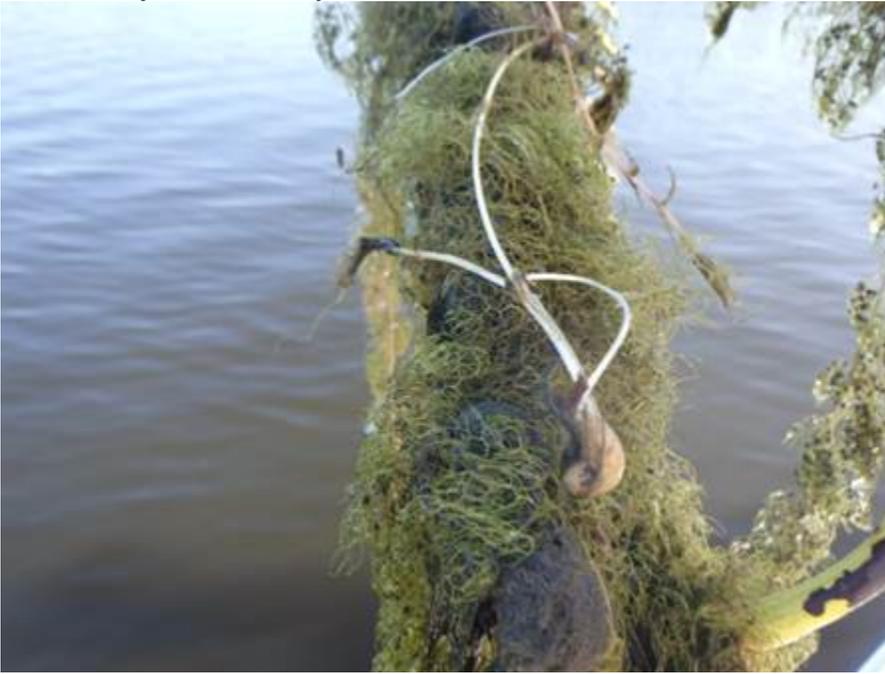
Hydrilla was found mixed in with native vegetation to a depth of 8 feet in both lakes. Hydrilla tubers can lay dormant for more than 4 years. As the tubers begin to propagate it is hoped that the grass carp fish will forge on this new growth. We will continue to monitor hydrilla in both lakes to see if any action will be necessary.

Photos: Hydrilla and hydrilla tubers mixed in with bladderwort.

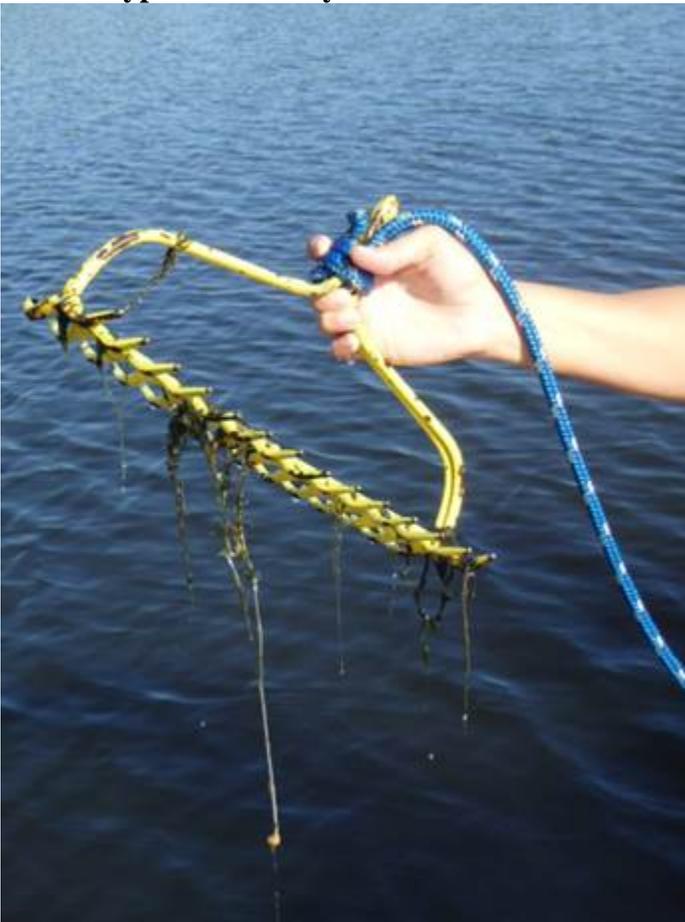
Photo: Typical size of hydrilla found in Lakes Martha and Burkett.

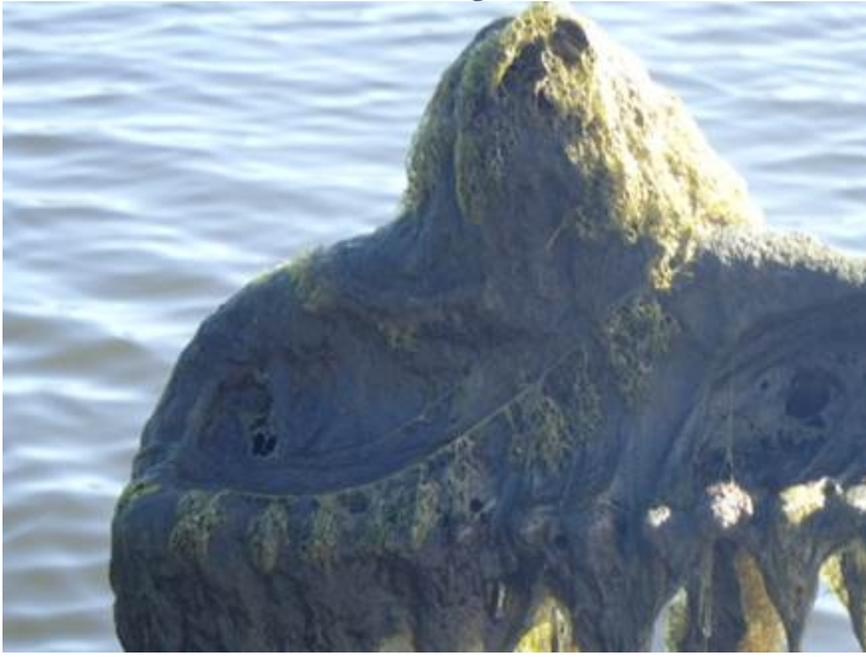
Several species of native SAV were observed during the inspection, including: baby's tears to 1 foot, southern naiad to 7 feet, stonewort to 6 feet, bladderwort to 7 feet, and eelgrass to 6 feet. Bladderwort, stonewort and southern naiad were expanding in both lakes.

Photo: Bladderwort mixed with algae.

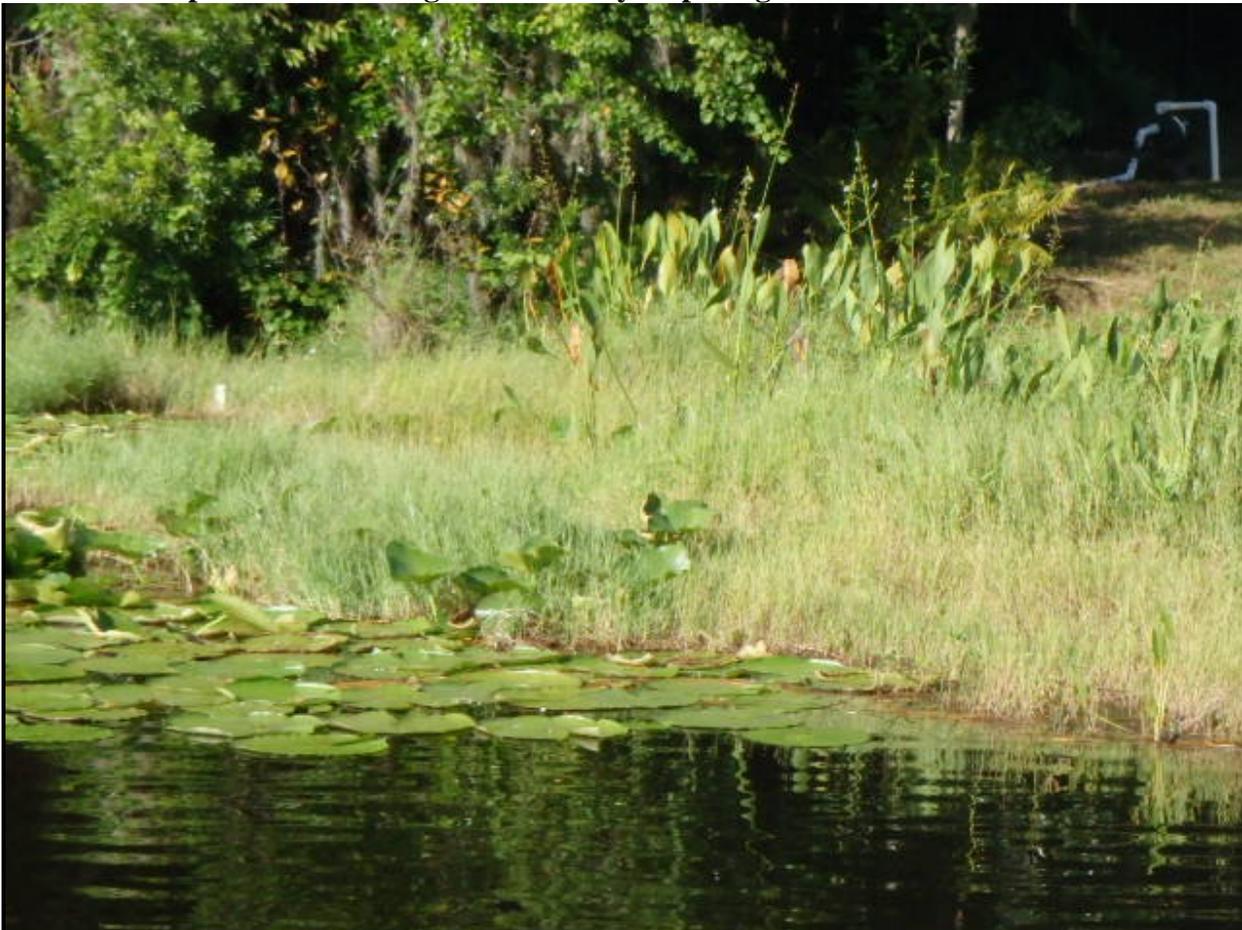
Exotic emergent vegetation observed during the inspection included: alligatorweed, torpedo grass, and wild taro. Native emergent vegetation included: canna, rush fuirena, bulrush, pickerelweed, duck potato, and fire flag. Plantings from last year's lake restoration event were expanding well. However, in many areas torpedo grass is taking over stands of native vegetation.

Photo: Duck potato stand being taken over by torpedo grass.

1 Work together or establish a lake association with other lakefront owners to control invasive plants and increase native aquatic plantings along shoreline (such as pickerelweed and duck potato). Have at least one annual lake association meeting, invite guest speakers (such as county or state biologists) and discuss lake specific issues.

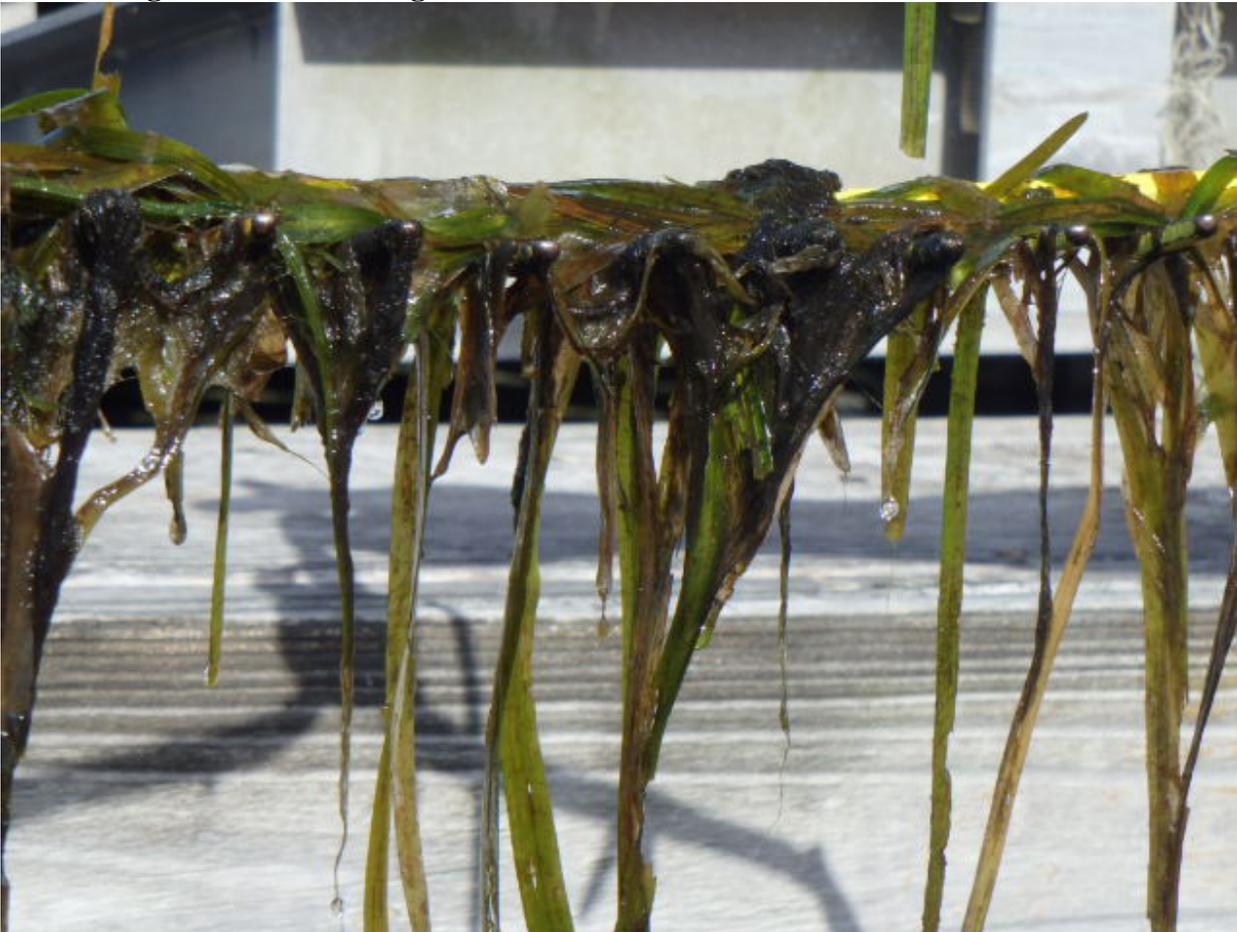
Several species of native SAV were observed during the inspection, including: baby's tears to 1 foot, southern naiad to 6 feet, stonewort to 4 feet, bladderwort to 4 feet, and eelgrass to 6 feet. Bladderwort, eelgrass and southern naiad were expanding in both lakes.

Photo: Eelgrass mixed with algae.

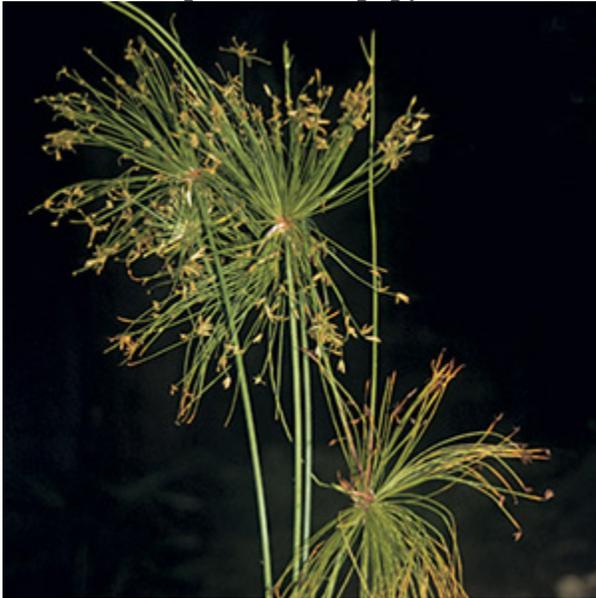
Exotic emergent vegetation observed during the inspection included: alligatorweed, torpedo grass, dwarf papyrus and wild taro. Native emergent vegetation included: canna, rush fuirena, pickerelweed, duck potato, Carolina red root, and fire flag.

Photo: Example of dwarf papyrus.

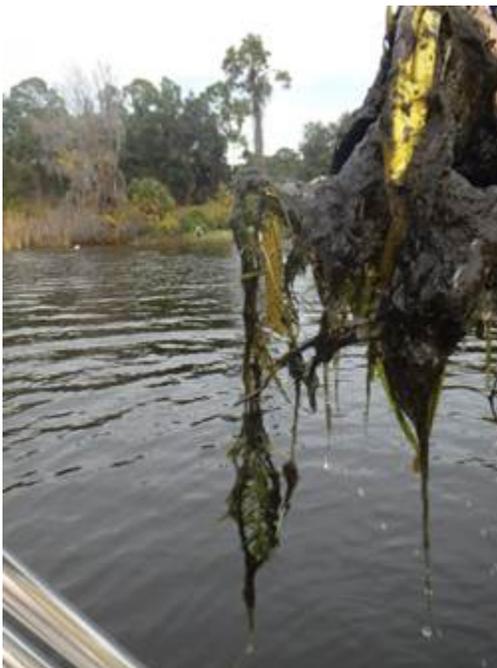
Hydrilla was found mixed in with native vegetation to a depth of 7 feet in both lakes. This was an increase in depth since the previous inspection. We will continue to monitor hydrilla in both lakes to see if any action will be necessary.

Photo: Hydrilla on north portion of Burkett intermixed with native southern naiad.

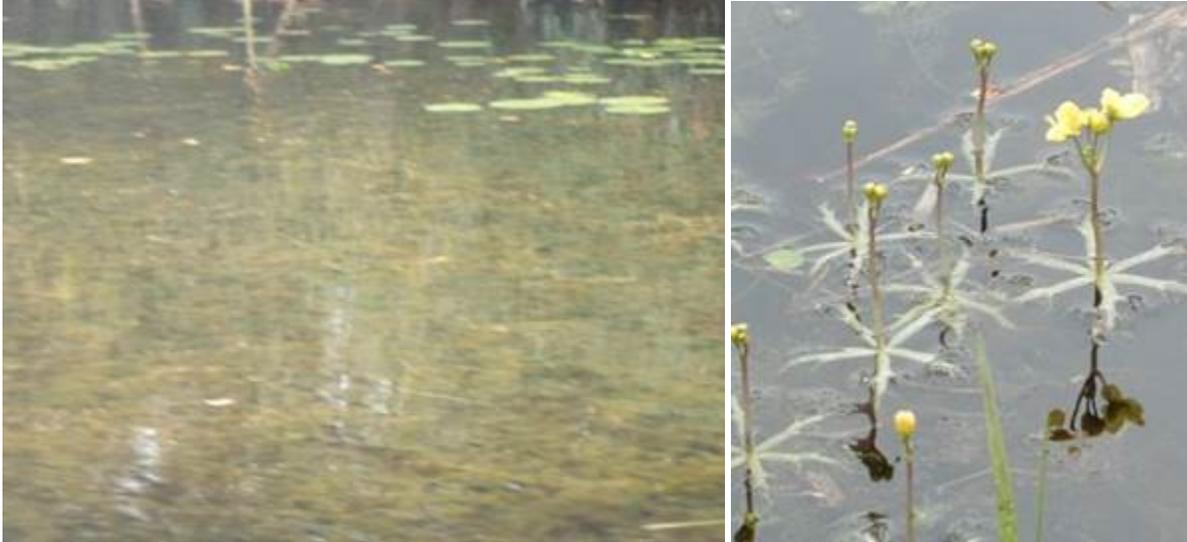
Several species of native SAV were observed during the inspection, including: baby's tears to 1 foot, southern naiad to 7 feet, stonewort to 4 feet, bladderwort to 7.5 feet, and eelgrass to 3.5 feet. Bladderwort has expanded to become the dominant inshore plant. Bladderworts are unique in that the underwater leaves bear small oval "bladders" that trap and digest small aquatic creatures.

Photo: Bladderwort in Lake Martha (left) with example of flower (right).
