Greetings Horseshoe Lake North residents!

Below, please find the latest bioassessment for your lake. The next lake inspection will be conducted on December 22nd, 2014. Key highlights of this assessment include:

On **November 12th, 2014**, Seminole County Lake Management Program (SCLMP) personnel (Gloria Eby, Thomas Calhoun, Joey Cordell, and Sophia Pengra) surveyed the aquatic plants in Horseshoe Lake North.

On **October 14th, 2014**, Seminole County Lake Management Program and Water Quality Program personnel, Marianne Pluchino and Gloria Eby, surveyed the aquatic plants in Horseshoe Lake North.

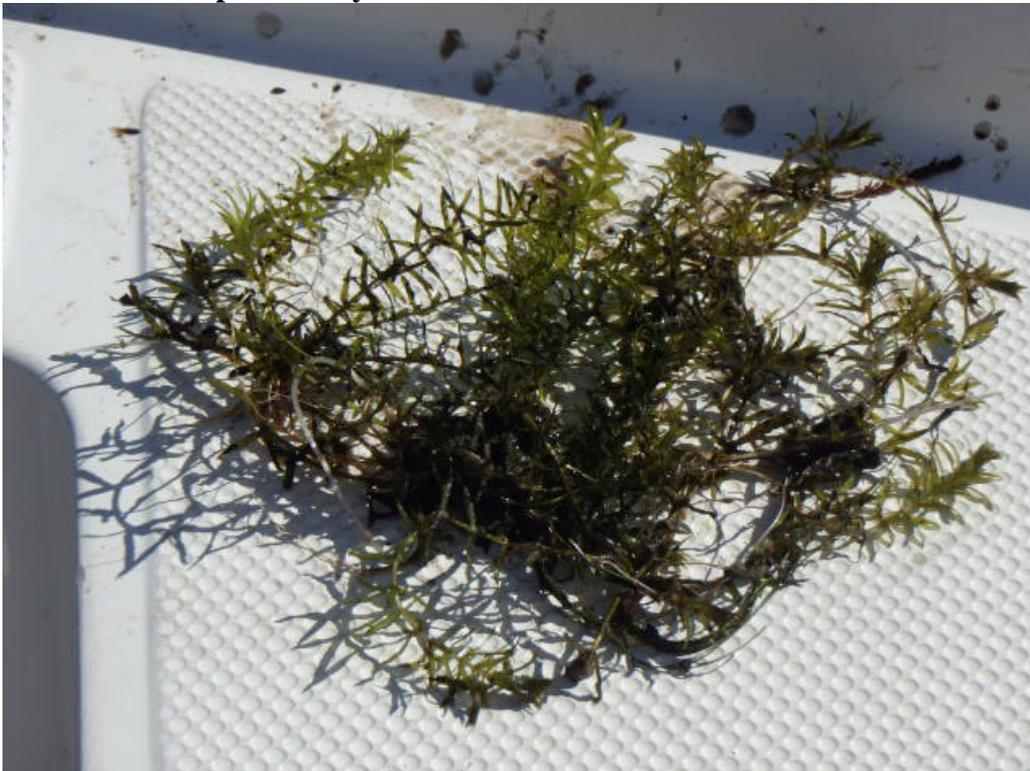
Two small patches of the invasive SAV hydrilla were found in less than 1 foot of water along the northeast shoreline by the mouth of the 8th Street Canal. These patches were hand removed from the lake in its entirety by its roots. Hydrilla rapidly reproduces from stem fragments, buds, and tubers. Tubers can remain viable in the sediment of the lake for more than 4 years. There are many ways to manage hydrilla. These include; chemical treatment, grass carp fish, mechanical removal, water draw down, and hand removal. Currently the amount of hydrilla found only warrants hand removal. Hydrilla sprigs when found should be pulled out by hand ensuring you get the root crown. More information on hydrilla can be found at: <http://plants.ifas.ufl.edu/node/183>.

Photo: A small patch of hydrilla hand removed from Lake Horseshoe North.

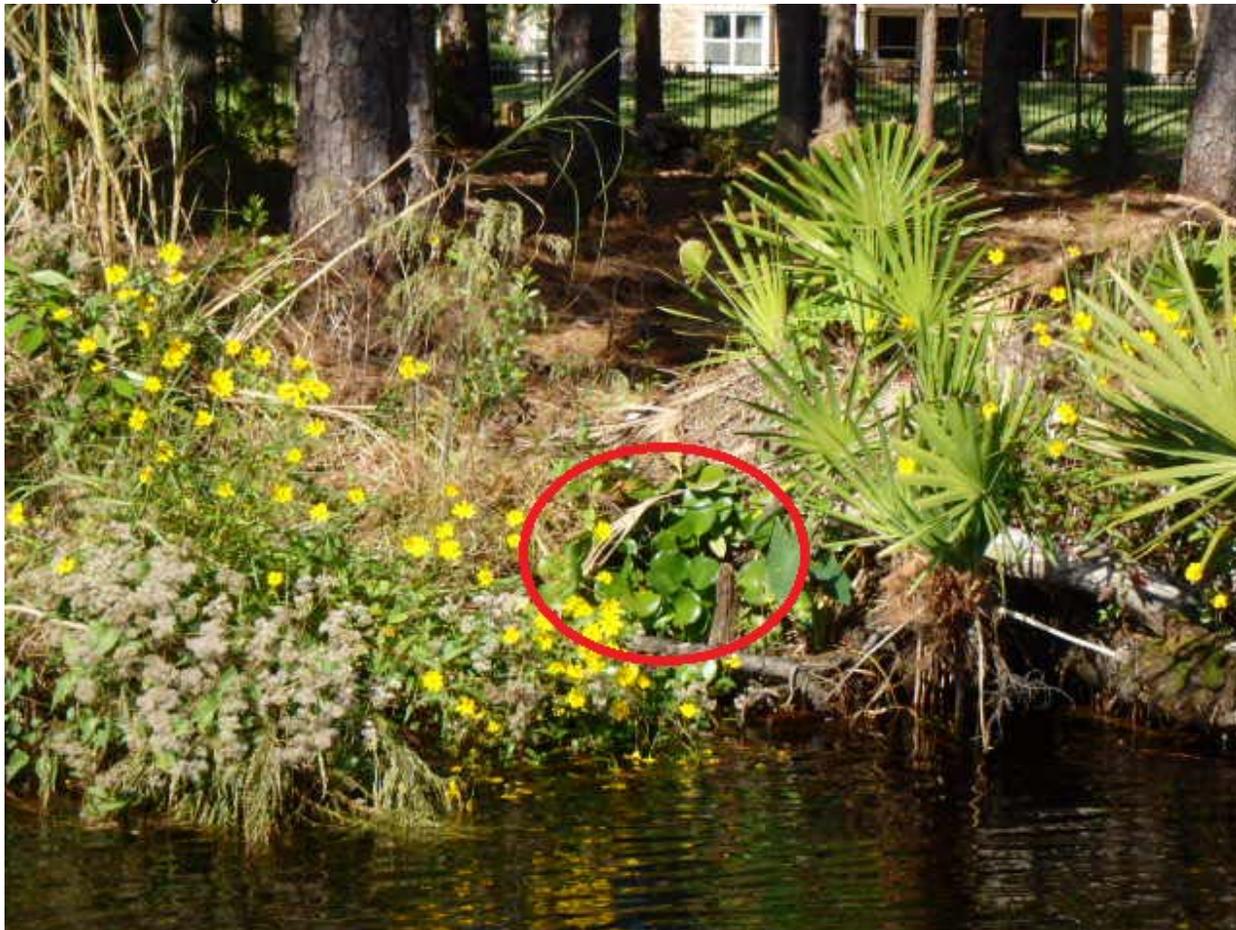
Other invasive species observed included: alligatorweed, wild taro, water hyacinth, primrose willow, torpedo grass, bur-head sedge, and salvinia. The alligatorweed that was observed was impacted by past herbicide treatments and in poor health. The numbers of water hyacinth in the lake is very low with only a few plants observed. We encourage hand removal of water hyacinth from the lake. This practice will control the population of this invasive plant which has a reputation of spreading rapidly.

Photo: Water hyacinth.

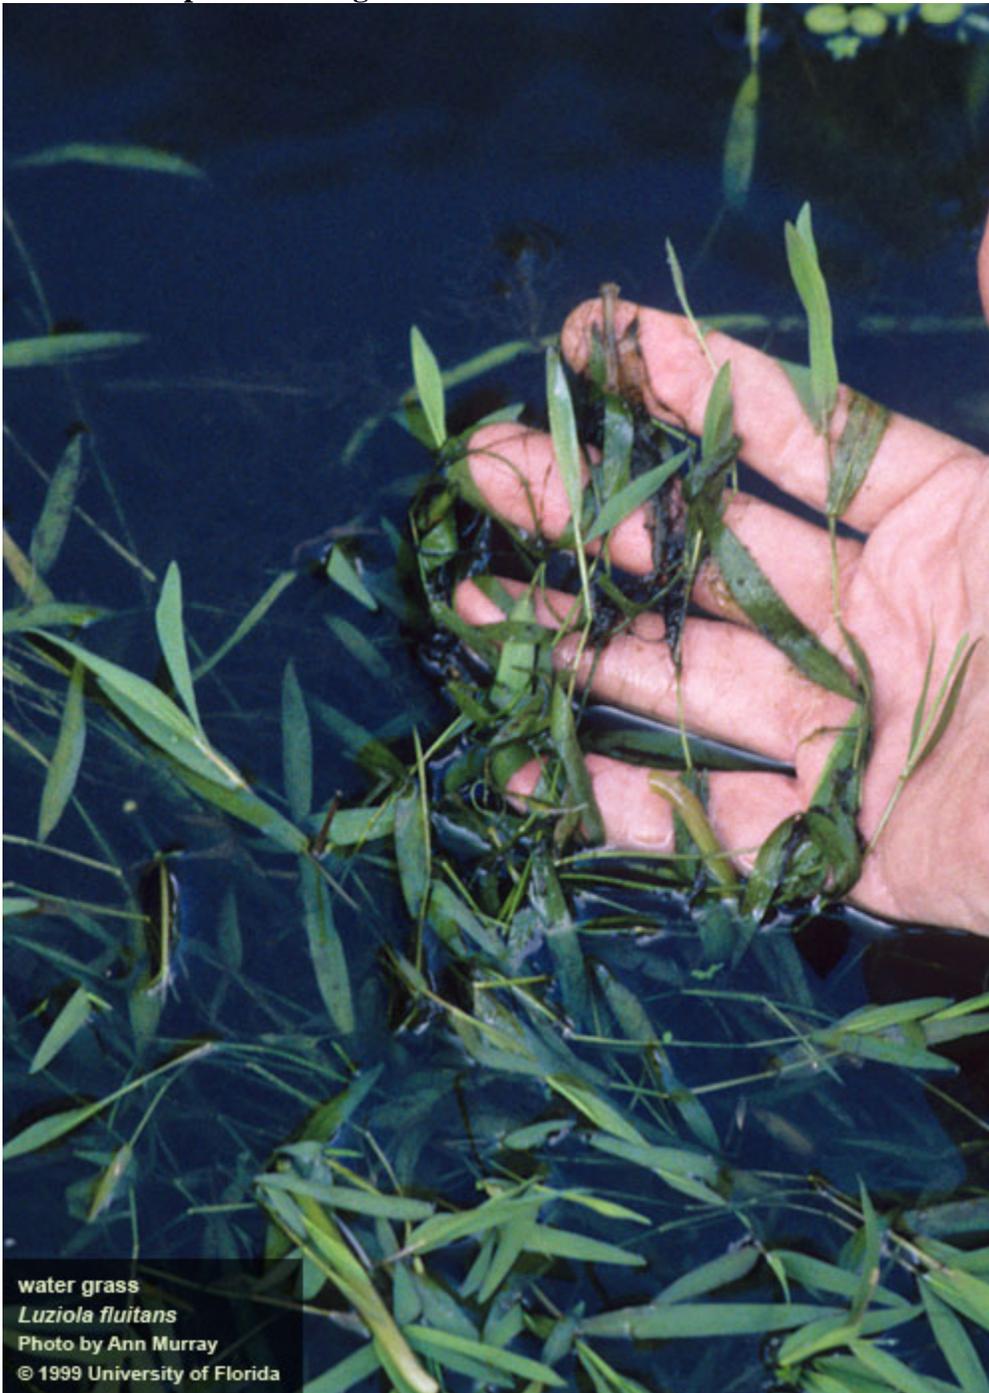
Native emergent vegetation found during the inspection included: canna, sawgrass, pennywort, water grass, yellow cow lily, fragrant water lily, maidencane, pickerelweed, duck potato, arrowhead, lizards tail, bulrush, and fireflag. There was a reduction in planted maidencane, but the maidencane that was present was in good health.

Photo: Example of water grass.

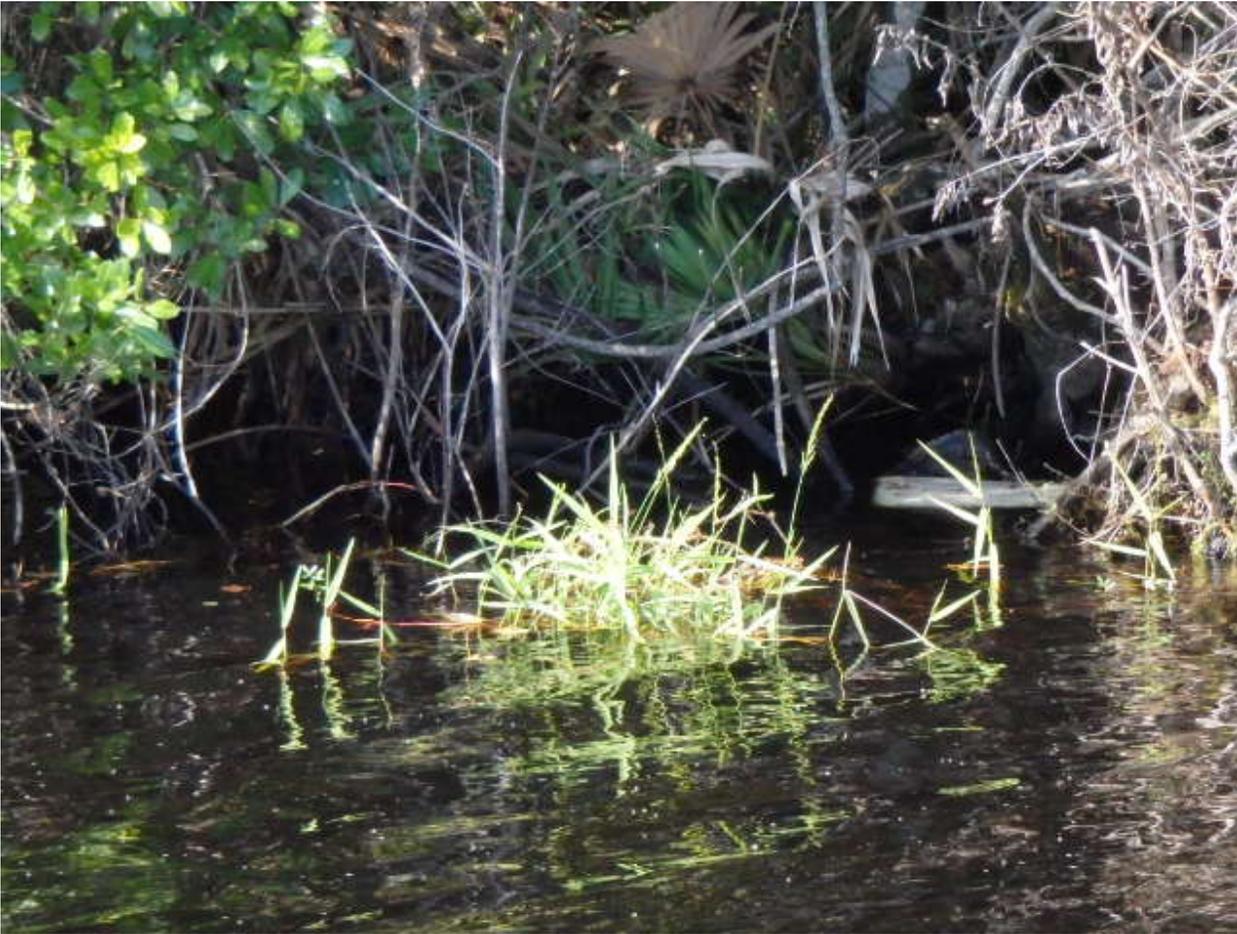
Most of the restoration planting sites are in great condition. The plants that survived are well established. Expansion of these plants should be noticeable by next year. As mentioned, maidencane was found to be reduced along the southeast planting zone likely due to wind/wave action uprooting the plant.

Photos: Planted maidencane.

- 2 Continue to establish a beneficial native shoreline for Horseshoe Lake North, especially in locations that are devoid of emergent aquatic plants. Given that some plants are stressed, or did not survive from the previous planting session, the planting of native species should continue until successful establishment is achieved. SCLMP recommends planting in new locations that are shallower and have more sunlight.

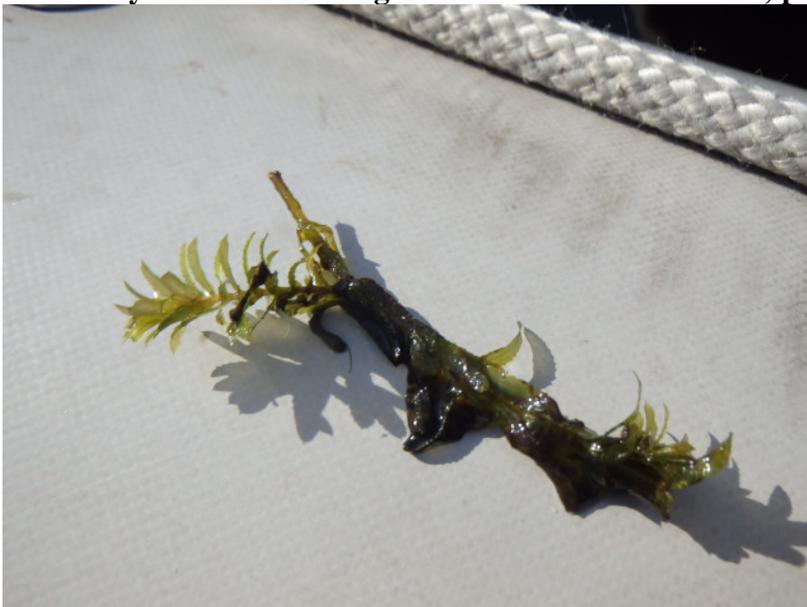
One sprig of the invasive SAV **hydrilla** was found in less than 1 foot of water along the northeast shoreline during this inspection. Hydrilla reproduces from stem fragments, buds, and tubers (potato like seeds). Tubers and turions are deposited by the plant into the sediment and are used to perennialize the plant as a means of propagation (re-growth). Tubers and turions can remain viable for many years; one square meter of hydrilla can produce 5,000 tubers. We will continue to monitor the inshore areas of the lake to enable rapid response to new hydrilla growth.

Photo: Hydrilla found along the north eastern shoreline; plant was hand removed from lake.

There are many ways to manage hydrilla. These include: chemical treatment, grass carp fish, mechanical removal, water draw down, and hand removal. The current amount of hydrilla only warrants hand removal. Hydrilla sprigs, when found, should be pulled out by hand, ensuring you get the root crown and entire stalk without breakage. Currently we have carefully hand removed the sprigs we have personally observed. More information on hydrilla can be found at: <http://plants.ifas.ufl.edu/node/183>.

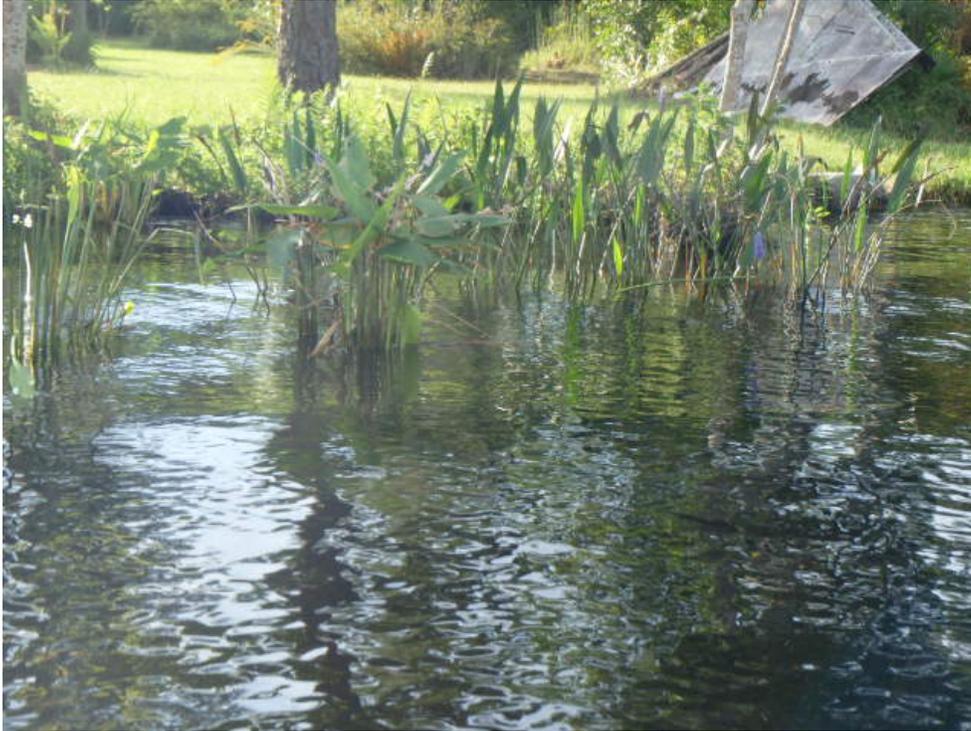
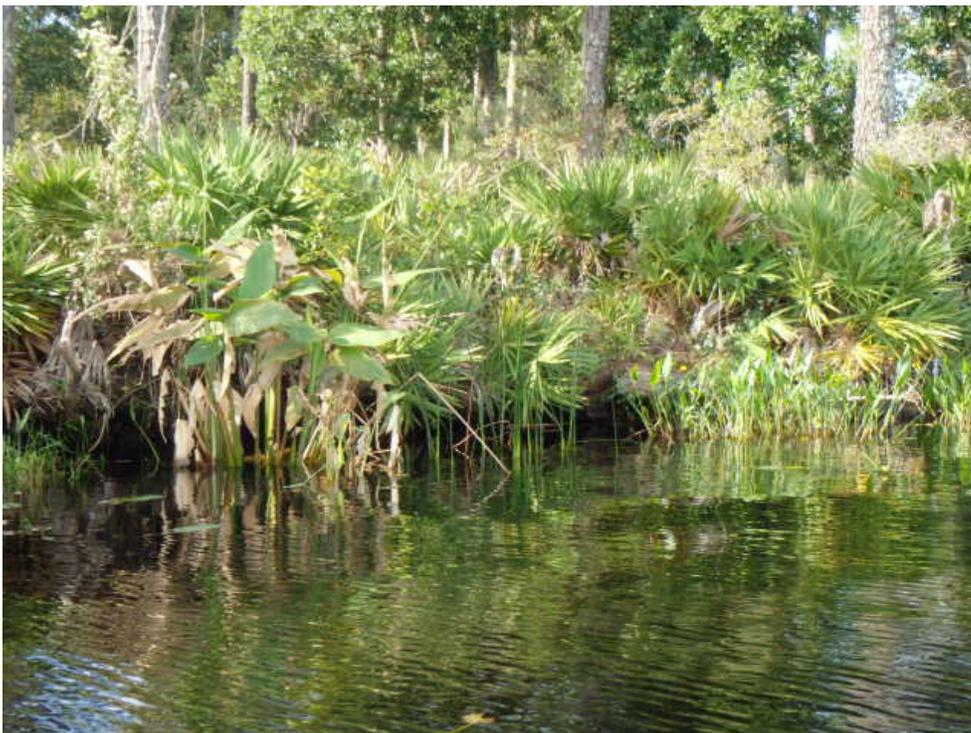
Baby's tears, a beneficial SAV species, was found to a depth of 2 feet. A small patch of eelgrass was observed in 1 foot of water. Native emergent vegetation observed during the inspection included: button bush, sawgrass, flat sedge, pickerelweed, canna, fire flag, duck potato, bulrush, lizard tail, and maidencane. The planted maidencane and pickerelweed from the August 16th restoration event is establishing well around the lake. A complete loss of plants has occurred at one site location, likely due to wind/wave action as these plants were planted in deeper water.

Photos: Planting locations performing well!

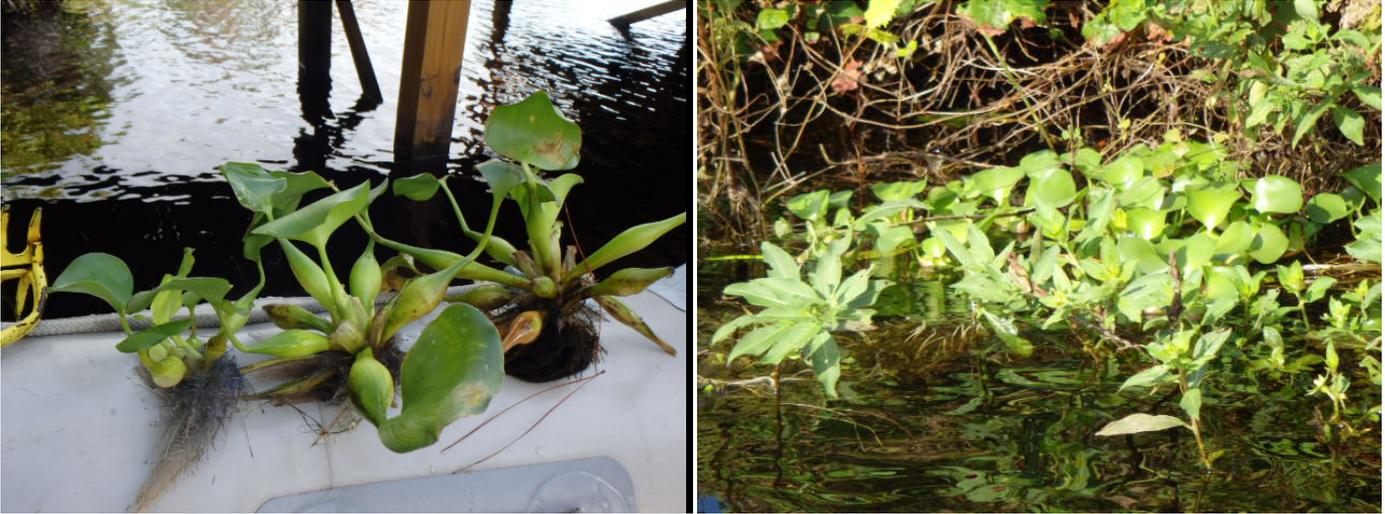
Water hyacinth, now coined one of the worst floating weeds in Florida, was noted mainly along the west shoreline of the lake of which was targeted the October treatment. A new publication on this plant can be found at: <http://edis.ifas.ufl.edu/pdffiles/AG/AG38500.pdf>.

Photo: Water Hyacinth (with daughter plants).

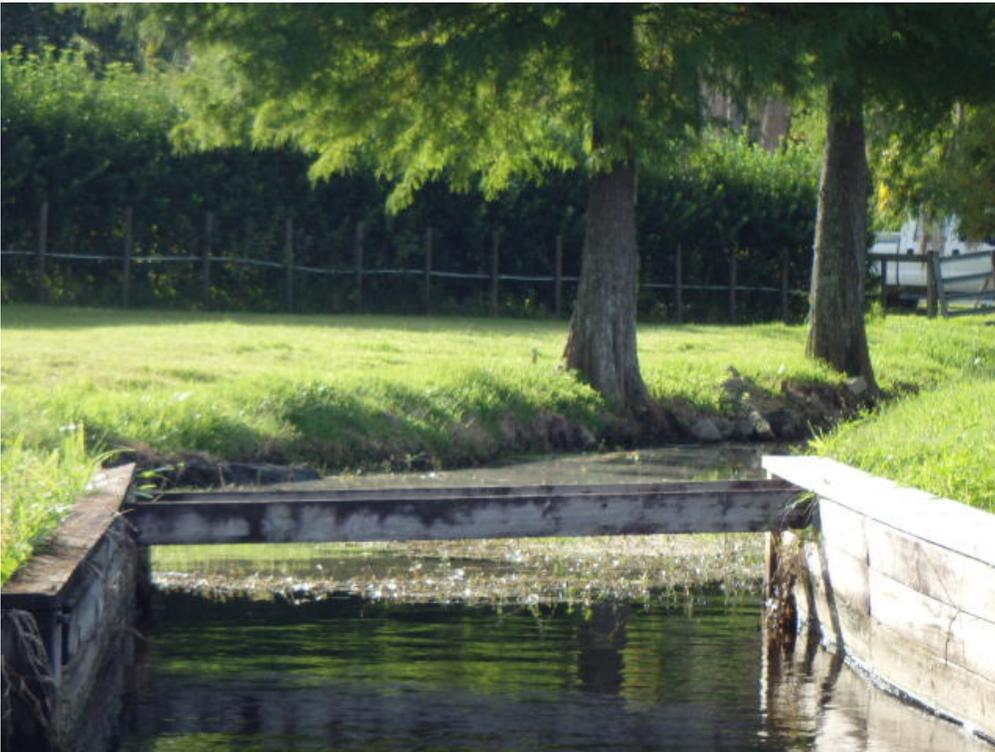
Photo: 8th Street Canal.

The 8th Street Canal continues to be routinely treated for alligatorweed, torpedo grass, and salvinia.
