Please find the latest assessment for the lakes below.

**Harney:**

On **June 8<sup>th</sup>, 2011**, Seminole County Lake Management Program (SCLMP) personnel Gloria Eby, Marianne Pluchino, Dean G Barber, Kelli Gladding (FWC), David Scharr and Kalina Warren (DEP) surveyed the aquatic plants of **Lake Harney** and conducted an LVI. The LVI was created by the Florida Department of Environmental Protection as a rapid screening tool (bioassessment) for ecological condition; it determines how closely a lake's flora (aquatic plants) resembles that of an undisturbed lake. Lake Harney is 7,935 surface acres in size with a mean depth of 7.3 feet and is located in the St. Johns River watershed. Historical LVI scores for Lake Harney range from 37 to 77 with 77 being the most recent score that is within in the healthy category range.

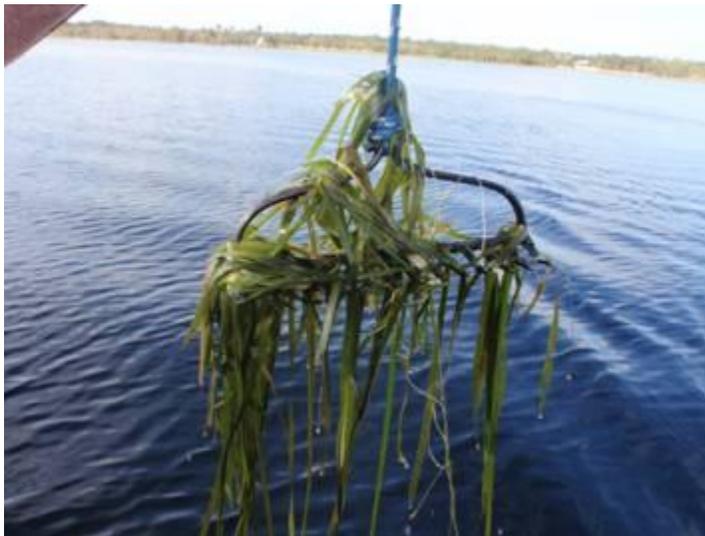
SAV included: eelgrass to 10 feet, coontail to 7 feet, southern naiad to 8 feet, eleocharis to 4 feet, bladderwort to 6 feet, and hydrilla to 6 feet. Eelgrass was the dominant SAV and was observed around the entire perimeter of the lake. Along the south side of the lake eelgrass blades were found in excess amounts washed up along the shoreline. Hydrilla was found sparse and intermixed within the eelgrass.

Photo: SAV collected inshore.

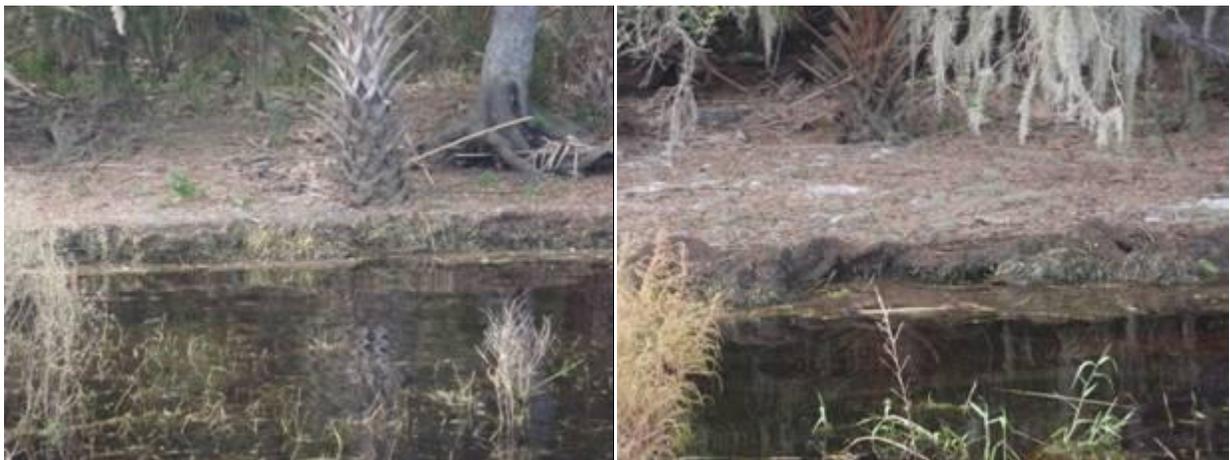
Photo: Eelgrass and leaf blades washed ashore observed during inspection.

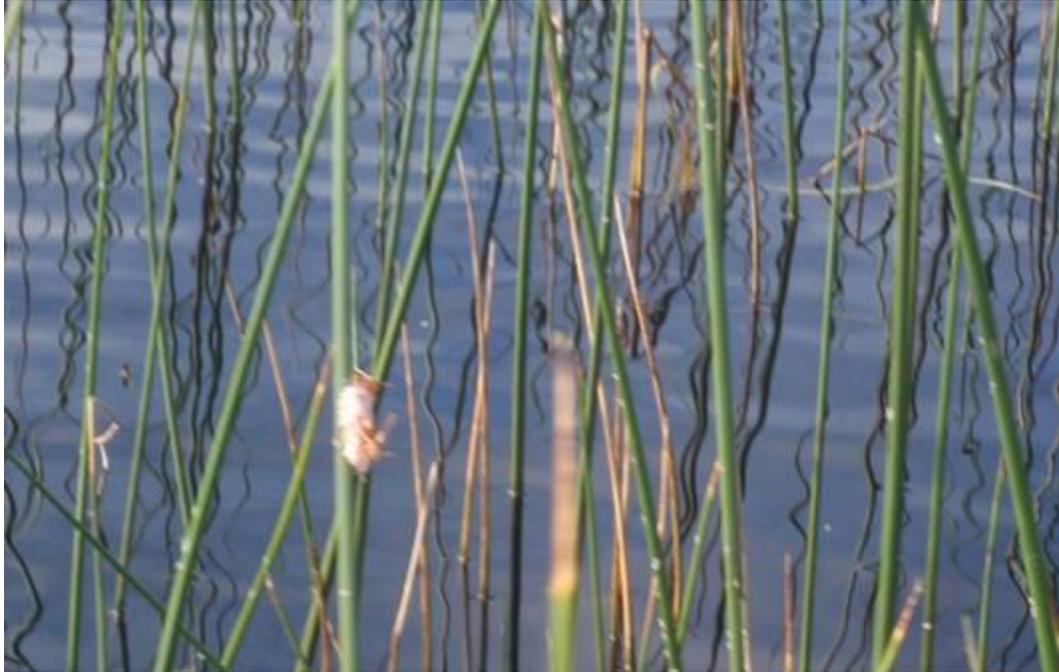
Several clusters of exotic island apple snails were observed on aquatic vegetation in the NW side of the lake and had wasps predating on the eggs. This occurrence was reported to Jennifer Bernatis with FWC, biologist coordinating island apple snail research projects.

Photo: Invasive island apple snail eggs with wasps predating on eggs.

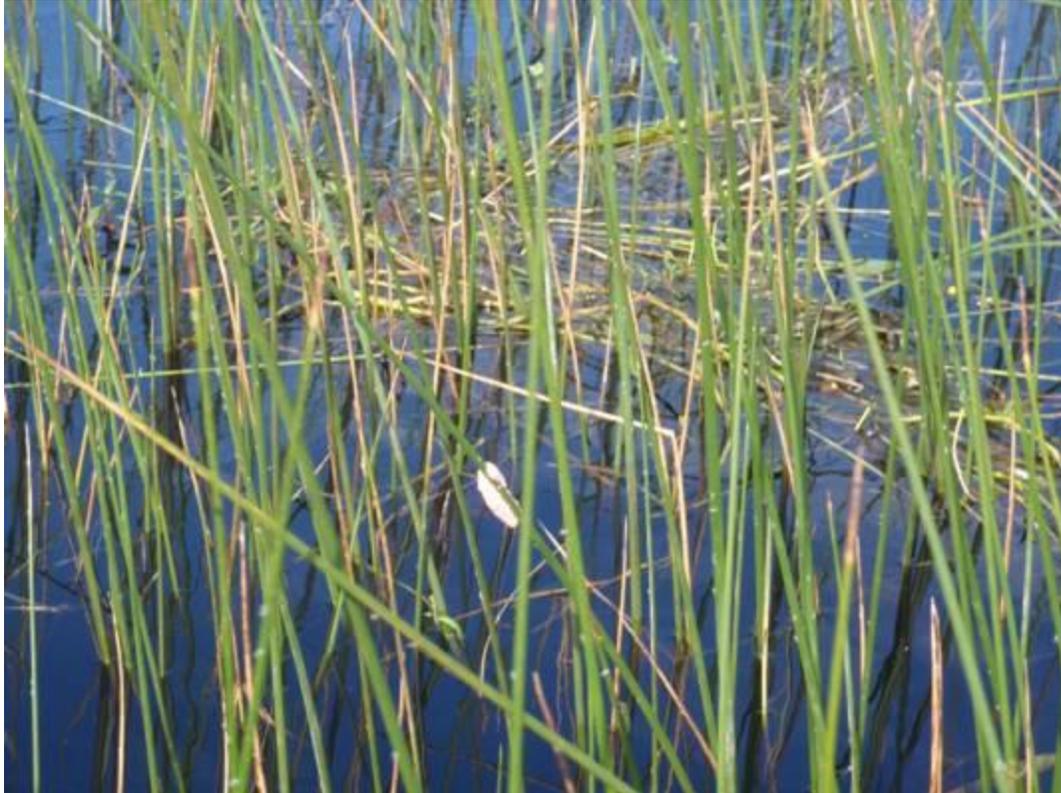
Photo: Soft stem bulrush with invasive island apple snail eggs attached.

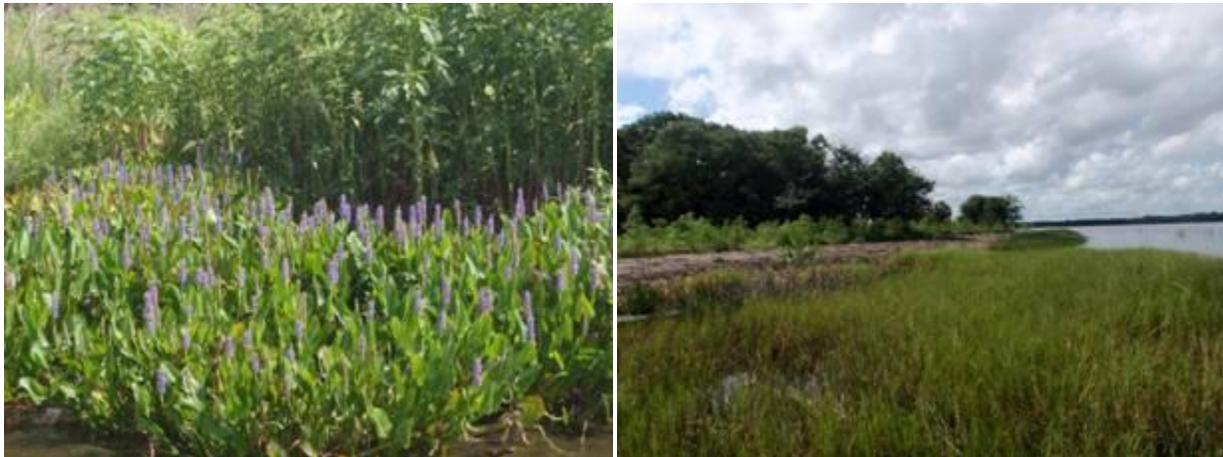
Only 0.1 acres of water hyacinth were observed. However, there was over 20 acres of water lettuce which was present in small populations (less than 0.1 acres) throughout the lake and within the area adjacent to Soldiers Creek. Re-vegetated aquatic plants within Site 1, both in the water and adjacent to the bank, are doing extremely well. Throughout the site, the bulrush has done remarkably well expanding in all directions such that the population looks natural. Most species that are in the water, mainly pickerelweed and bulrush, are 3 to 4 times their planted size. The trees, rush, and cord grass are healthy and still not impacted by invasive species, like phragmites and paragrass. Thalia has continued to expand, especially in Site 1 west of the 417 Bridge. This area was previously under herbicide management by SCLMP however funds are no longer available for continued treatments within the area. SCLMP is actively seeking grants that can be applicable to Lake Jesup.

Photos: Site 1 plantings expanding and doing well.

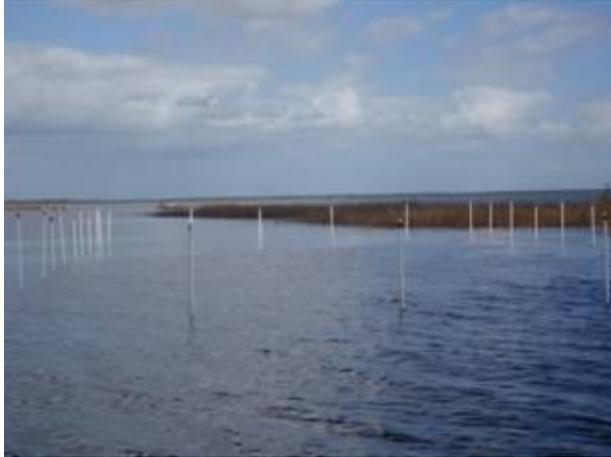
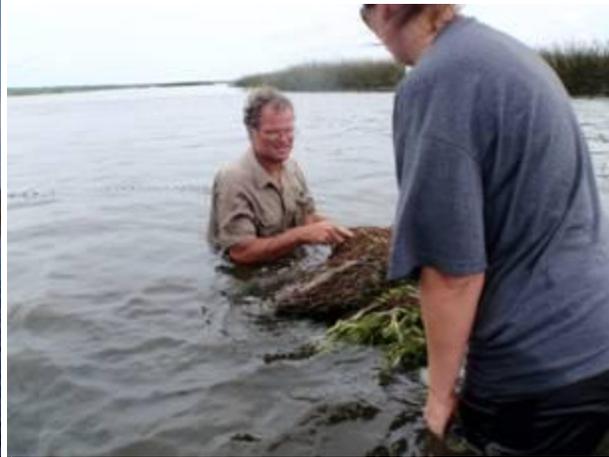
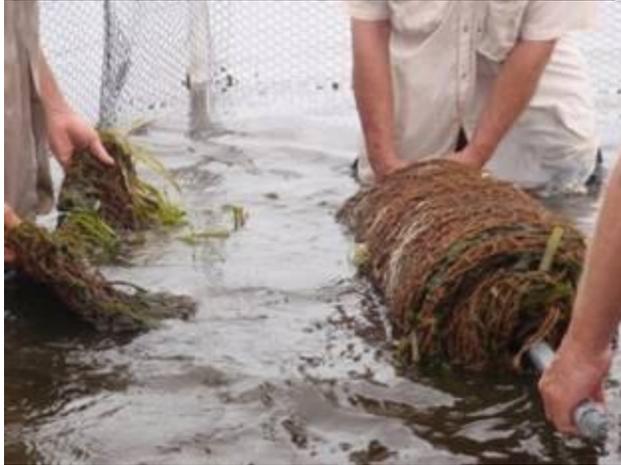
The August 30<sup>th</sup>, 2011 planted eelgrass by FWC and assisted by Seminole County was not visually observed within the FWC enclosures due to high water. Since the eelgrass installed was rooted to coco-matting, the frotus was not used to rake and evaluate presence.

Photo: FWC eelgrass enclosures and planting of rooted eelgrass in coconut fiber mats.

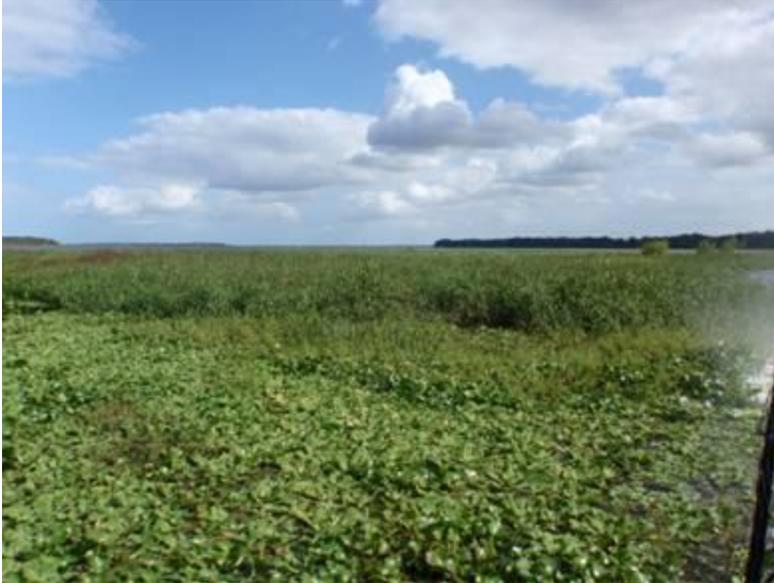
Along the western shoreline, approximately 10 acres, dominantly water lettuce with some water hyacinth, were present in and around the Soldiers Creek entrance reducing access into Soldiers Creek. Once fragmented vegetation, this area has shifted to exist as one large mass of vegetation.

Photo: Water lettuce and hyacinth around Soldiers Creek.

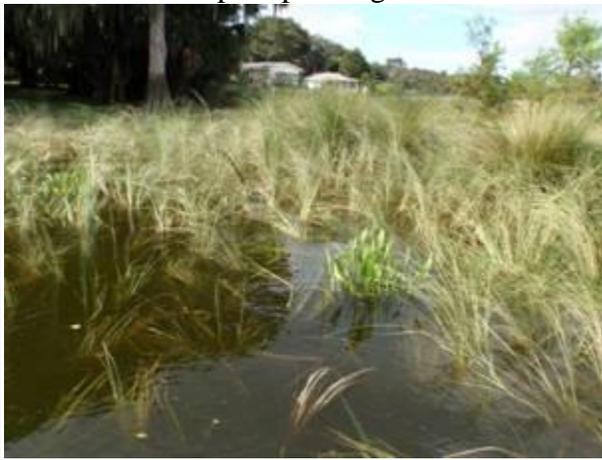
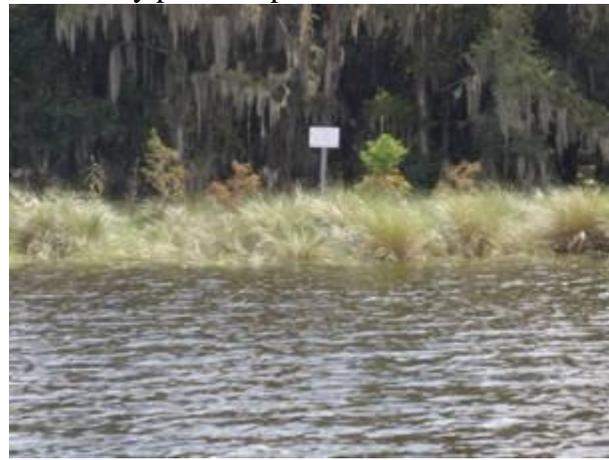
FWC-AHRES and Seminole County Cooperative Restoration Project continues to thrive with natives planted at Overlook Park and is doing well with the spartina planted with some loss to the pickerelweed and duck potato. Additional spartina was planted with in the restoration site by SCLMP.

Photo: Overlook park plantings. Photo on left shows newly planted spartina.

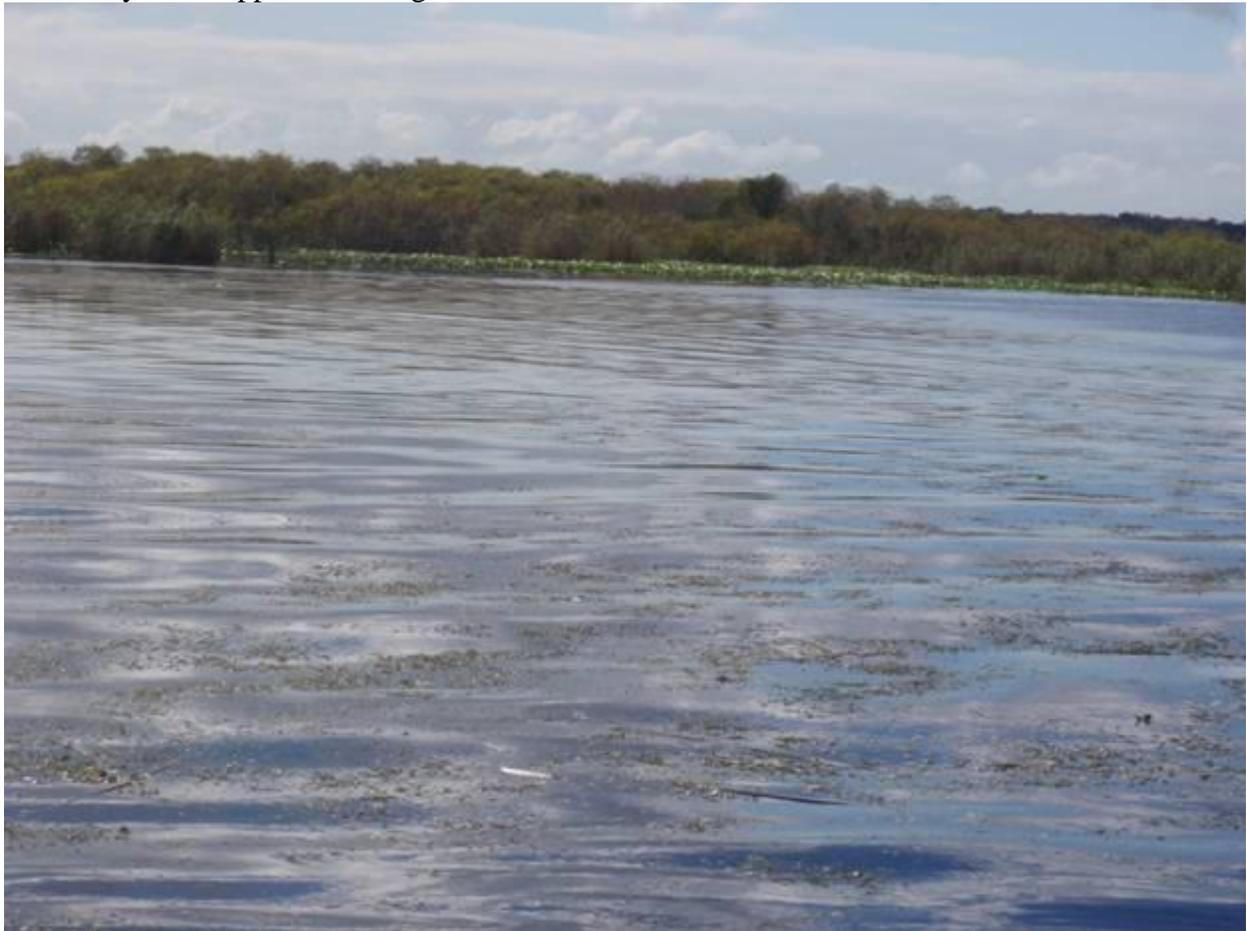
Native submerged aquatic vegetation (SAV) observed included: coontail (*Ceratophyllum demersum*), southern naiad (*Najas guadalupensis*), road grass (*Eleocharis spp*), eelgrass (*Valisneria americana*) to a depth of 6 feet, and bladderwort (*Utricularia foliosa*). One exotic SAV, hydrilla (*Hydrilla verticillata*) was found to a depth of 8 feet. Hydrilla was found in at deeper depths than the previous inspection due to higher water conditions. Eelgrass is the dominant SAV throughout the lake but hydrilla has expanded to almost the same abundance. Both plants are topping out in depths less than 5 feet around the perimeter of most of the lake.

Photo: Hydrilla topped out along eastern shore.

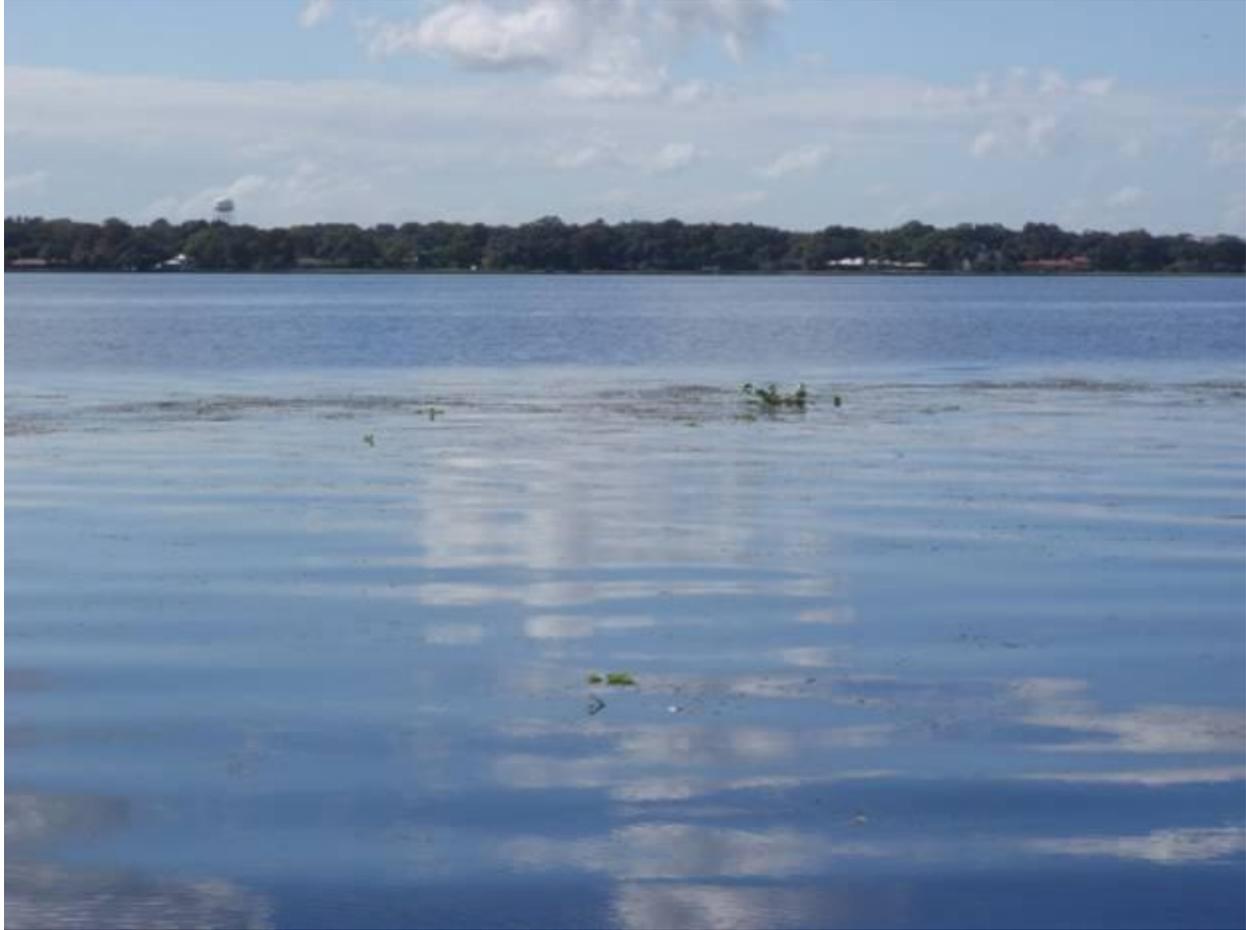
Water hyacinth and water lettuce were found around in small populations around the lake with majority existing on the east side of the lake near the river.

Photo: Topped out hydrilla and water hyacinth.
