LAKE ECOSUMMARY

Lake Florida, WBID 2998A

Seminole County

Sampled July 23, 2018 and May 22, 2019

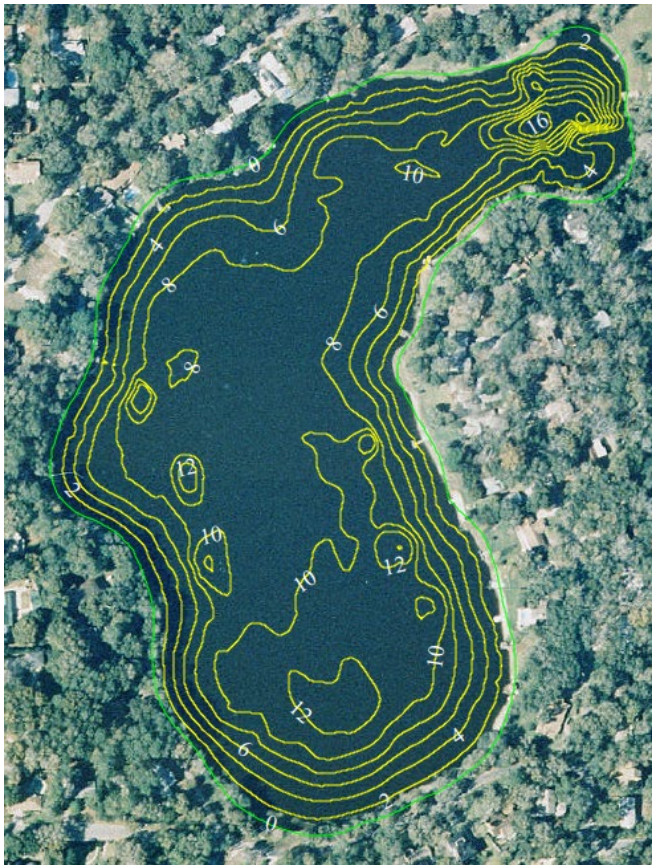
Figure 2-1. Depth Contour Map for Lake Florida
(Source: Seminole County Water Resource Atlas)

The lake is approximately 25 acres in size. It is part of the Middle St. Johns River drainage basin and is located in Seminole County, near the border of Orange County (Figure 2). The bathymetric depth contours shown in Figure 2-1, are using a surface water elevation of 54.36 ft (NAVD 88). Depths measured on 07/23/2018 and 05/22/2019 were 3.9 meters and 2.9 meters, respectively. The predominant land uses surrounding Lake Florida are medium density residential and forested wetland. This lake is not currently listed on the Impaired Waters Verified List (11/15/2019). Per an assessment of watershed data, WBID Run 58 dated 09/17/2019, the lake is on the Study List for biological parameters. Additional information about this WBID is available in the TMDL Tracker application (<https://fdep.maps.arcgis.com/home/webmap/viewer.html?webmap=1b4f1bf4c9c3481fb2864a415fbeca77>).
