LAKE ASSESSMENT REPORT

ROCK LAKE

8 /29/2002

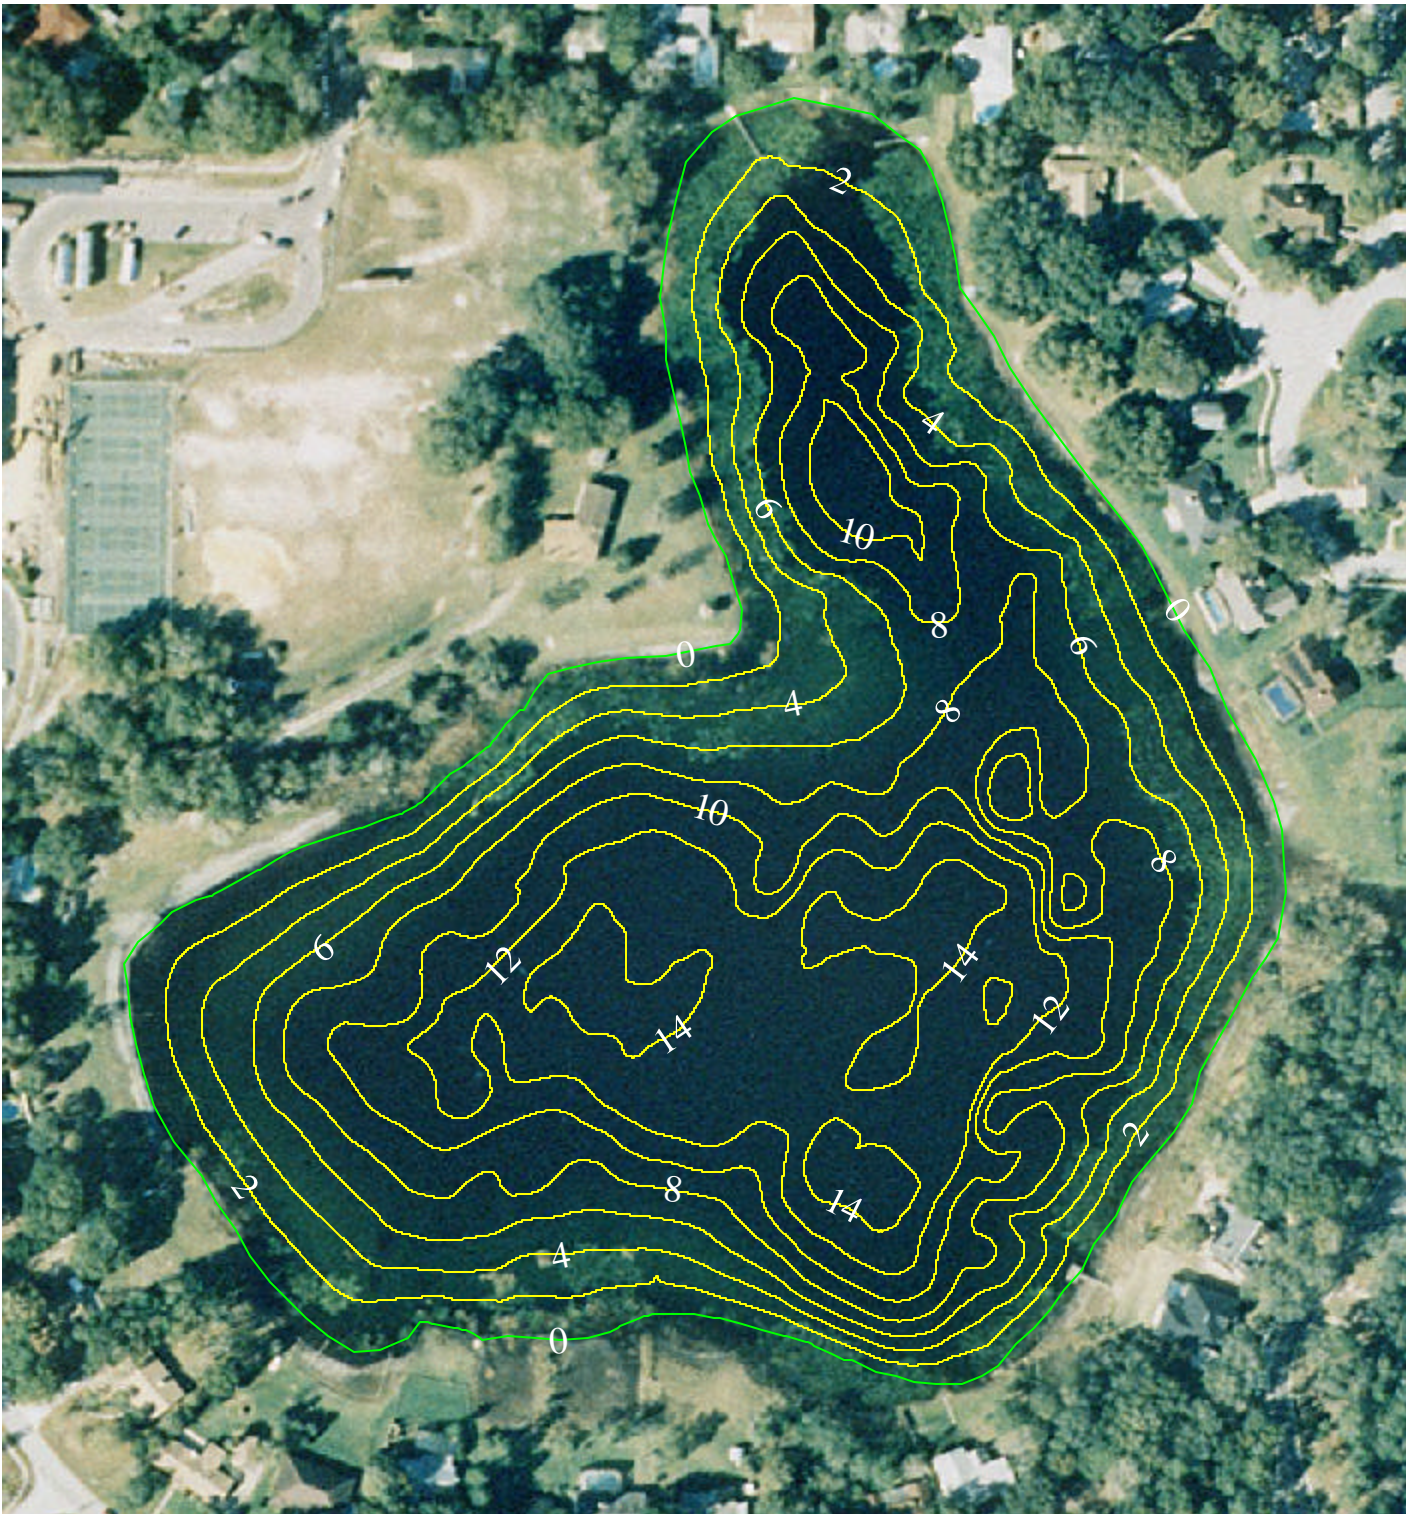
Rock Lake

Contour Lines
Expressed in
2-Foot Intervals

Lake water level was 79 feet above sea level when the lake was assessed. Contours are expressed in absolute depth below this level and may not exclude the presence of submersed aquatic vegetation.

Seminole County 1999 color aerials provided by Seminole County Public Works. All contours generated by Florida Center for Community Design and Research based on GPS/Sonar data provided by the Seminole County Stormwater Division.

The bottom of the lake was mapped using a Global Positioning System (GPS) to determine the boat's position, and a depth-finder to provide depth associated with that measured position. The result is an estimate of the lake's area, mean and maximum depths, and volume (Table 1) and the creation of a bottom contour map. *NOTE: This map is for recreational purposes only.*
