## Lake Assessment Report DAWSON LAKE 8/27/2004

# Dawson Lake

Section Township Range 5-20-30

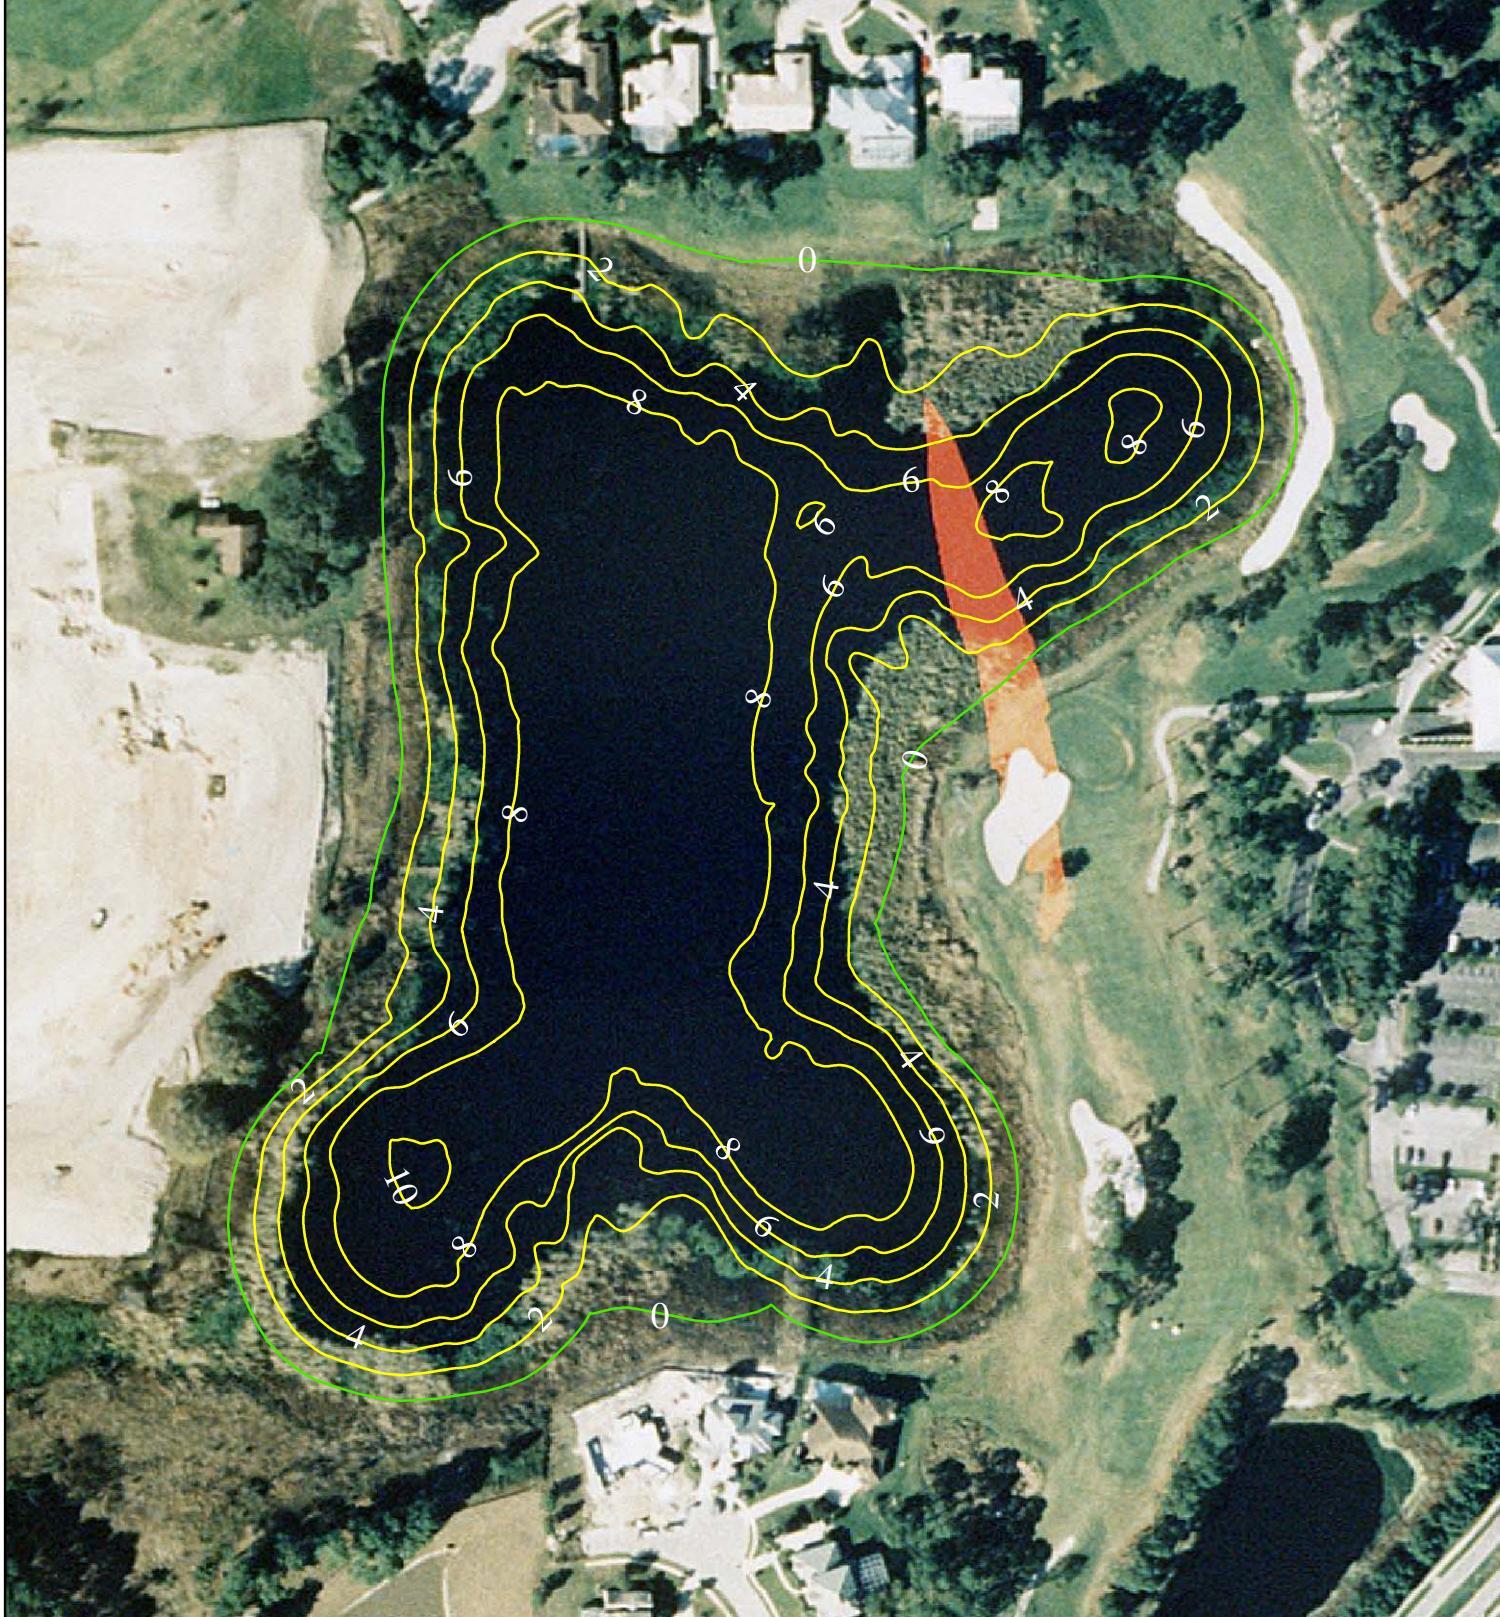
Contour Lines Expressed in 2 Foot Intervals

EXPLANATION: Assessment Date: August 02, 2004 Lake water level was 40.7 ft above sea level when the lake was assessed. Contours are expressed in absolute depth below this level and may not exclude the presence of submerged aquatic vegetation.
