Greetings Lake Amory!

On **28 June 2011** Seminole County Lake Management Program, Thomas Calhoun (Assistant Scientist) and Dean Barber (SC Contractor), surveyed the aquatic plants of Lake Amory.

On **27 July 2011**, Seminole County Lake Management Program, Gloria Eby (Senior Scientist) and Thomas Calhoun (Assistant Scientist) surveyed the aquatic plants and conducted a Lake Vegetation Index (LVI) of Lake Amory.

On **September 28, 2011** Seminole County Lake Management Program, Gloria Eby (Sr. Environmental Scientist), Thomas Calhoun (Contracted Scientist) and Kathy Moore (MSBU Program), surveyed the aquatic plants of Lake Amory.

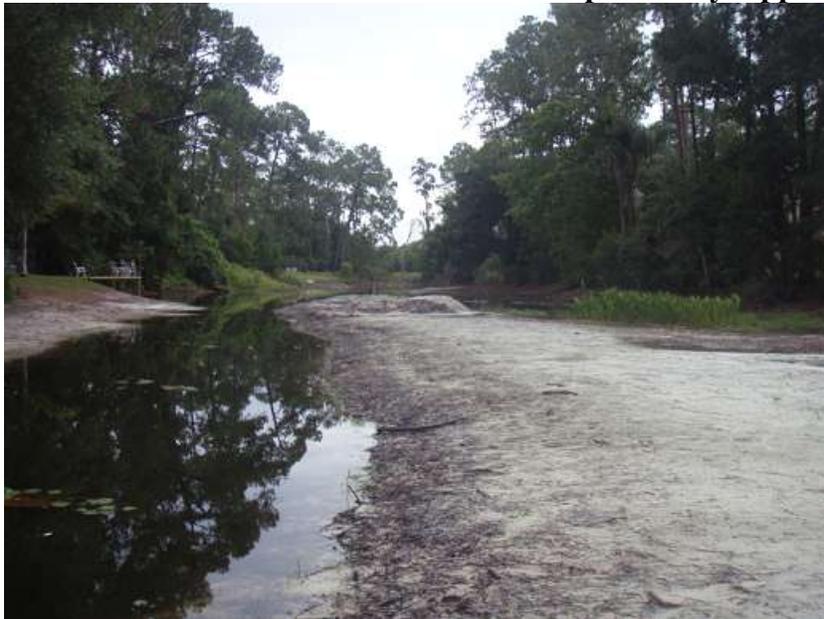
**Cactus Canal, Outfall Canal and Bird Island** was inspected on foot due to low water. Only a few sprigs of coontail were seen during the inspection and no hydrilla was found in any of these areas. Even with the low water, most of the native shoreline vegetation planted during the restoration events is still healthy and expanding. Areas within this portion of the lake are encouraged to plant shoreline natives, especially duck potato, as it has demonstrated lake wide that it can tolerate large lake level fluctuations. Cord grass is another plant that will greatly assist in reducing sediments from eroding into the lake in this area.

**Photo: Area within Outfall Canal that was previously topped out with hydrilla.**

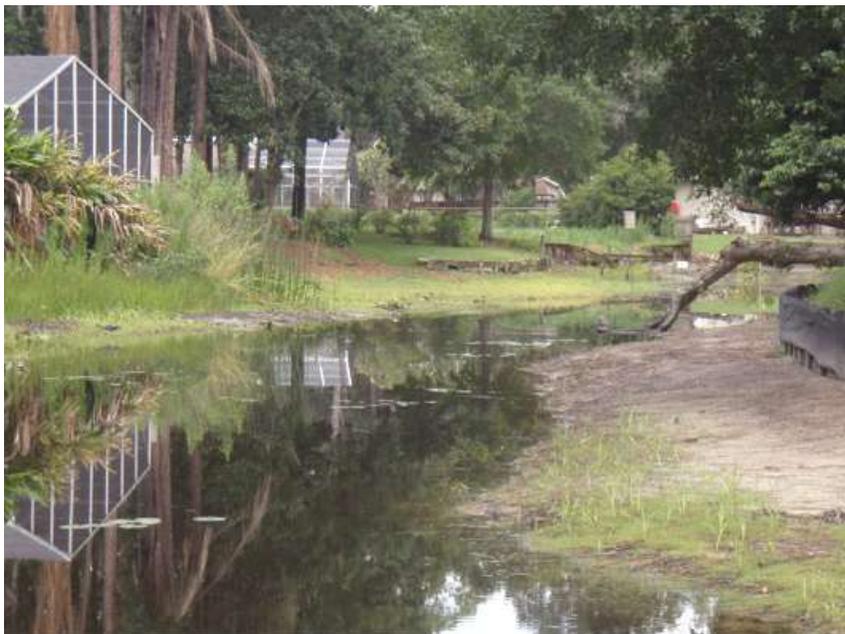
In **The Cove**, no submersed aquatic vegetation was found. Native sedge and spike rush have established during low water levels. It is expected that the sedge will naturally be controlled as the lake level rises. Native shoreline vegetation that was planted last year (bulrush, spike rush) is expanding and doing well. In addition, duck potato and native canna along the planted parcel are expanding and doing well. Other areas are encouraged to plant shoreline natives, especially duck potato, as it has demonstrated lake wide that it can tolerate large lake level fluctuations.

**Photo: Entry to the Cove; emergent natives establishing on dry banks during low water elevation.**

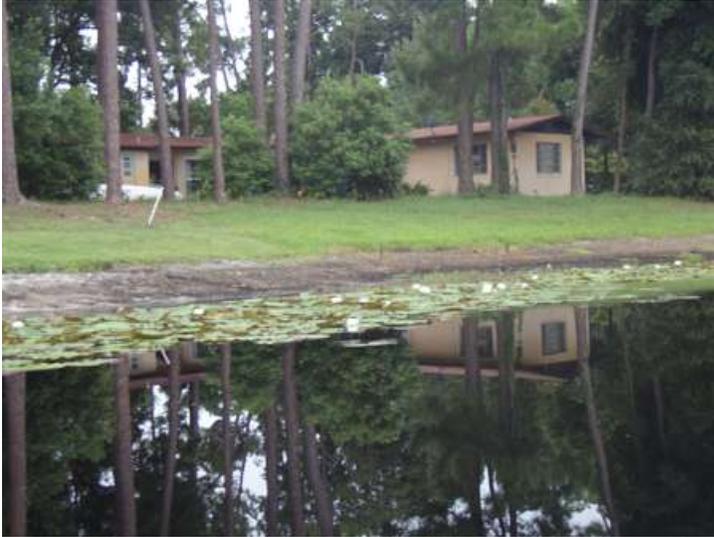
The **Lake Proper** has been the least affected by the low water level with depths still reaching 15 ft. SAV found in the lake include coontail to a depth of 3 ft. and road grass found to a depth of 1 ft. No hydrilla was found in this area. The access corridors at time of inspection were too shallow to treat and will not be treated until the water level rises. There is a terrestrial grass that has started to grow on the exposed areas due to low water. Residents along the shoreline are encouraged to plant shoreline natives. Pickerel weed, canna, and duck potato are more suitable for this area due to the gradual sloping of the shoreline.

**Photo: Lake Proper in need of shoreline native plants.**

As prior, the residential shoreline is encouraged to be planted with natives; pickerelweed, canna, and duck potato are more suitable for this area due to the gradual sloping of the shoreline.

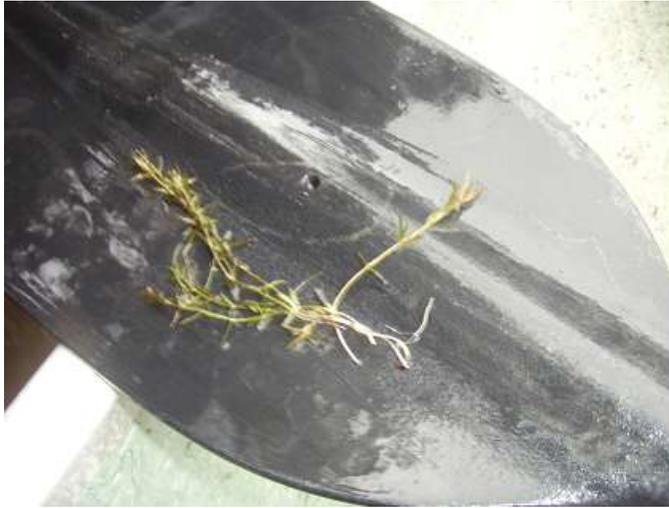
**Cactus Canal, Outfall Canal and Bird Island** where inspected via canoe with the recent rise in water elevation. Lake elevation at time of this survey was 39.1 ft as compared to 38.64 ft in prior assessment. A few sprigs of coontail were seen during the inspection and hydrilla was found in inches of water where grass carp are unable to access to feed upon. Most of the native emergent vegetation planted during the restoration events is still healthy and expanding. Other

**Photo: Hydrilla sprig found along shallows near Bird Island.**

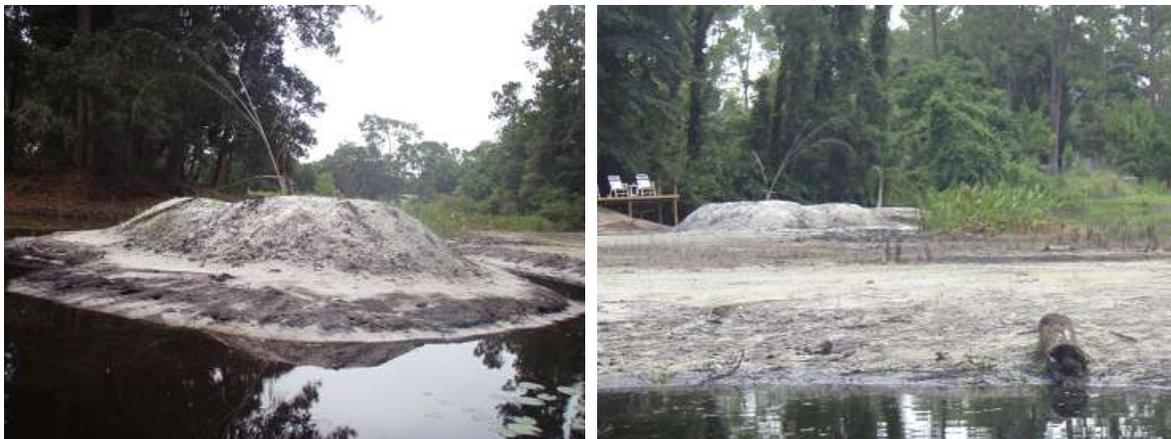
bare shoreline areas are encouraged to plant shoreline natives as recommended prior. Upon inspection, Bird Island was altered in that the lake bed was mounded and palms were planted on top of the mounds.

**Photo: Unnatural alteration of lake bed.**

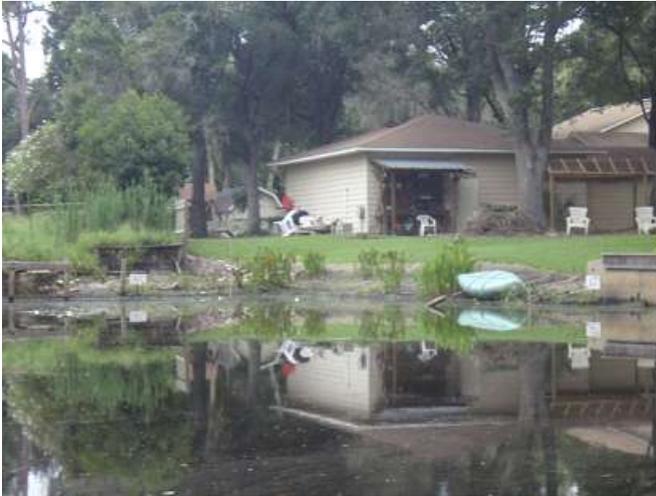
In **The Cove**, sparse submersed aquatic vegetation was found which includes hydrilla and filamentous algae. The native sedge and spike rush that established during low water have been naturally controlled by the rise in lake level. Native shoreline vegetation that was planted last year (bulrush, spike rush) is expanding and doing well. In addition, duck potato and native canna plantings along the planted parcel are expanding and doing well. Other areas are encouraged to plant, especially duck potato, as it has demonstrated lake wide it can tolerate the large lake level fluctuations. Sheen was noticed on the water's surface, characteristic of plant breakdown where the stored oils of the plant (hydrocarbons) are released. In addition, floating

**Photo: Duck potato and canna plantings expanding and doing well.**

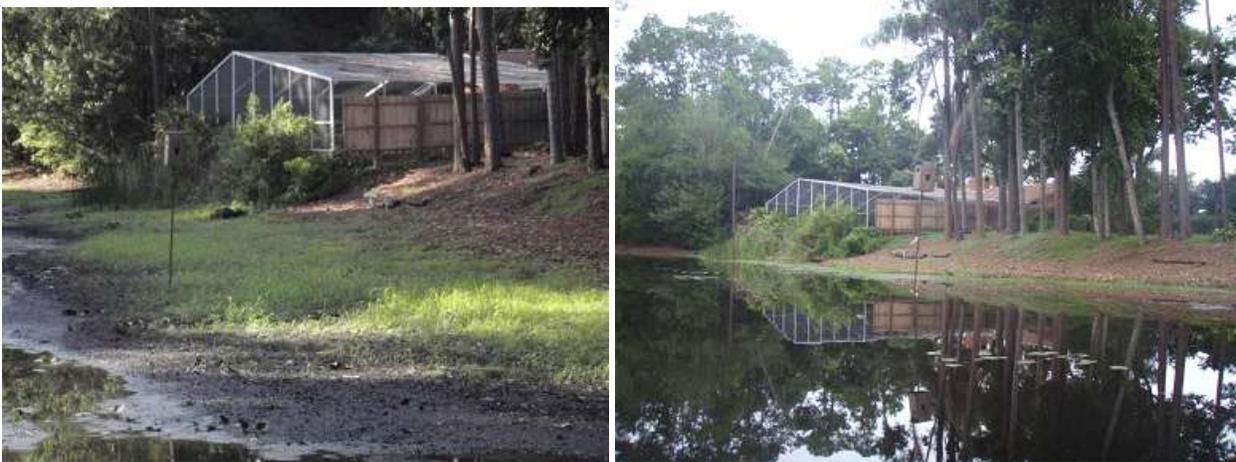
**Photo: Water fluctuation and natural plant community control. Photos taken June 23<sup>th</sup> (left) then again on July 27<sup>th</sup> (right).**

Water fluctuations play an important role in the ecosystem. The rise and fall of the water can change the plant communities from non-native to native and vice versa. Exposing the lake bed to sunlight allows for the buildup of sediment/organics to bake, consolidate and thus improve the water quality of the lake. Often during drawdown, seeds from plants grow (germinate) mainly wetland type plants. This is a natural defense to impede non-natives from establishing; then becoming the dominant emergent plant.

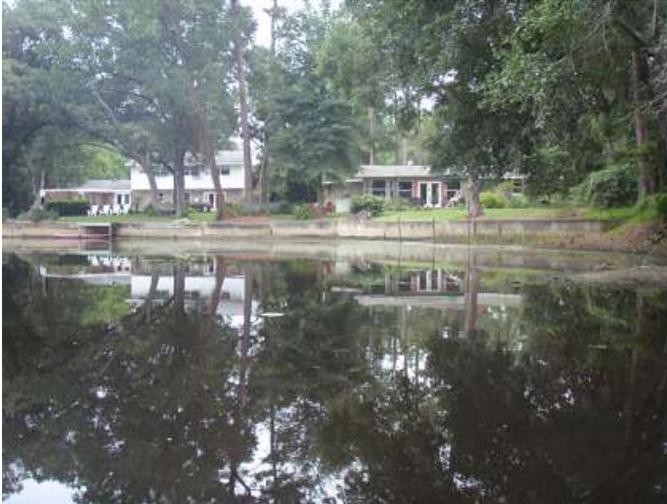
**Photo: Cove area in need of shoreline native plants.**

2 Increase native aquatic plantings along shoreline (such as pickerelweed, duck potato, and canna). Native shoreline plants help absorb nutrients from rain-fall/run-off improving habitat and water quality and reduce shoreline erosion which imports sediments/organics into the lake. Over time, this process will fill the lake creating a wetland type of environment. Planting natives now can assist in slowing this process down (which is formally known as eutrophication). In addition, native plantings can reduce your herbicide costs/needs providing a savings to you!

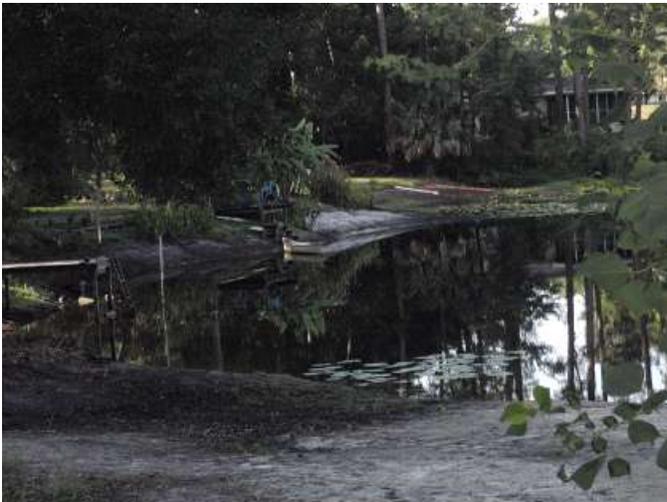
The **Lake Proper** SAV found in the lake includes road grass, red ludwigia, and bladderwort. No hydrilla was found in this area. The access corridors at time of inspection were recently treated and appeared open. The terrestrial grass that has started to grow on the exposed areas due to low water was treated. Closest to the golf course within the wetland, barnyard grass and dog fennel were observed. Of which upon adequate water elevation, given boating access, contractor will treat these species.

**Photo: Low water elevation found in lake.**

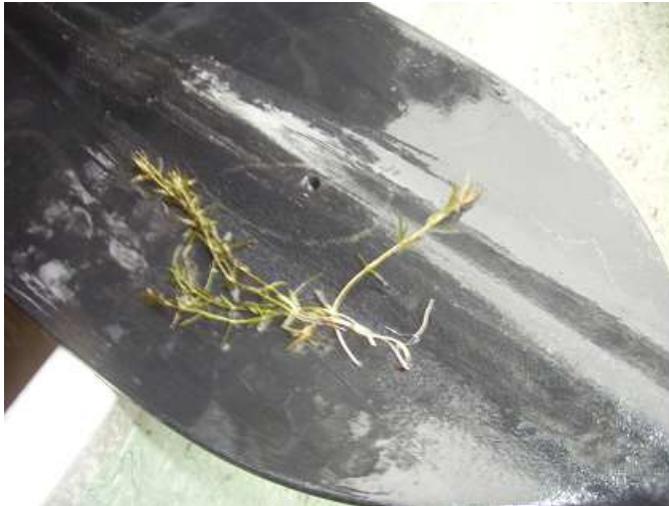
**Photo: Hydrilla sprig found along shallows near Bird Island.**

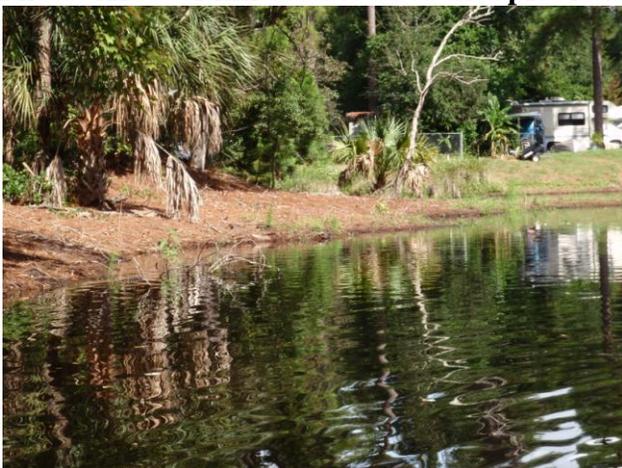
In **Cactus Canal, Outfall Canal, and Bird Island**, coontail and hydrilla were not found during this inspection as previously observed. Greater water elevation likely allowed the existing grass carp fish population to forage upon the hydrilla. In depths of 13 feet or less, no submersed aquatic vegetation (SAV) was found. Bird Island area continues to establish natives however torpedo grass is trying to establish amongst the natives making herbicide treatments selective. Water sprite previously establishing on the western bank has survived treatment and will continue to be treated once services resume in November. It is anticipated that with greater leaf foliage available, the herbicides will effectively be absorbed into the plant for a better kill. Areas within this portion of the lake are encouraged to plant shoreline natives, especially duck potato, as it has demonstrated lake wide that it can tolerate large lake level fluctuations. Cord grass is another plant that will greatly assist in reducing sediments from eroding into the lake in this area. The grass carp barrier was inspected and found to be in good condition.

**Photo: Area within Cactus Cove that previously had hydrilla topped out.**

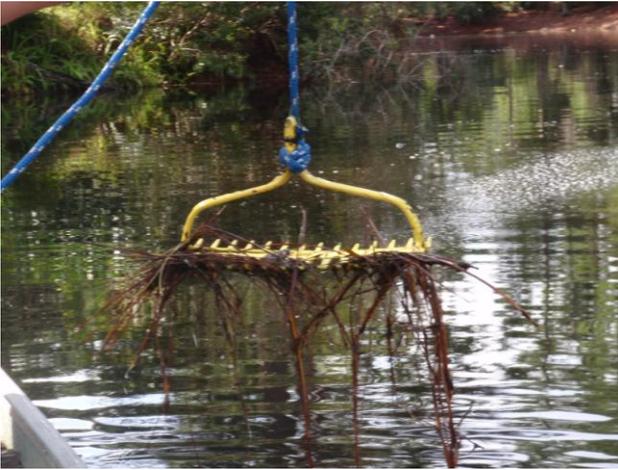
**Photo: No SAV at 13 feet or less in Outfall Canal.**

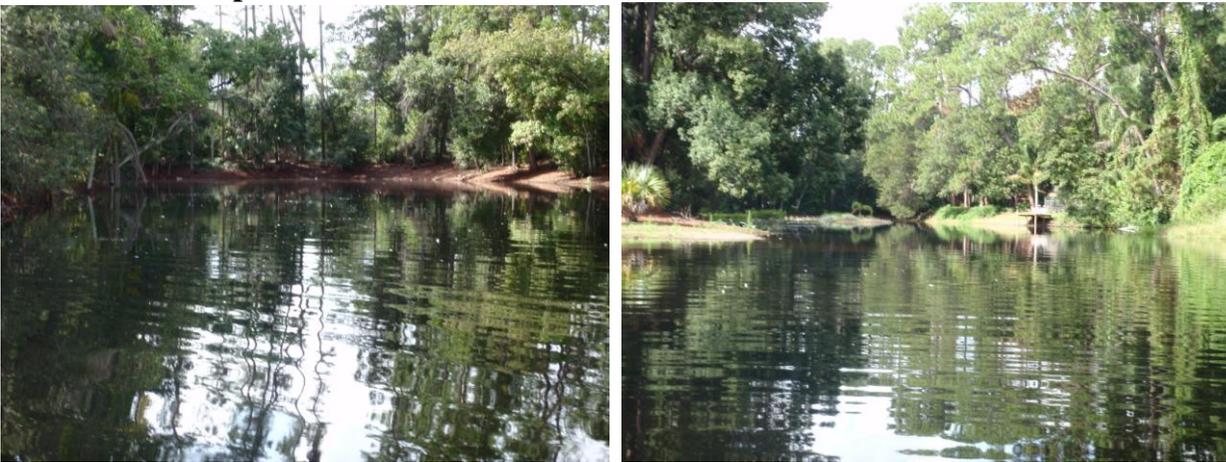
**Photo: Overview photos of Outfall and Cactus Canals.**

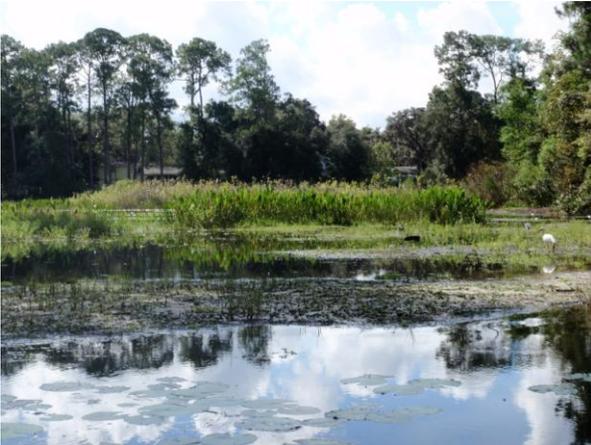
**Photo: Overview of Bird Island and waterfowl highly utilizing the area.**

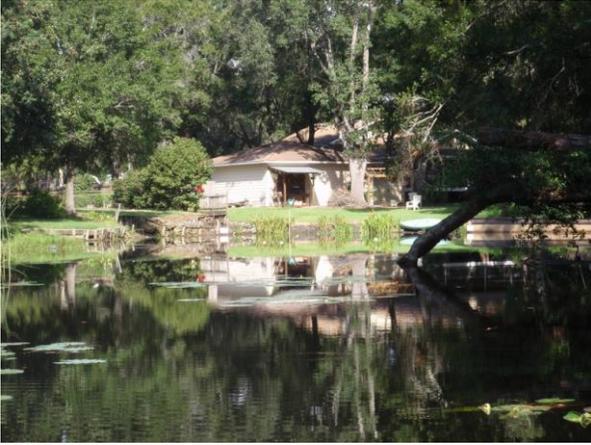
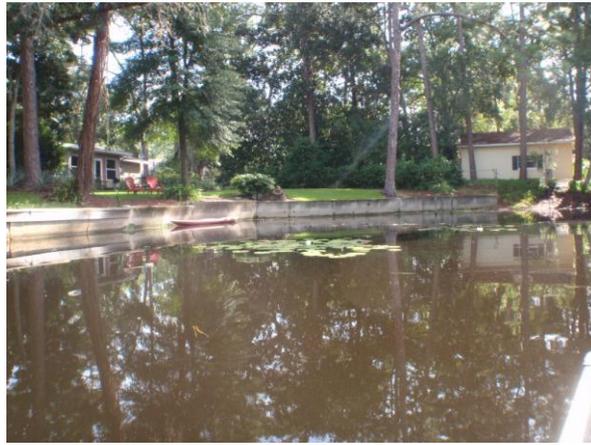
In **The Cove**, no SAV was found. Duck potato and native canna along the planted parcel are expanding and doing well. Water sprite previously establishing on the western bank was effectively reduced and will continue to be treated once services resume in November. Residents may hand pull these young plants with ease if so desired prior to next scheduled treatment. Other areas are encouraged to plant shoreline natives, especially duck potato, as it has demonstrated lake wide that it can tolerate large lake level fluctuations.

**Photo: Photos of the Cove. 70% of the water sprite within cove was effectively treated.**

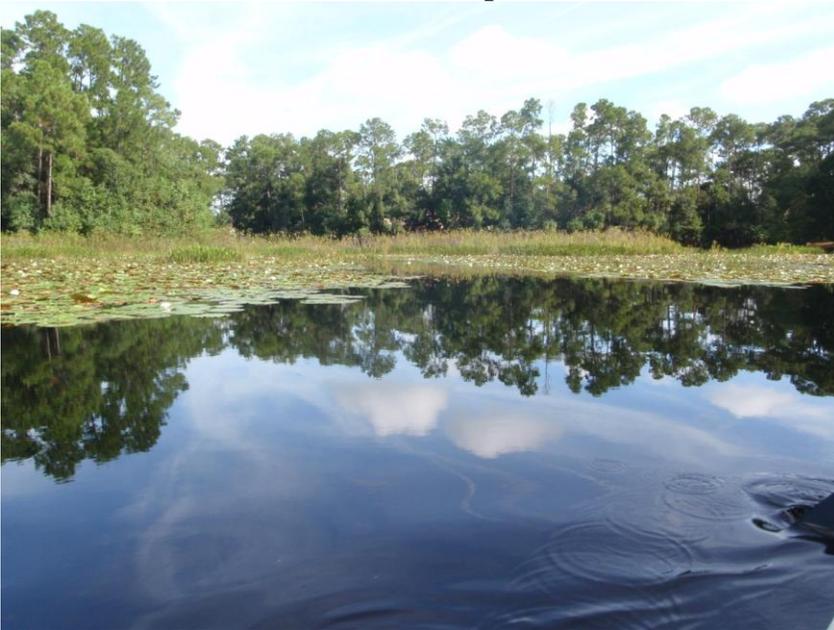
**Lake Proper** SAV found includes bacopa to a depth of 3 feet and road grass found to a depth of 1 foot. No hydrilla was found in this area. The access corridors at time of inspection were open with assistance from the herbicide treatments. Residents along the shoreline are encouraged to plant shoreline natives. Pickerelweed, canna, and duck potato are more suitable for this area due to the gradual sloping of the shoreline.

**Photo: Access corridor in Lake Proper.**
