# LAKE ASSESSMENT REPORT

## CONCORD, LAKE

8 /9 /2000

# Lake Concord

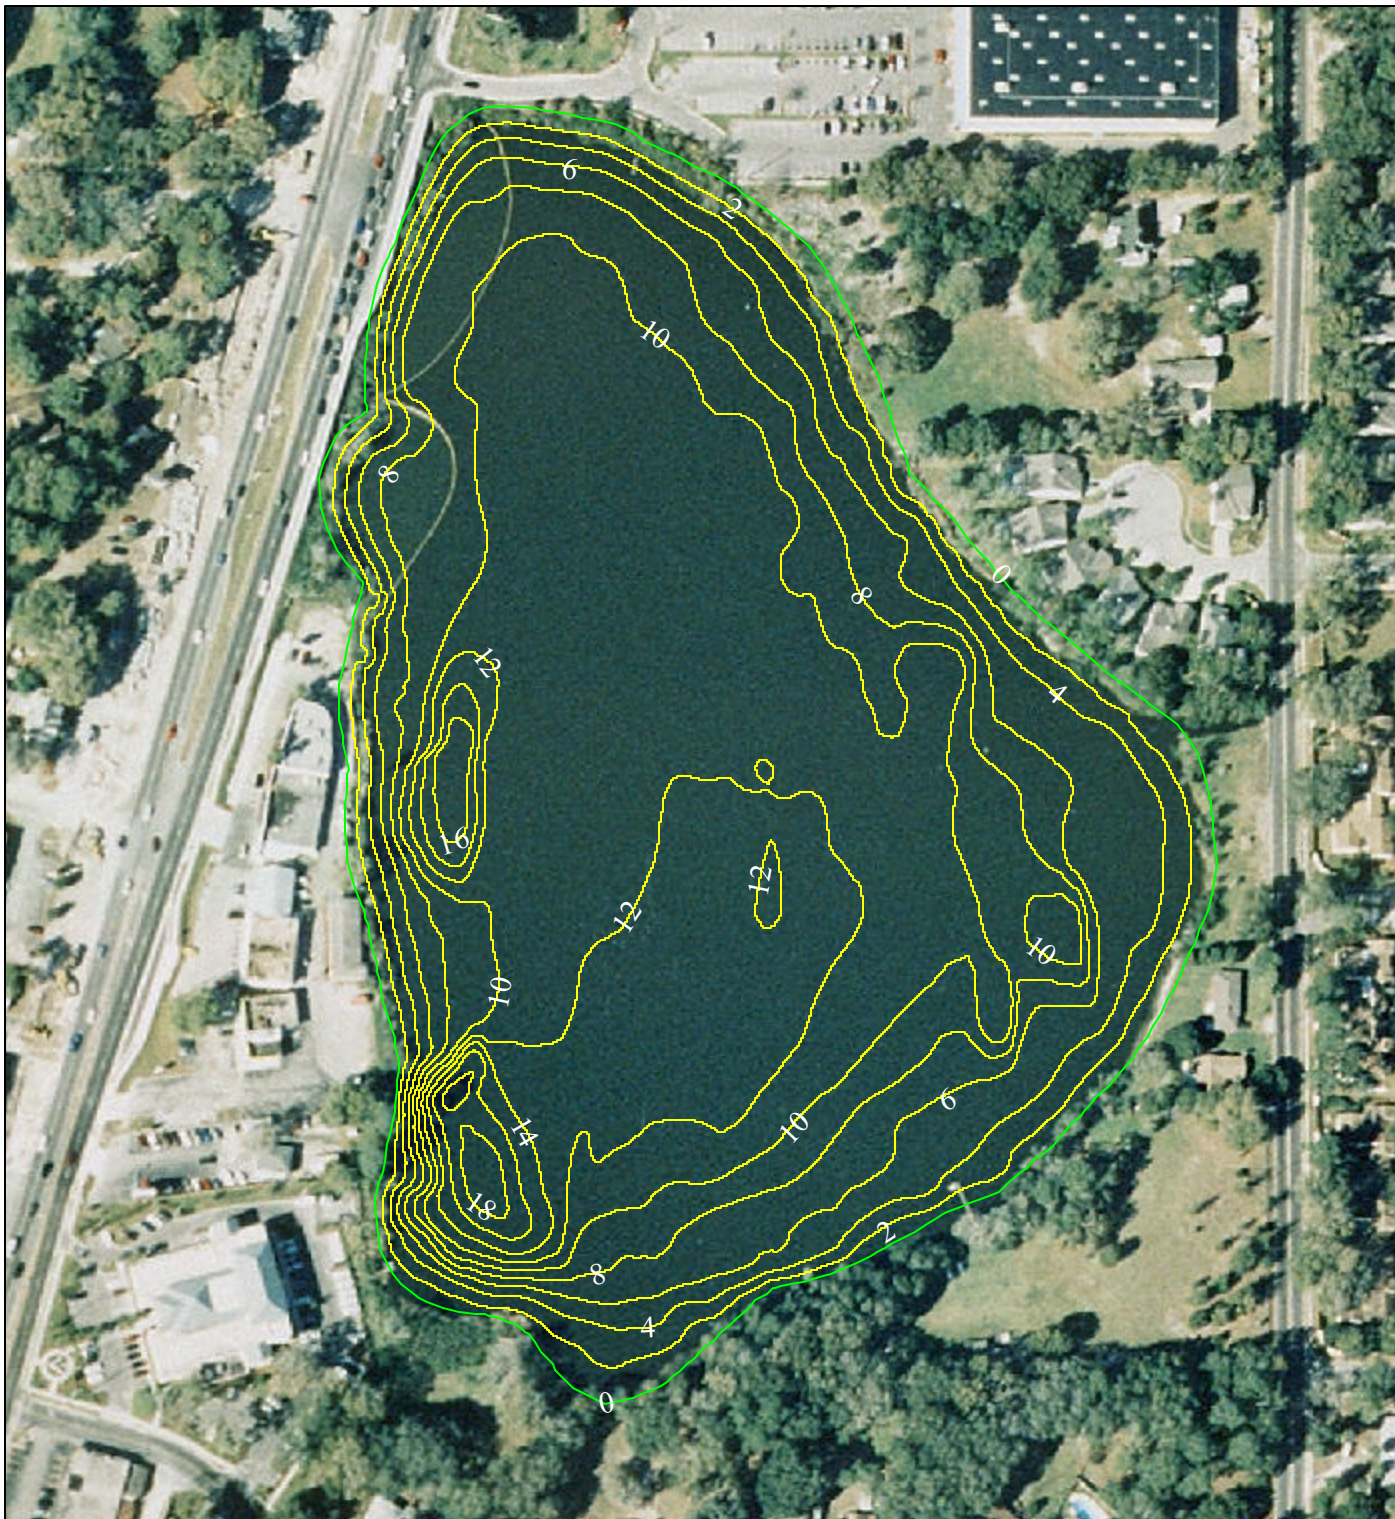
Contour Lines  
Expressed in  
2-Foot Intervals

Estimated Lake  
Perimeter

Assessment Date: August 7, 2000.

Lake water level was 58.1 ft.  
above sea level when the lake was  
assessed. Contours are expressed in  
absolute depth below this level.

Seminole County 1999 color aerials  
provided by Seminole County Public  
Works. All contours generated by  
Florida Center for Community Design  
and Research based on GPS/Sonar  
data provided by the Seminole County  
Stormwater Division.

The bottom of the lake was mapped using a Global Positioning System (GPS) to determine the boat's position, and a depth-finder to provide depth associated with that measured position. The result is an estimate of the lake's area, mean and maximum depths, and volume (Table 1) and the creation of a bottom contour map. *NOTE: This map is for recreational purposes only.*
