LAKE ASSESSMENT REPORT

EAST LAKE

8 /3 /2001

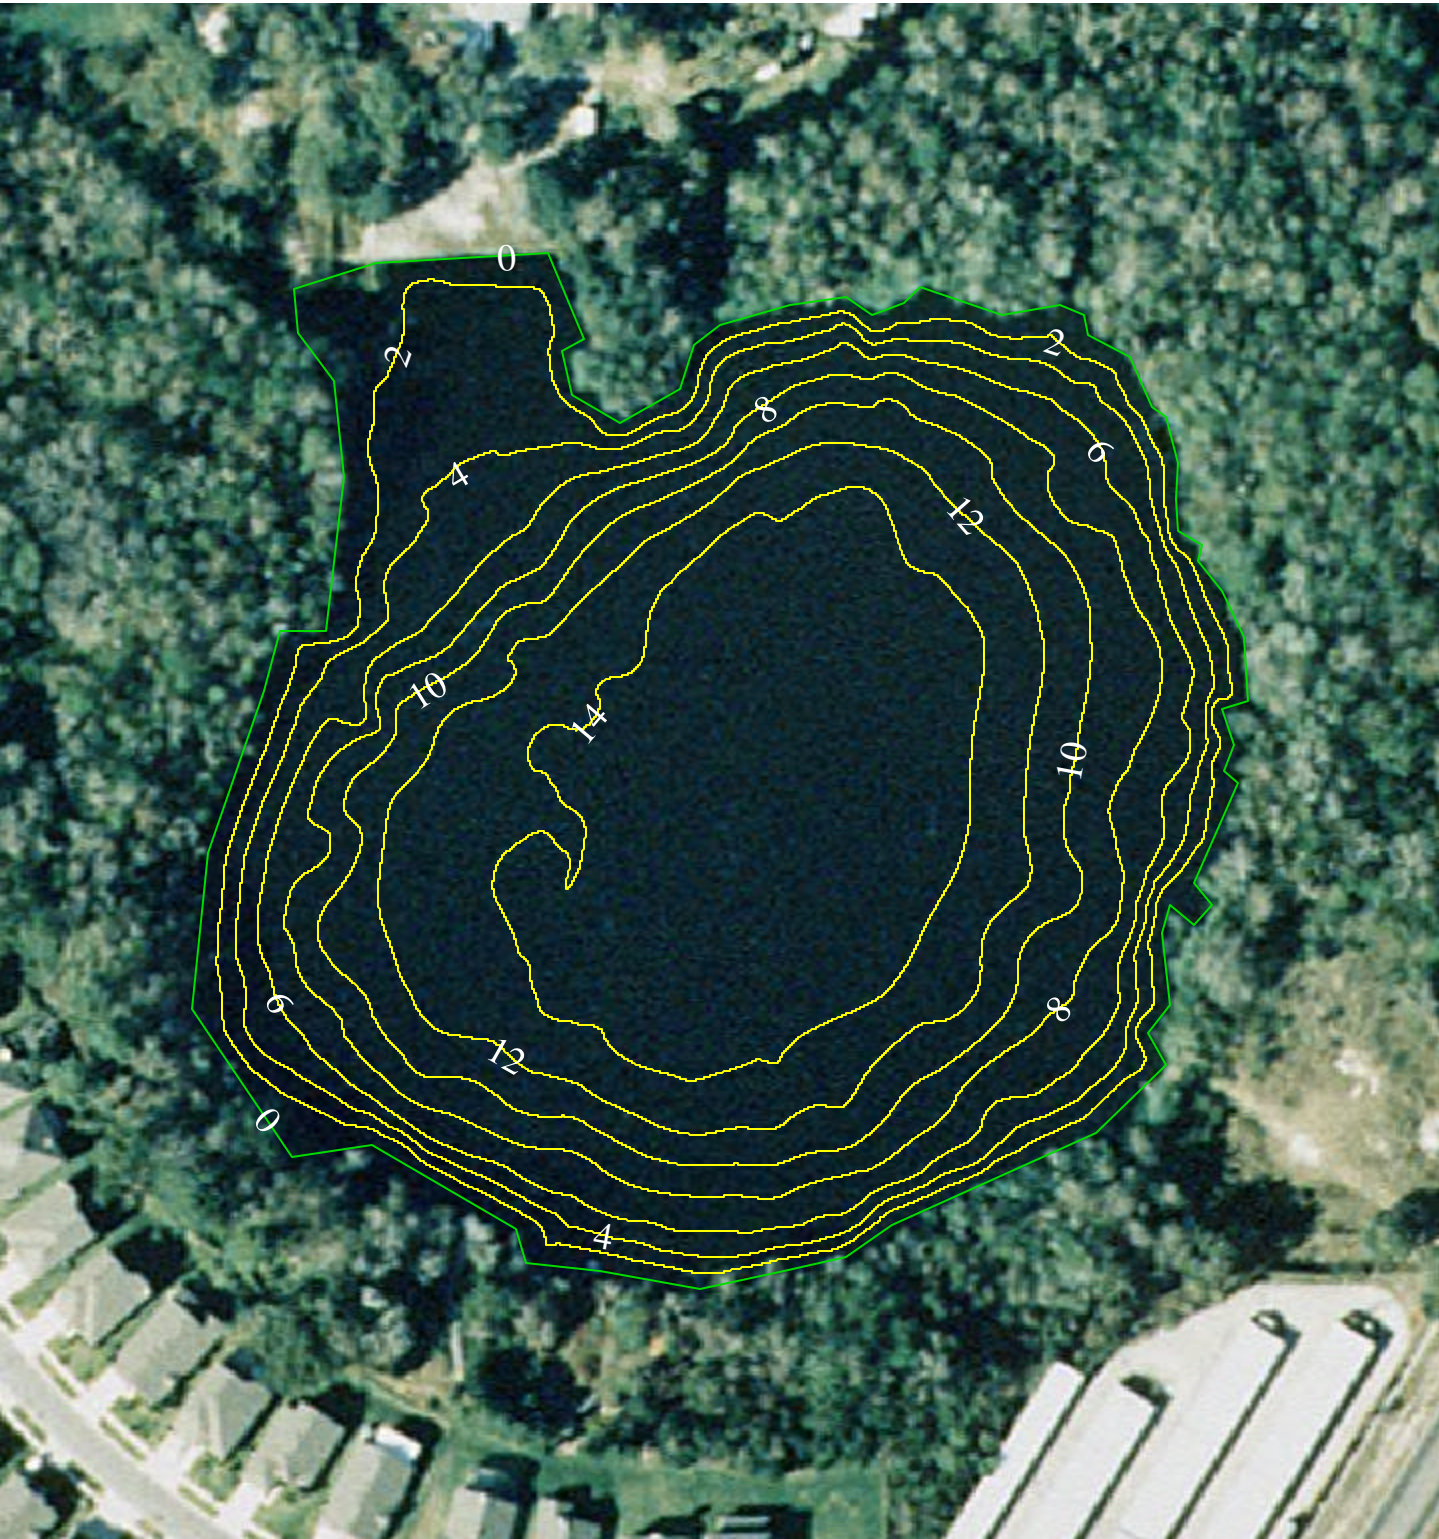
East Lake

Section - Township - Range
32-20-30

EXPLANATION:
Assessment Date: August 3, 2001.
Lake water level was 58.9 ft.
above sea level when the lake was
assessed. Contours are expressed in
absolute depth below this level.

DATA SOURCES:
Seminole County 1999 color aerials
provided by Seminole County Public
Works. All contours generated by
Florida Center for Community Design
and Research based on GPS/Sonar
data provided by the Seminole County
Stormwater Division.
