# LAKE ASSESSMENT REPORT

## RESERVOIR LAKE

5 /28/2002

# Reservoir Lake

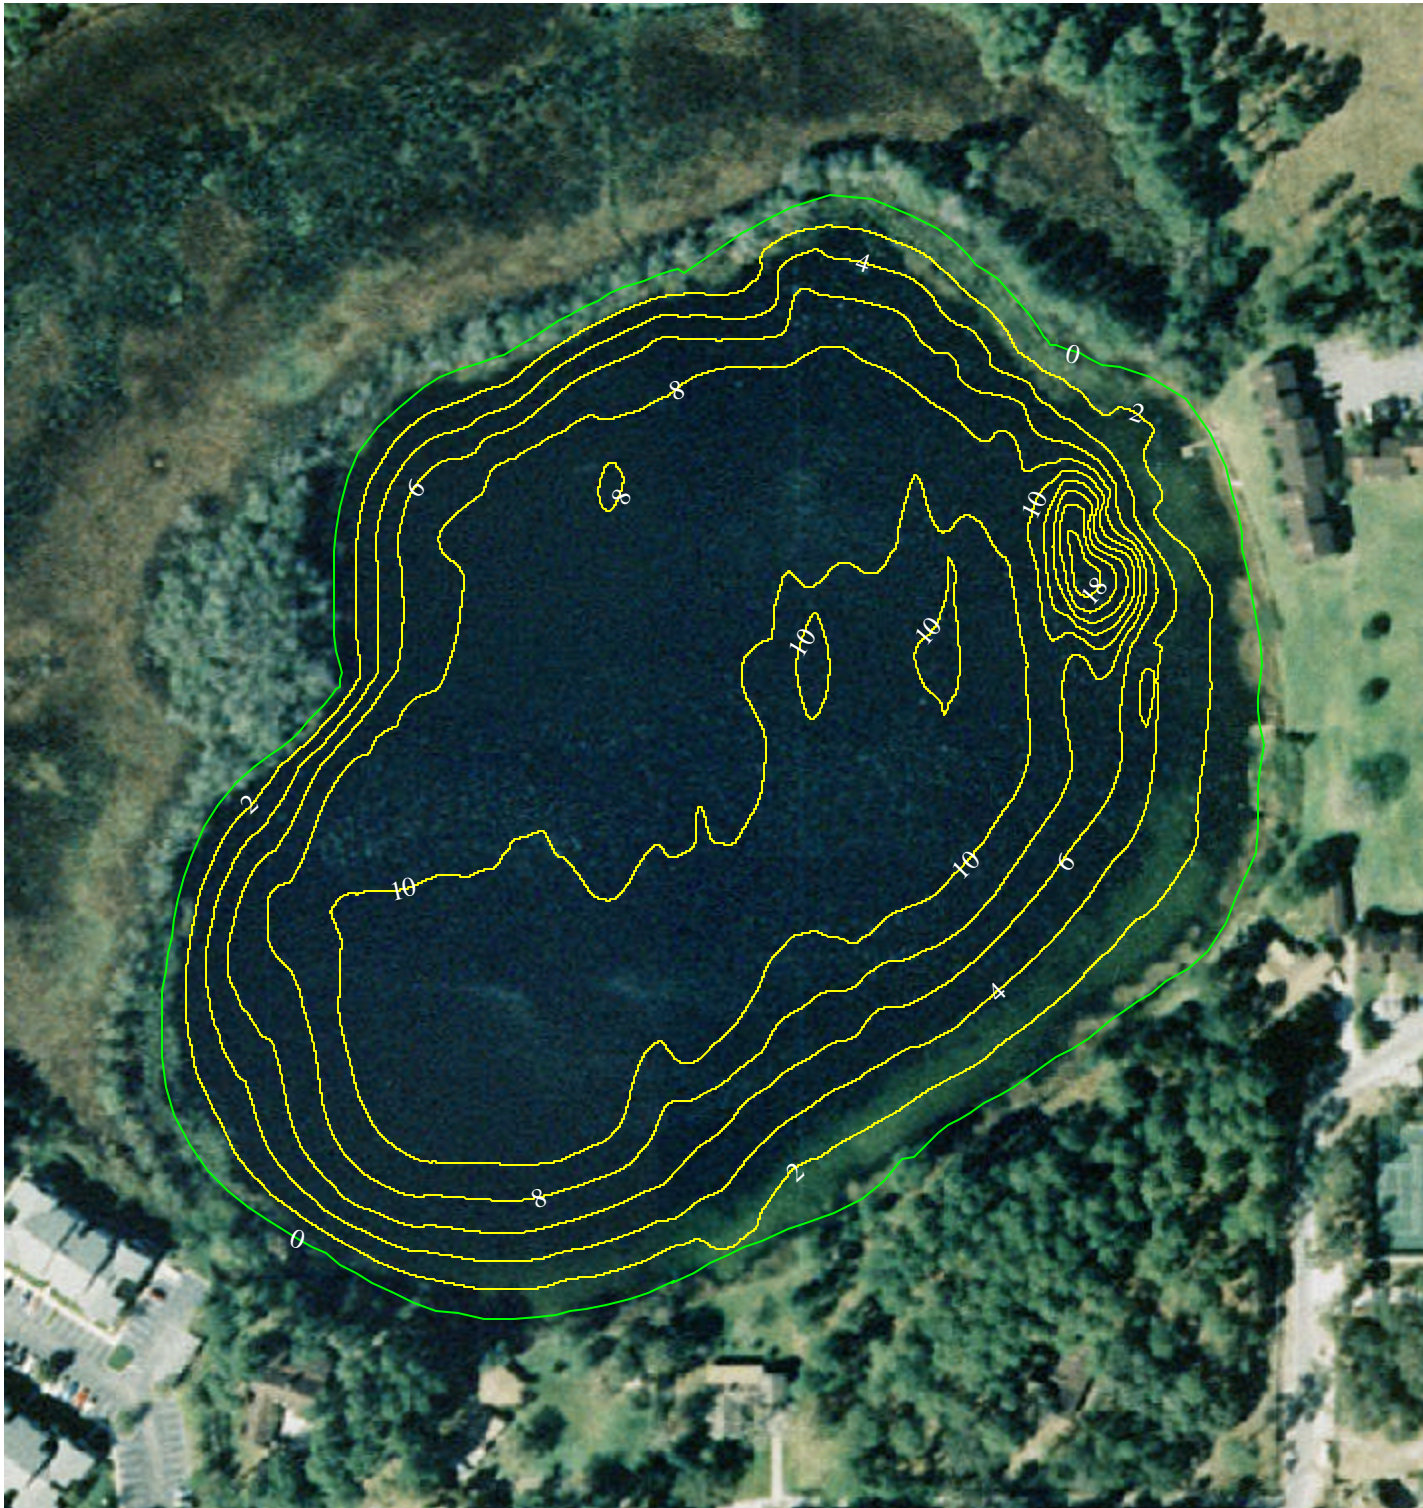
Contour Lines  
Expressed in  
2-Foot Intervals

Estimated Lake  
Perimeter

Assessment Date: May 28, 2002.  
Lake water level was 43.35 feet above sea level when the lake was assessed. Contours are expressed in absolute depth below this level and may not exclude the presence of submersed aquatic vegetation.

Seminole County 1999 color aerials provided by Seminole County Public Works. All contours generated by Florida Center for Community Design and Research based on GPS/Sonar data provided by the Seminole County Stormwater Division.
