### Lake Observations:

**On May 24, 2011**, Seminole County Lake Management Program staff Gloria Eby and Thomas Calhoun, joined by county intern Aisha Umar, surveyed the aquatic plants in Prairie Lake. Hydrilla has expanded significantly since last inspection. We are observing hydrilla re-establishing in the inshore area to a depth of 12 feet and within the cove. Hydrilla biomass increases at depths of 8-10 feet with the average plant sample being 4 feet in length. Portions of Prairie Lake contained an algae bloom as result of the hydrilla plant reaching surface where it decomposes and fuels algae growth.

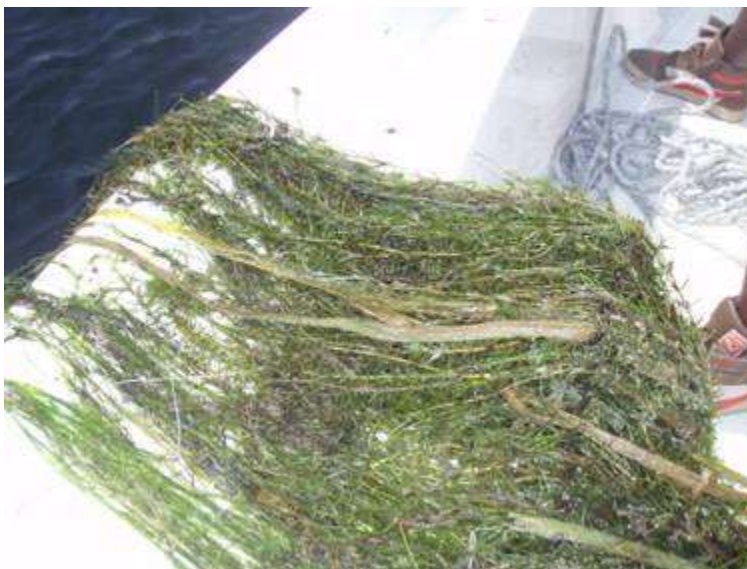
Photo of hydrilla biomass

Lake recommendations discussed for Prairie were to proceed with grass carp stocking to impact hydrilla in the deep water of Prairie Lake and to spot treat hydrilla in cluster areas inshore with FWC permit. Locations with concentrated biomass are: cove, cove entry, inflow pipe from Maltbie, inflow pipe south of lake (by exclusion cage) and shallow areas near American Legion hall.

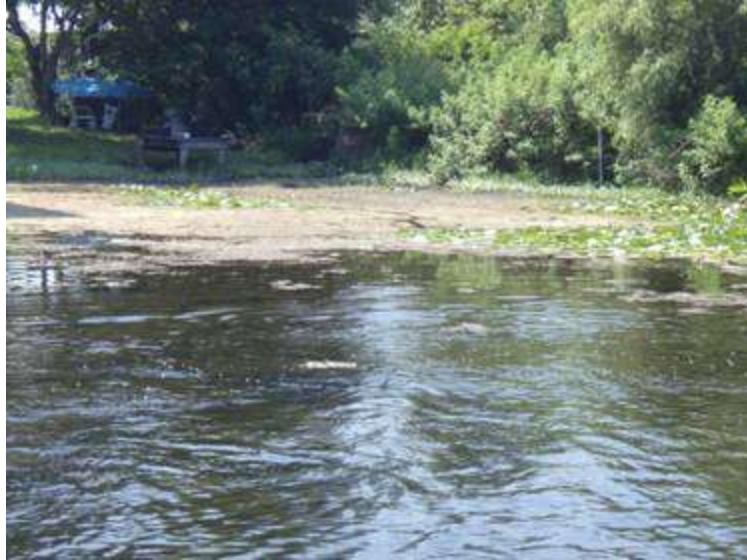
*Photo of algae as result of hydrilla decomposing at surface:*

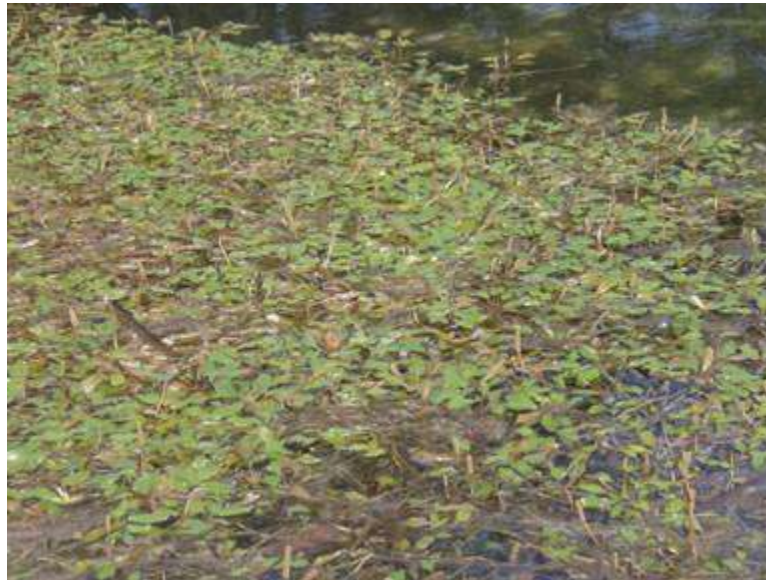
Hydrilla was found competing for space with native SAVs such as eelgrass (*Vallisneria americana*) also found to a maximum depth of 12 feet. Additional native SAV from inshore to depths of 9-10 feet includes the following: stonewort (*Nitella* sp.), southern naiad (*Najas guadalupensis*), bladderwort (*Utricularia radiata* and *U. inflata*), coontail (*Ceratophyllum demersum*) to 4 feet, and pondweed (*Potamogeton illinoensis*) to 5.5 feet. Pondweed was found surfacing at locations from the cove to southwest corner of lake and portions along north shoreline from canal to Pearl Lake blocking some boating access. Once pondweed reaches the surface, the leaf structure changes making it appear as a different plant. This is called leaf dimorphism.

*Photo of pondweed and dimorphic leaves:*

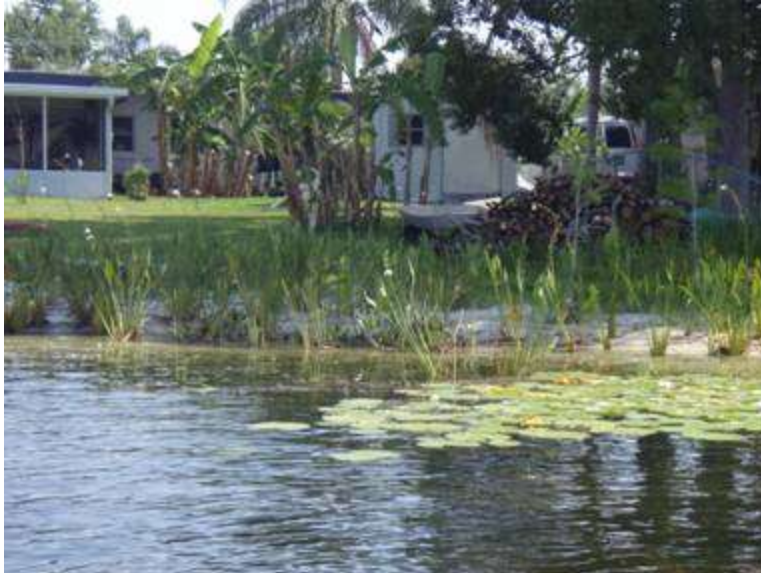
Most of the September 11, 2010 Prairie Lake plantings are doing extremely well to where natives are expanding. All these sites do need maintenance, especially to prevent torpedo grass from re-establishing and expanding. The Secchi reading (measurement for water clarity) was 10.5 feet in depths of 18.1 feet as compared to previous measurement of 7.6 feet in 10.5 feet.

*Photo of replanted shoreline:*
