Greetings Spring Lake Residents!

On **December 5th, 2015**, Seminole County Lake Management staff, Thomas Calhoun, Joey Cordell, and Beth Beals, surveyed the aquatic plants in **Spring Lake**.

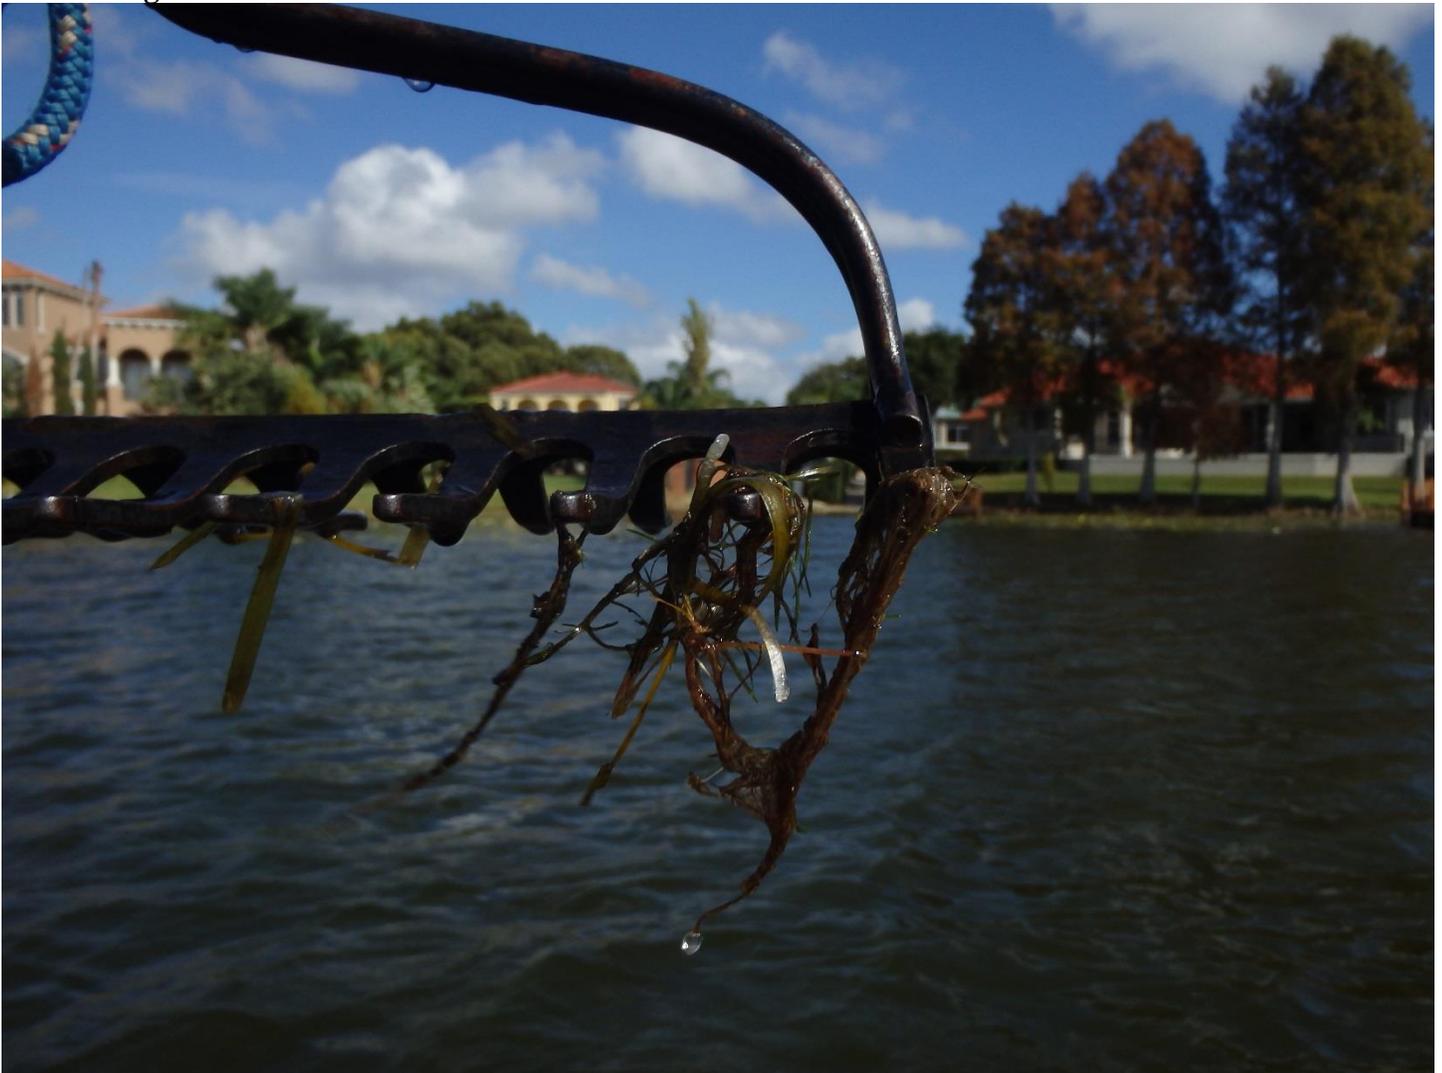
Two species of submersed aquatic vegetation (SAV) were observed during the inspection. These species were southern naiad to 3 ft and eelgrass to 3 ft. Eelgrass was the dominant SAV.

Photo: Eelgrass and southern naiad.

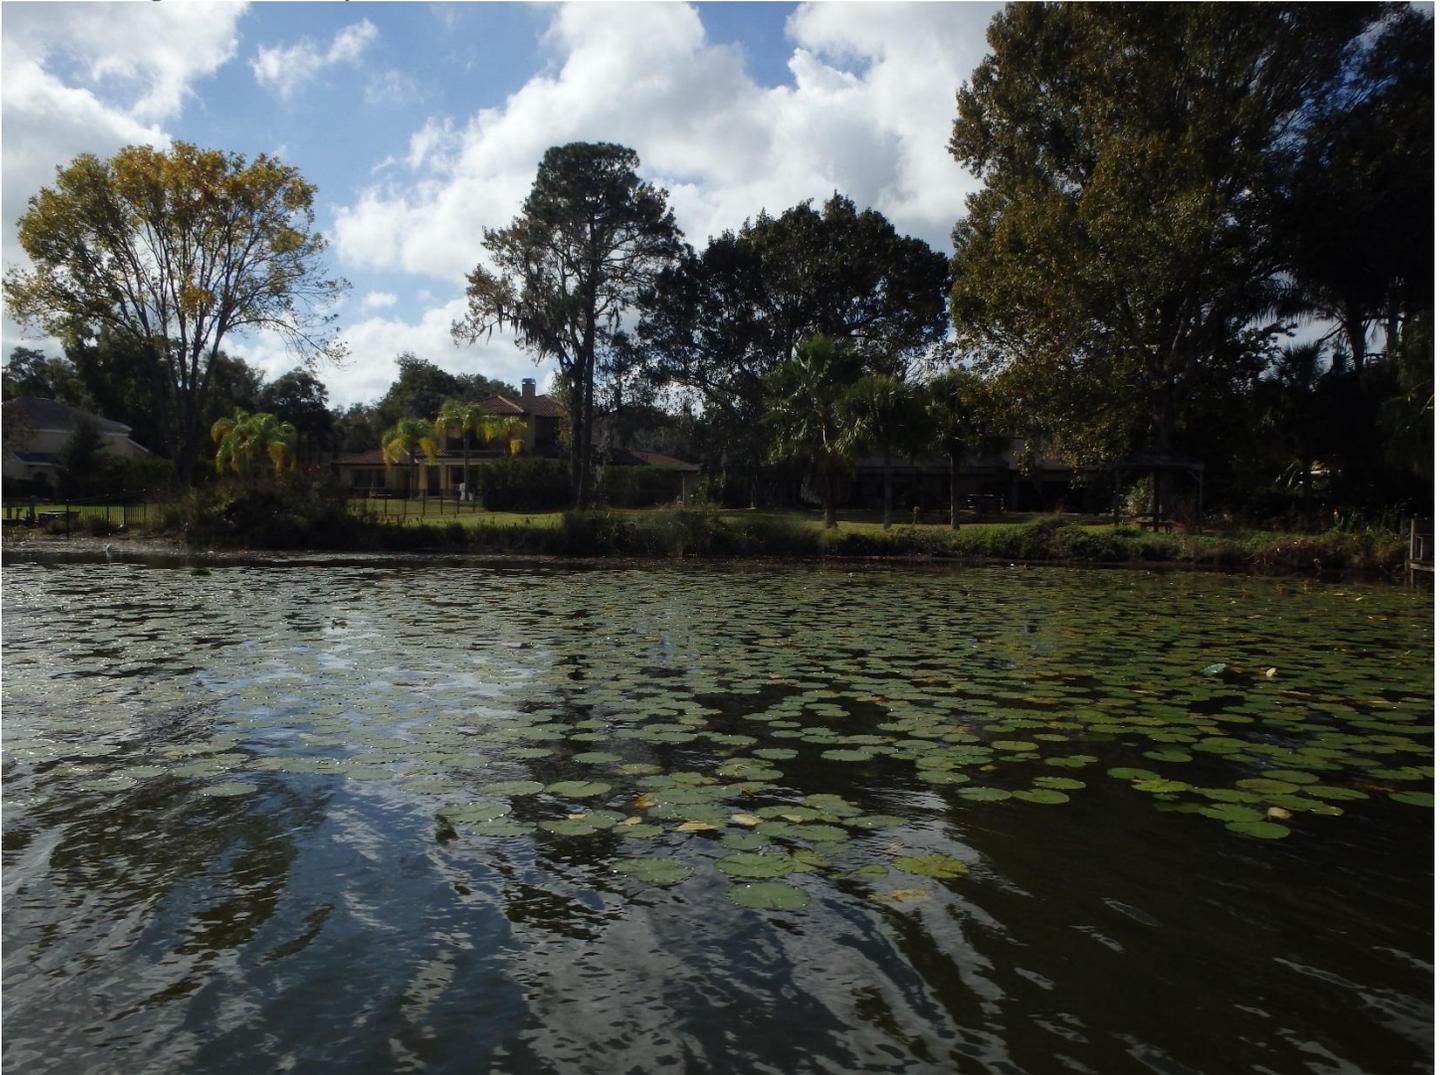
Native shoreline vegetation is very low on Spring Lake. Native emergent vegetation found during the inspection included: rush fuirena, hempvine, spatterdock, fragrant water lily, pickerelweed, carolina willow, bulrush, fire flag, cattail, and goldenrod.

Photo: Fragrant water lily.

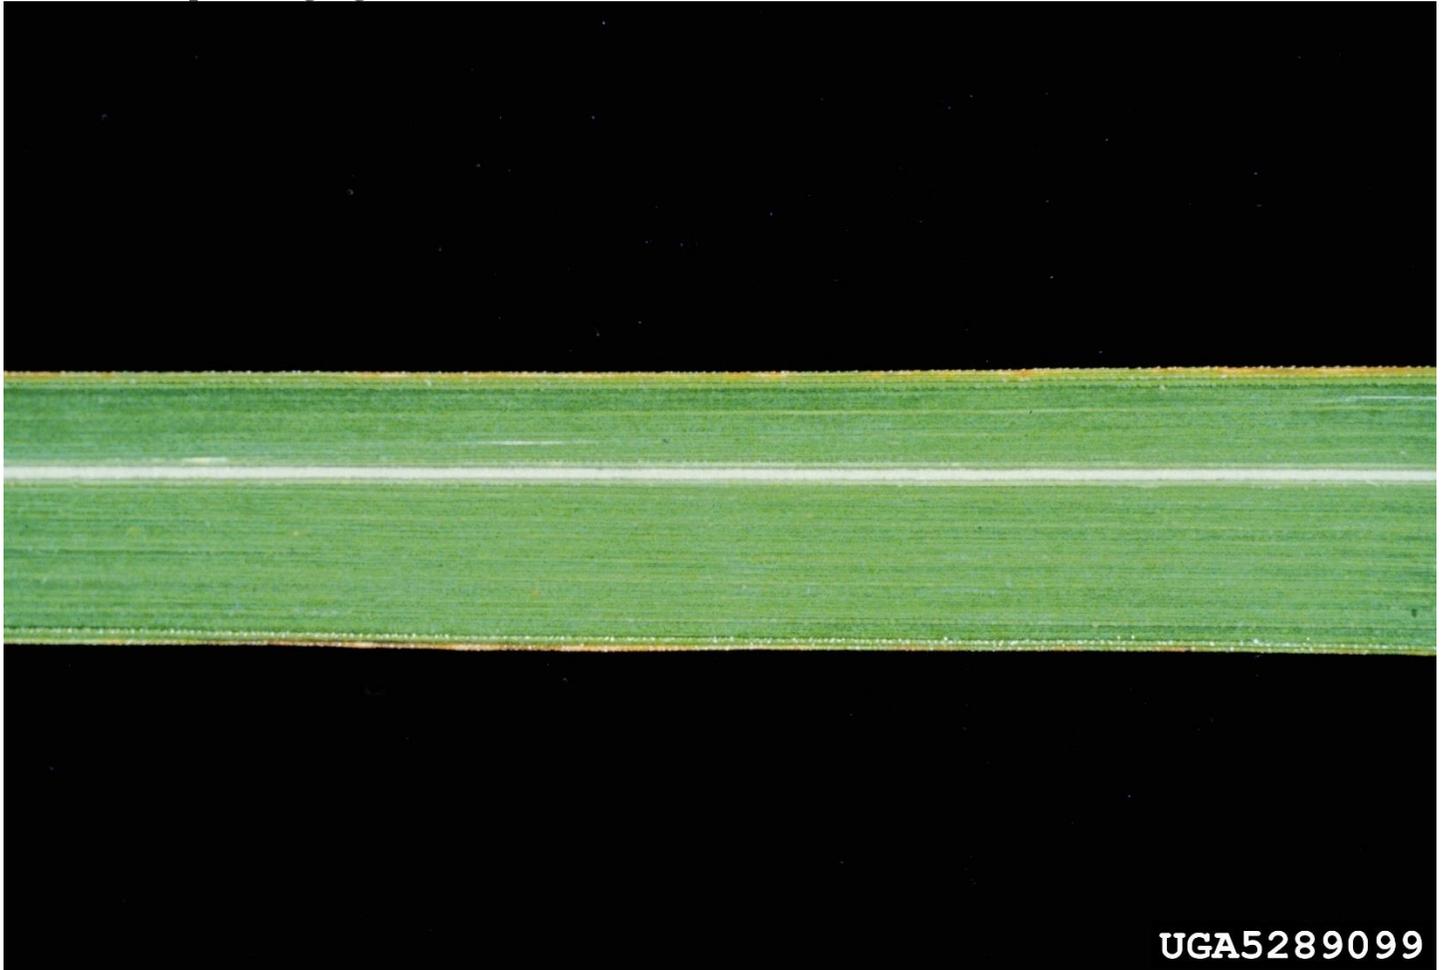
Invasive emergent vegetation found during the inspection included: wild taro, umbrella sedge, primrose willow, torpedograss, creeping oxeye, and cogongrass. No alligatorweed was seen during the inspection. Cogongrass is an invasive species that was just recently found on Spring Lake. It was found on the southwest shoreline. The Florida Exotic Pest Plant Council has labeled it a Category I invasive species. Cogongrass is identified by its off-centered white vein.

Photo: Example of cogongrass blade.
